Inspection report for the property at
6754 Sample Lane USA

This report is prepared exclusively for **Bono**
On: **2018-10-01**

Orca Inspection Services LLC

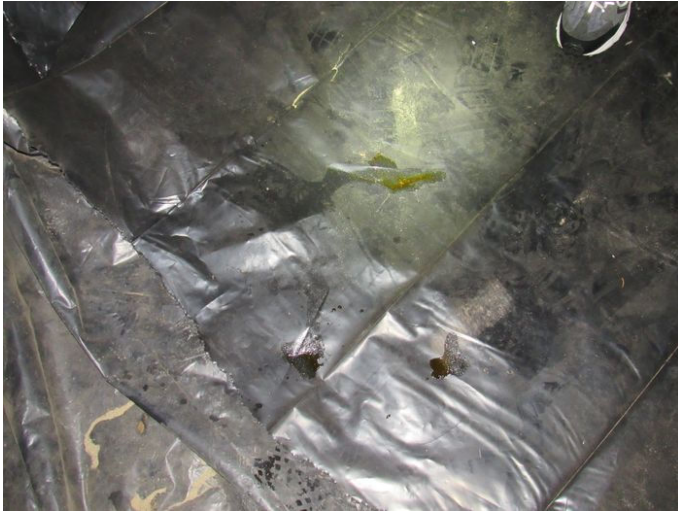
🔧 (PWDO-1) Repair: Minor rodent damage was noted in the crawl space below the house - see some urine stains on the vapor barrier. Rodent issues are very common in our climate and can often necessitate some on-going control and exclusion work. Hire a rodent control company to further investigate and clean the space and set and monitor traps to see if this is old or if any additional exclusion work is needed. Also, be sure to repair the damaged crawl space vent screens.

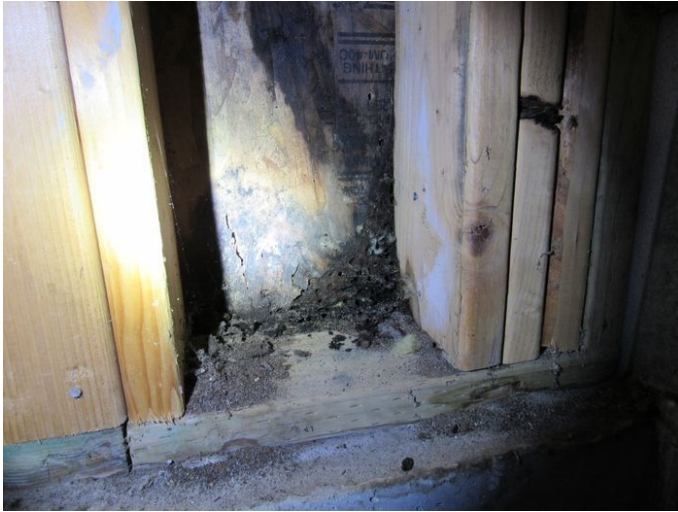
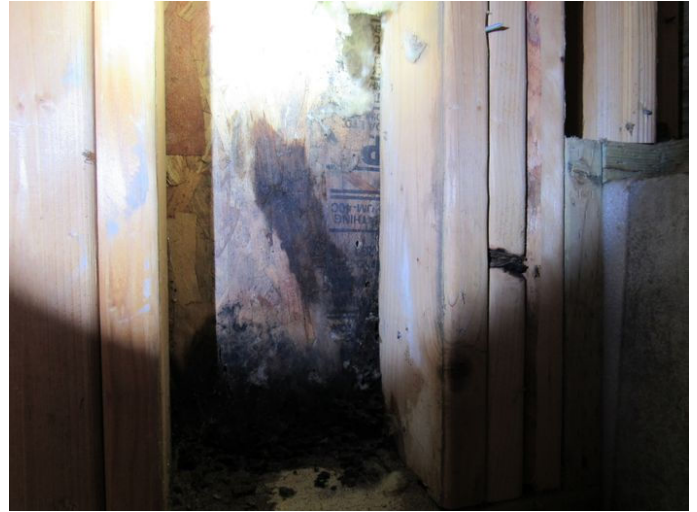
**(PWDO-2) Major Concern:** Moisture ant damaged wood was noted in a localized area of the building - see below the entry porch in the pony wall - west side of crawl space. Moisture ants are a wood destroying organism that indicate there is a problem with wet wood. They will often form nests and tunnels and can damage structural wood. Once repairs are made to eliminate the moisture sources, the ants typically go away, so treatment is rarely needed. In this case, **live ants were found** suggesting that the water problems require repair. Damaged sheathing was noted. This is a tricky spot where concrete is installed over the sheathing at the entry porch. I recommend additional inspection by a qualified contractor - repair as recommended.

Active moisture ant damage and activity - live ants were noted

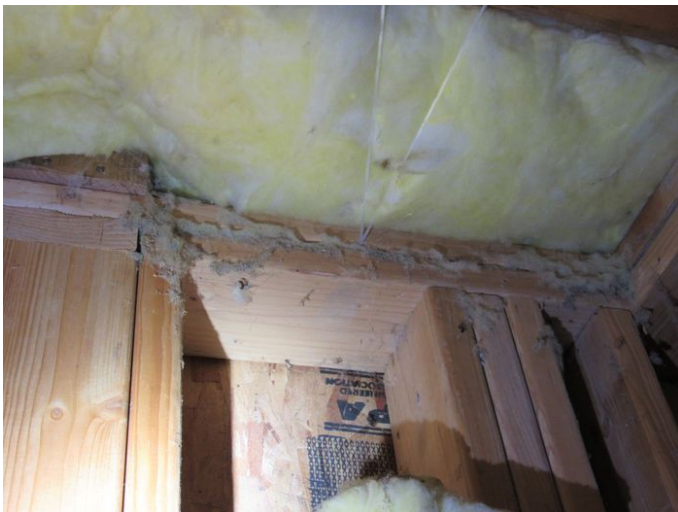
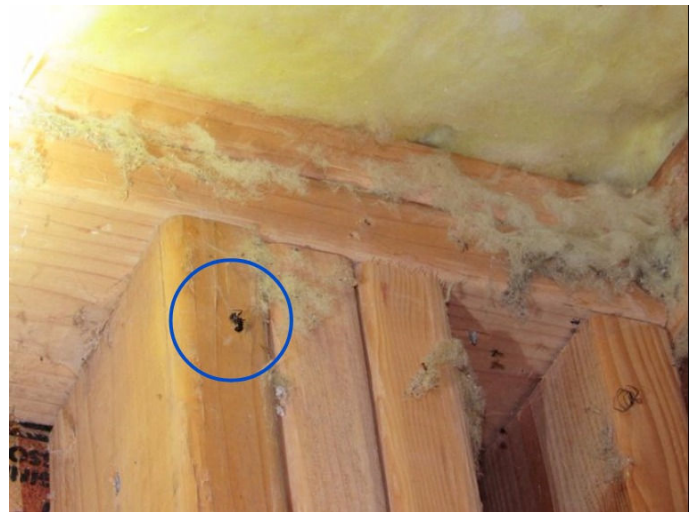
Dead carpenter ant also noted

👁️ 🐜 (PWDO-3) **Monitor:** Dead [carpenter ants](#) were noted during inspection today - see same location behind porch as the active moisture ant issues. No live ants were found during inspection, but a treatment may be needed. There is always a risk of hidden structural damage or a hidden moisture problem when there have clearly been carpenter ants in the home. Inquire with the seller for a history of repairs and treatment and monitor for large black ants. If ants are found, have the property evaluated and treated by a licensed pest control operator.

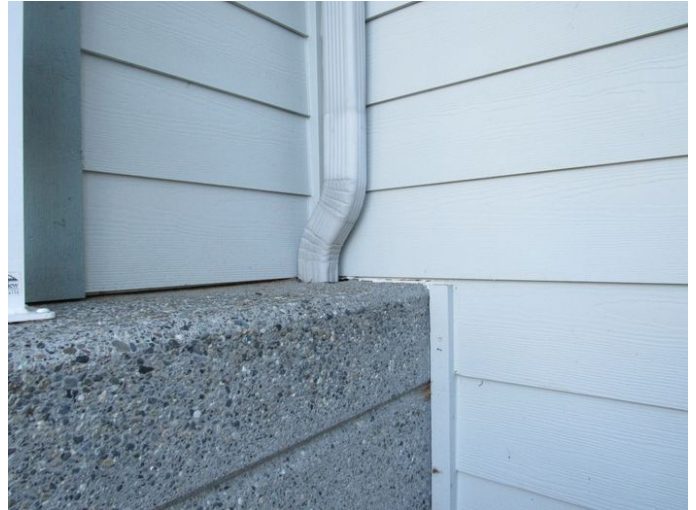
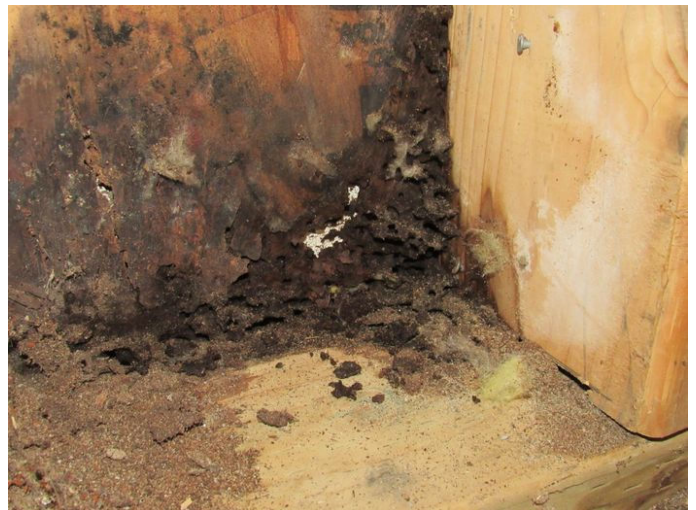
This shows the location of the moisture ant damage - west side of crawl space

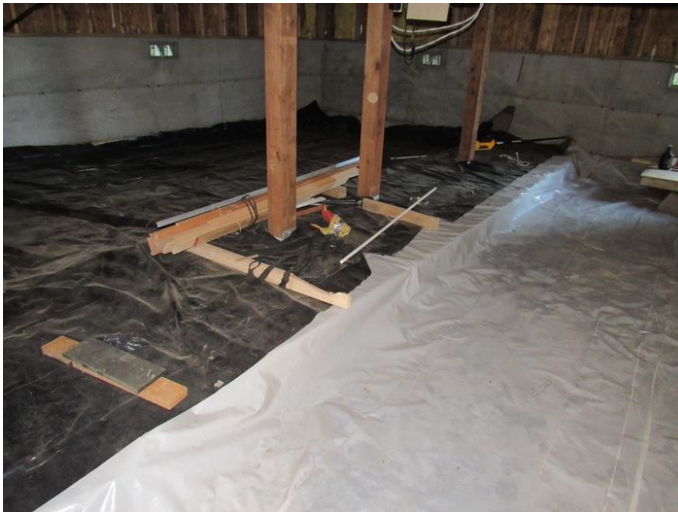
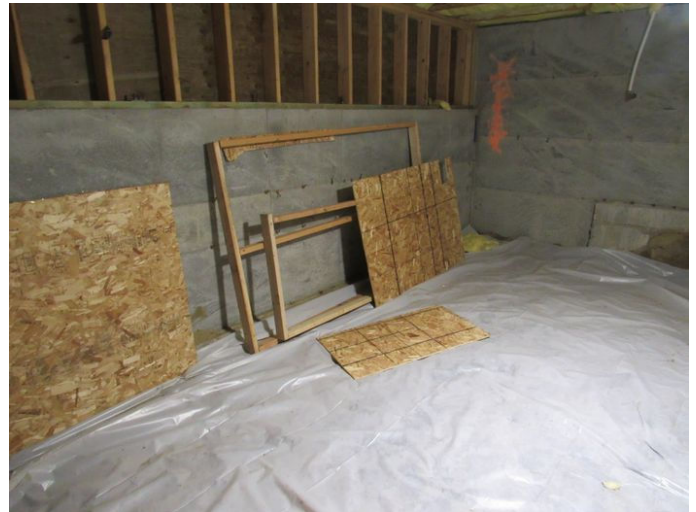
**(PWDO-4) Repair:** Wood and cellulose storage was noted in the crawl space. This can encourage wood destroying organisms. Removal of all cellulose debris from the crawl space is recommended to eliminate conditions conducive to wood destroying organisms.

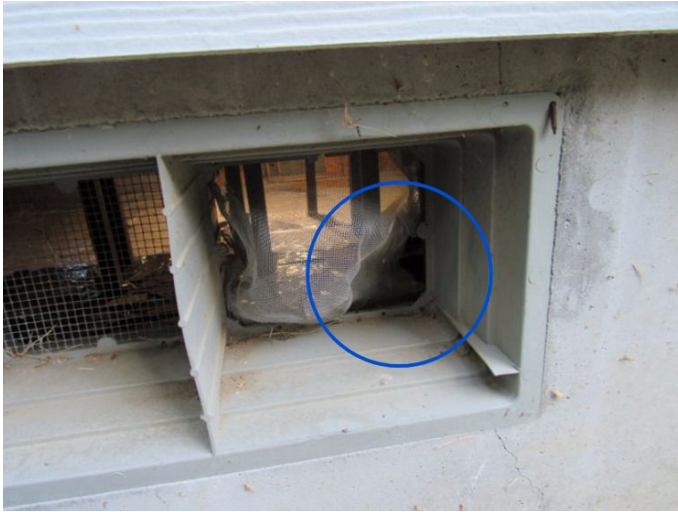
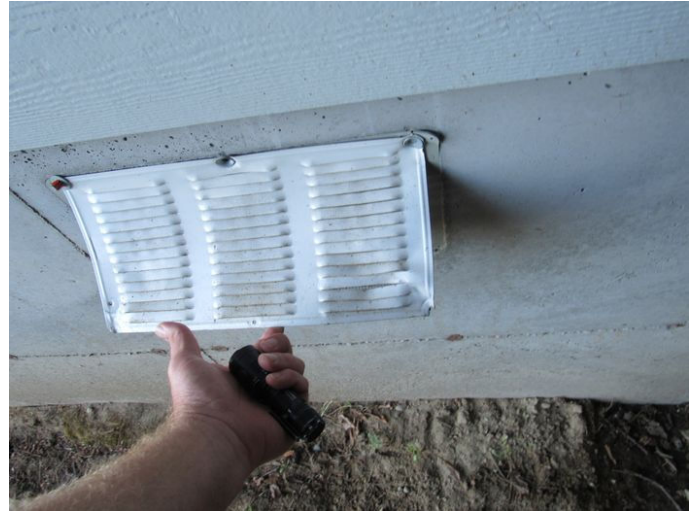
🔑 (CS-2) Repair: The screens for the crawl space vents are damaged and could allow rodent entry - see especially west side. Use 1/4 inch wire mesh screen and be sure all openings are well sealed to prevent rodent entry. Do not apply multiple layers of screen as this will restrict air flow.

This is below the south deck - remove this odd cover and be sure the screen is installed reliably.

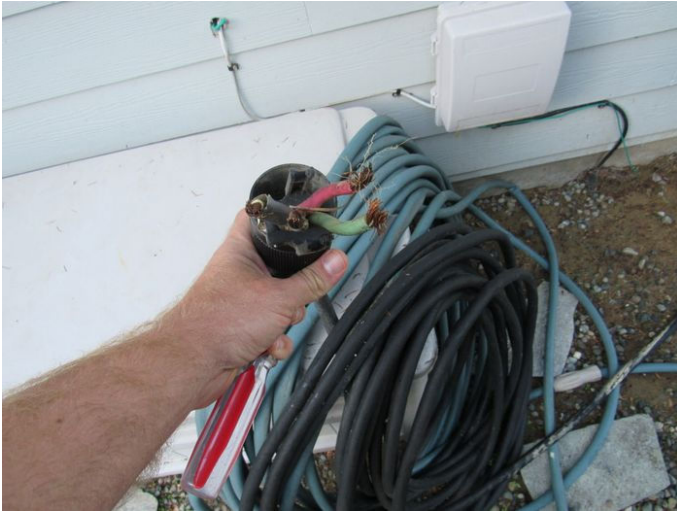
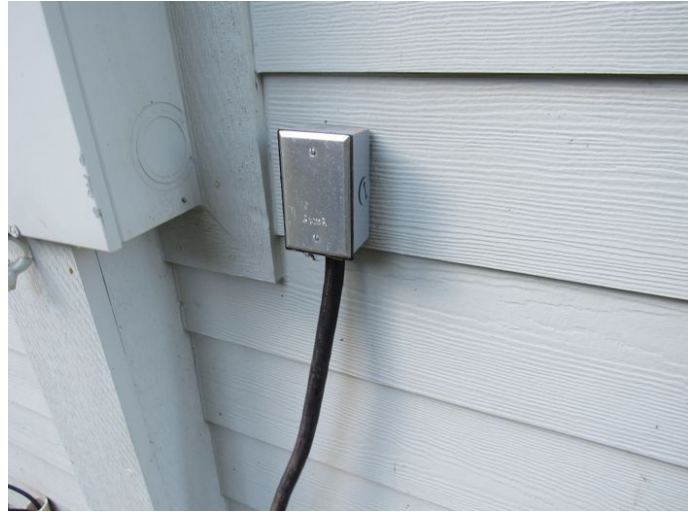
⚠️ (E-1) Major Concern: This building appears to be set up with [backup power from a generator](#). However, I did not find a transfer switch anywhere. These are critical: generator transfer switches must disable line load before generator loads can be opened up or you risk fatal injuries to linemen. Have this further evaluated and repaired as recommended by a licensed electrician.

The plug for the generator is also damaged

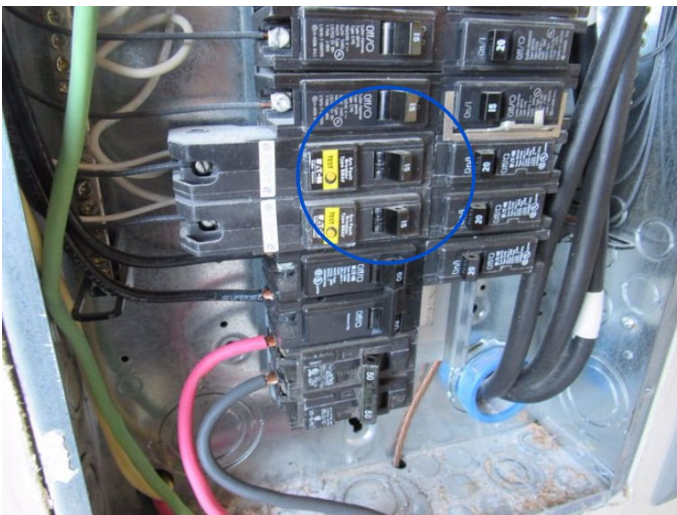
🔧 **(E-3) Improve:** The arc fault protection breakers in this panel are an older "branch feeder" model AFCI. These are first generation technology and they will not perform as reliably as new versions of arc fault protection known as "Combination" AFCI. Updating is recommended. Consult with a licensed electrician about updating to a combination AFCI where arc fault protection is desired and please note that our standards of where arc fault protection is required has changed over the years. How far you wish to go with updating is discretionary.

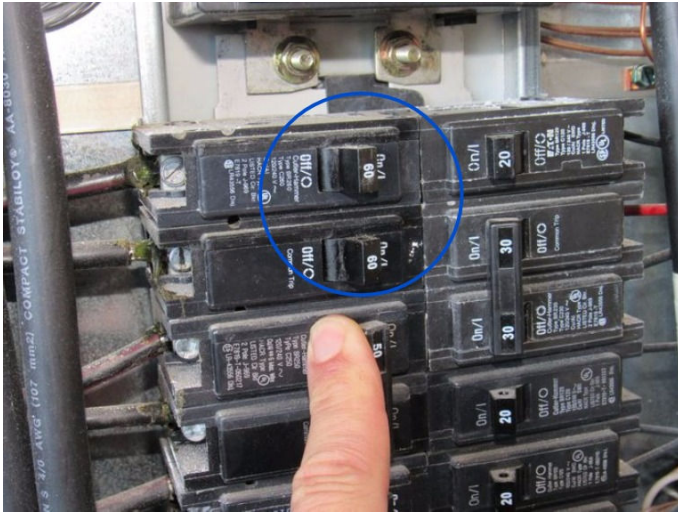
🔧 **(E-4) Repair:** Missing bridge connections were noted at the 240-volt circuits in the main electric panel - see right side panel. This risks only one pole of this circuit tripping. This is a

safety hazard that should be repaired by a licensed electrician.

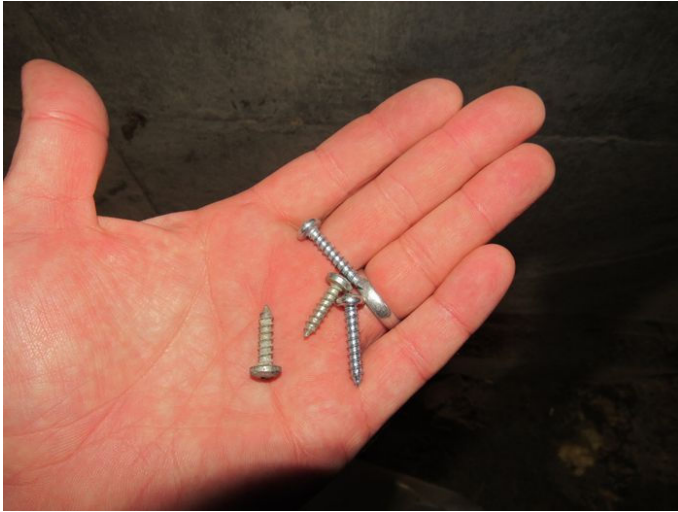
🔧 **(E-5) Repair:** Screws with sharp ends, like wood screws, are not recommended to secure the dead-front cover to the electric panel as these can puncture wiring insulation. Use blunt screws only.

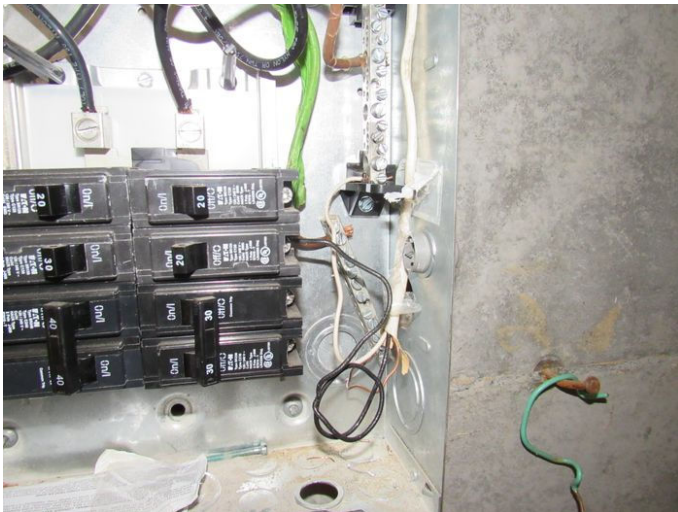
🔧 (E-6) Repair: Repair the over-fused circuit in the sub-panel. These #14s should be on a 15-amp breaker not a 40. Have a licensed electrician further evaluate and repair.

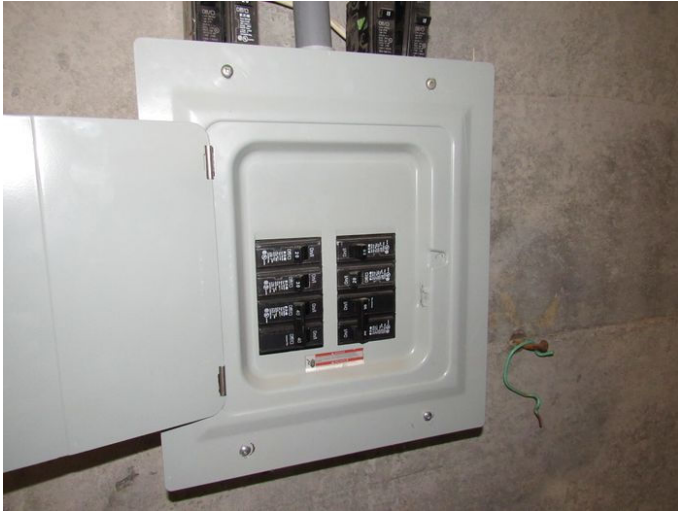
🔧 (E-7) Repair: Inadequate labeling of the breakers was noted during inspection of the sub-panel. This should be corrected for improved safety.

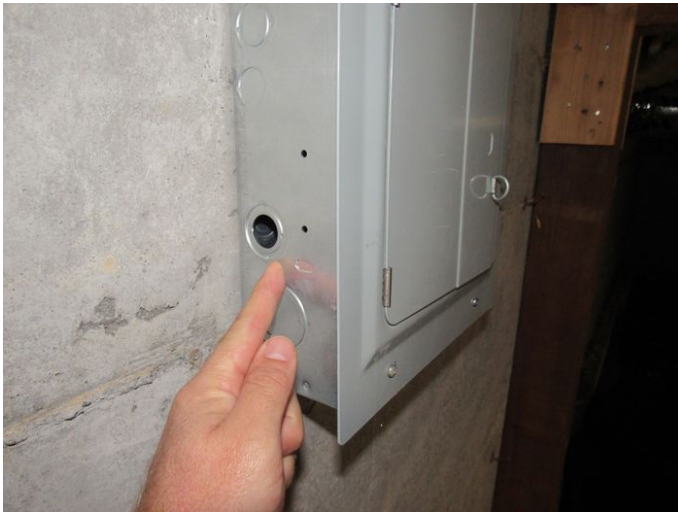
⚠ (E-8) Repair: Openings were noted in the sub-panel. This can allow unintended access to the wiring inside this sub-panel and can be a safety hazard. Cover all openings in the sub-panel.

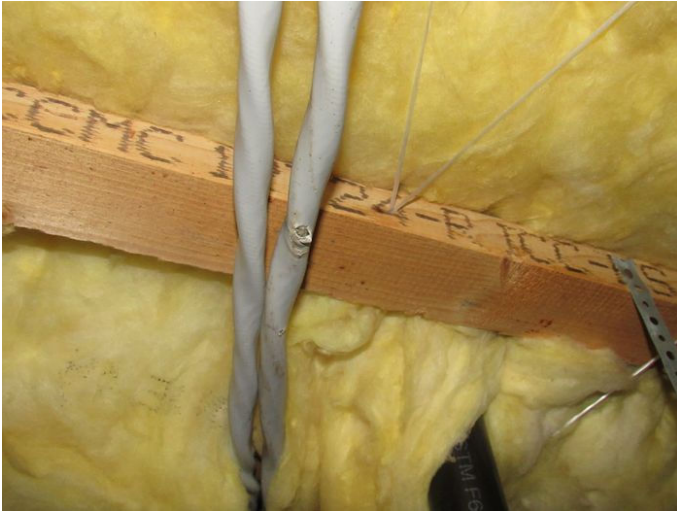
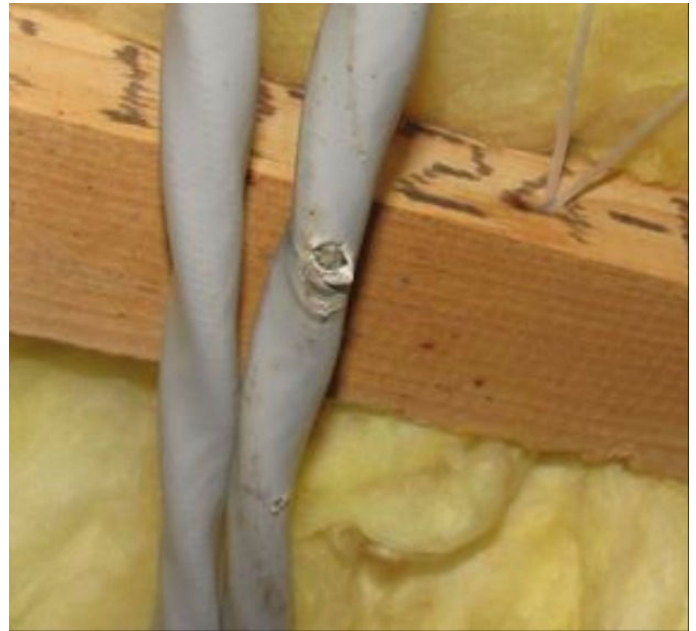
🔧 (E-9) Repair: Several nicks were noted on the wire cable in the crawl space - see NE corner. Cover damaged insulation on these cables.

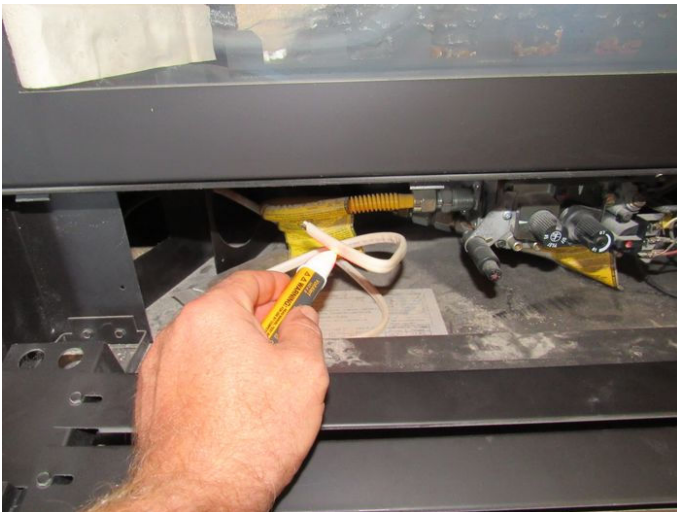
🔧 (E-10) Repair: Abandoned wiring was noted below the fireplace - master bedroom. This should be eliminated or properly terminated inside a listed junction box.

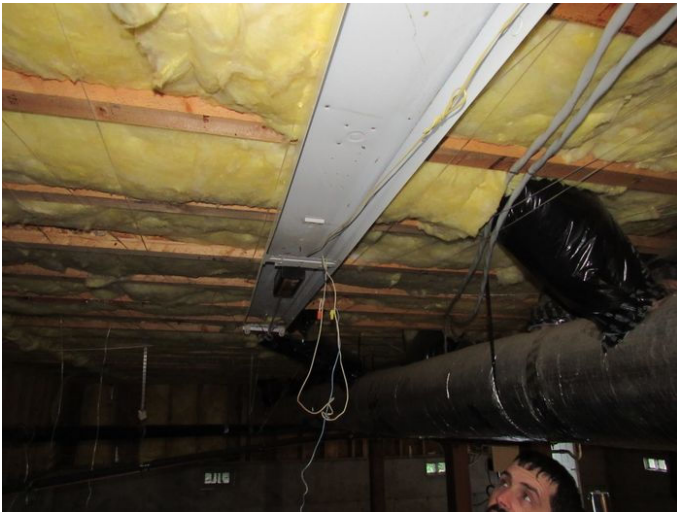
(E-12) Repair: Remove the abandoned lights in the crawl space.

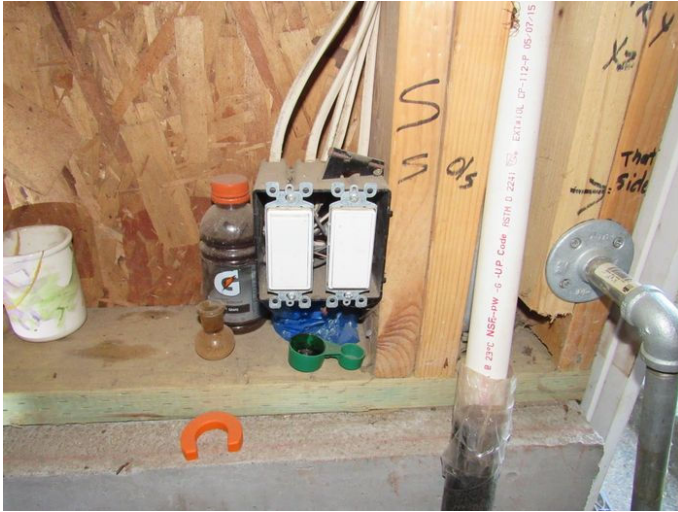
(E-13) Repair: The missing cover plates should be installed to cover all access to wiring at switches and receptacles - see switches in crawl space. Please note that extension rings may be needed as the reveal between the outlets and switches and the wall finishes is not even.

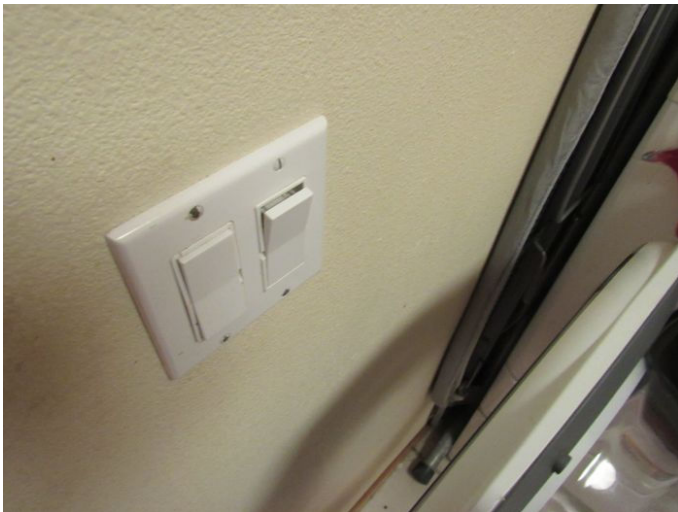
(E-14) Repair: The loose switch in the laundry room should be repaired or replaced as needed - see how the inside of the switch is exposed here.

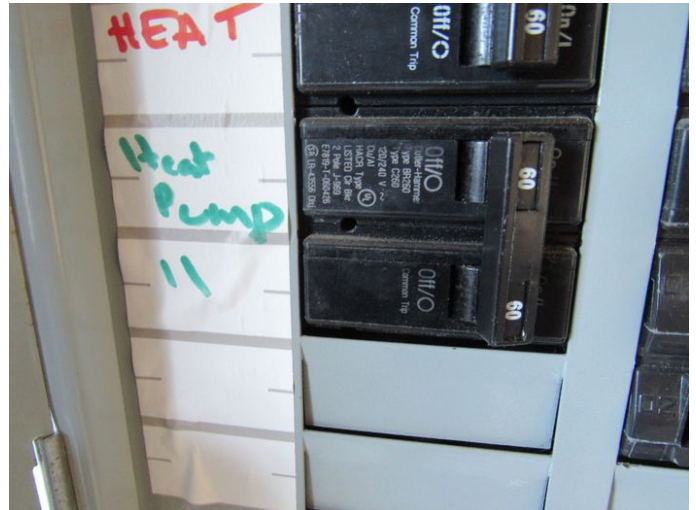
🔧 **(HCF-2) Repair:** The heat pump listing plate recommends over current protection for the heat pump compressor not exceed 40 amps. It appears that the heat pump is protected by a 60 amp breaker. Have this further evaluated and repaired as recommended by a licensed electrician to ensure the heat pump is adequately protected.

Hard to read but this says Max Fuse 40-amps

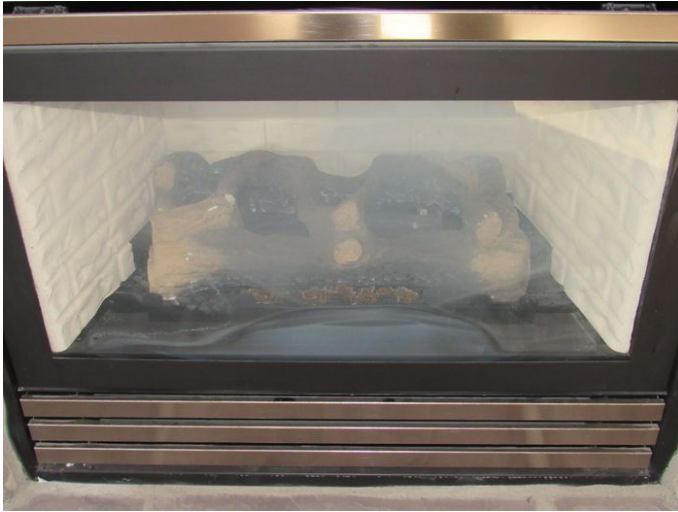
🔧 (HCF-5) Repair: The glass for the gas log fireplace is cloudy. Though very common, this is not the intended appearance of a decorative gas log fireplace. Sometimes, silicates from the logs can get etched onto the glass which can make cleaning nearly impossible. Hire a gas log specialist to service the gas log fireplace and clean or replace the glass as needed.

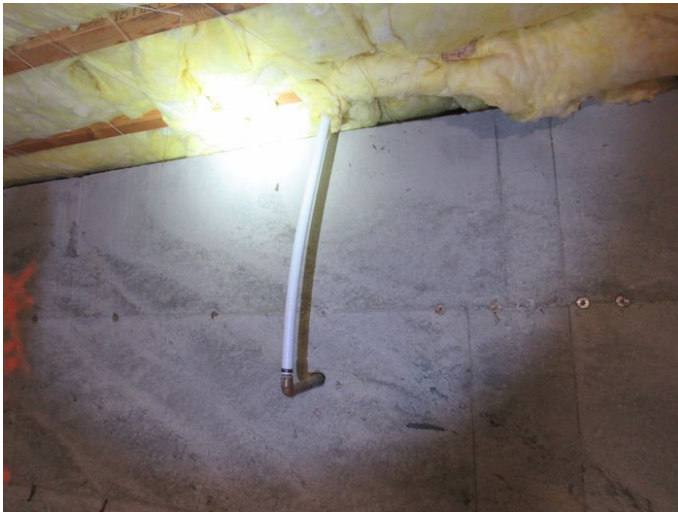
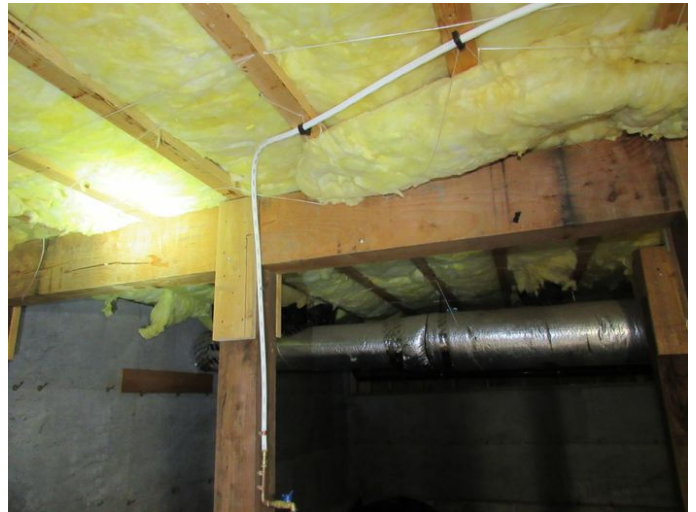
🔑 (P-3) Repair: The supply pipe insulation is incomplete in the crawl space. Be sure all supply lines in unheated spaces have been adequately insulated to protect from freezing conditions that could damage the pipes and to prevent heat loss from hot water pipes.

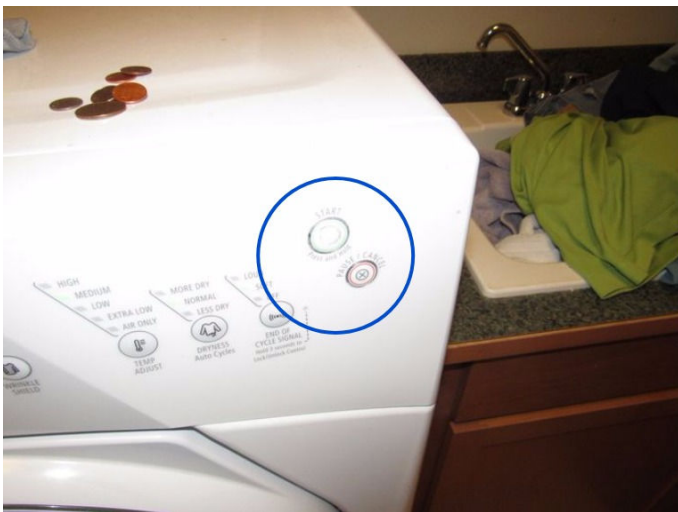
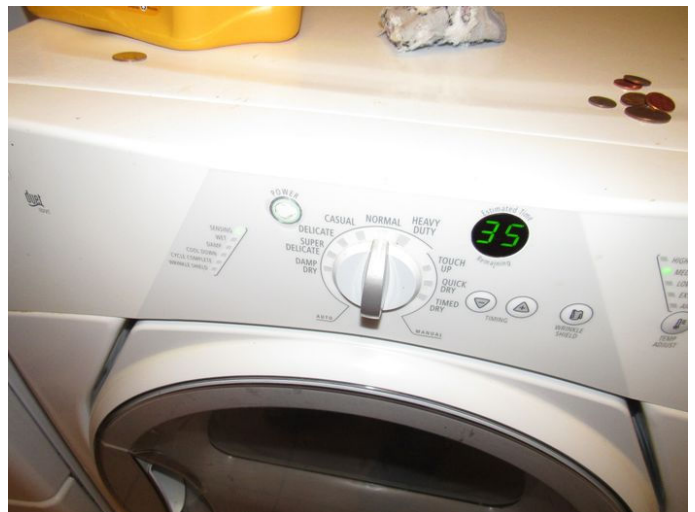
(P-9) Repair: The control panel buttons for the washer and dryer are damaged -see where the panels have worn through on primary control buttons. Repair as needed.

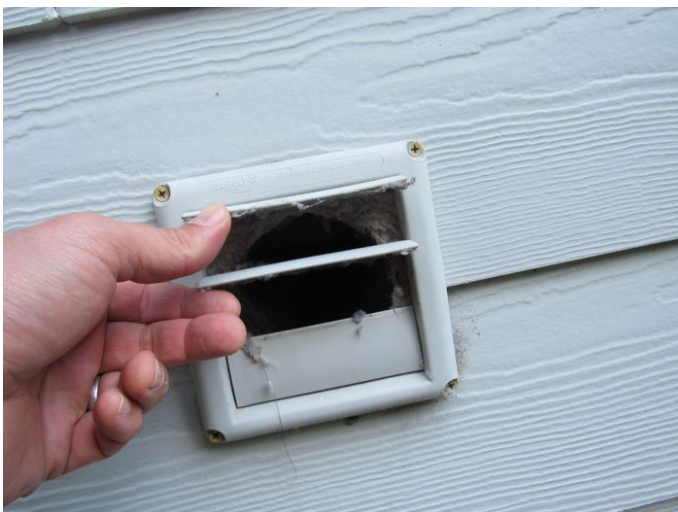
🔧 (P-10) Repair: The dryer exhaust duct should be cleaned for improved safety. This is important regular maintenance to eliminate a potential fire hazard.

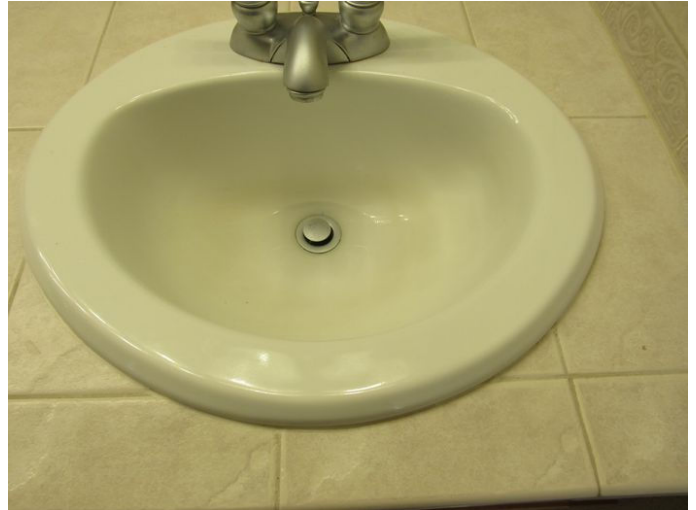
**(MB-1) Repair:** The trap seal is too deep for the right side master bath sink - this should not exceed 4 inches. Have this drain piping further evaluated and repaired by a licensed plumber.

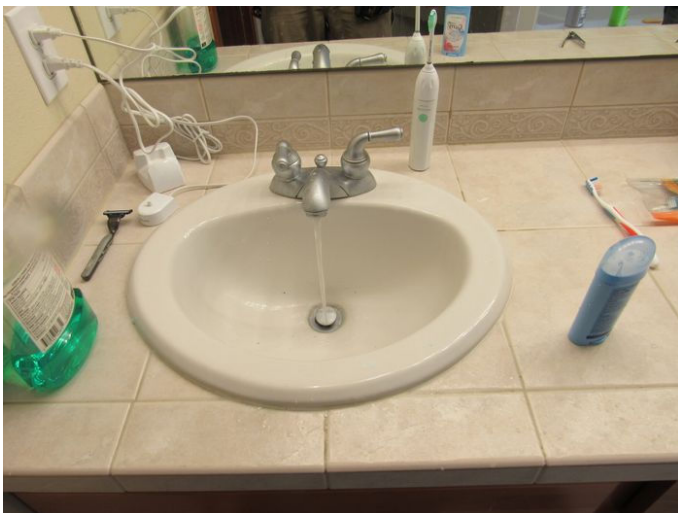
🔧 (MB-2) Repair: Poor functional flow was noted at this bathroom sink - see especially hot water at the left side sink. This may be from localized restrictions in the aerator, supply hoses or angle stops, or it may be indicative of a larger problem with the supply plumbing system. Hire a licensed plumbing contractor to further evaluate and repair.

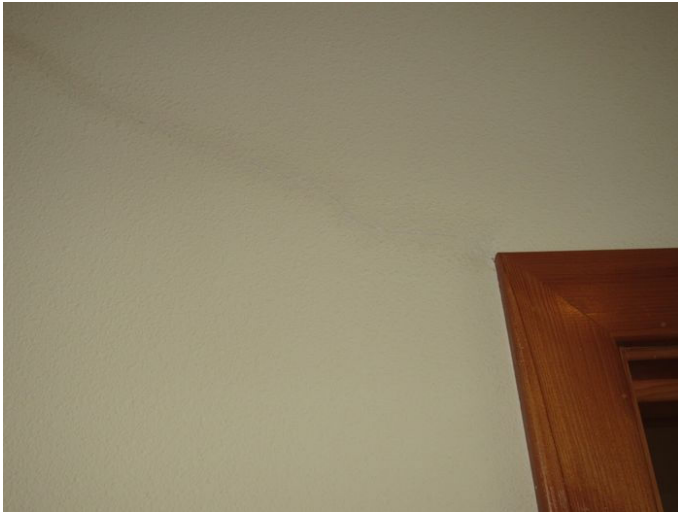
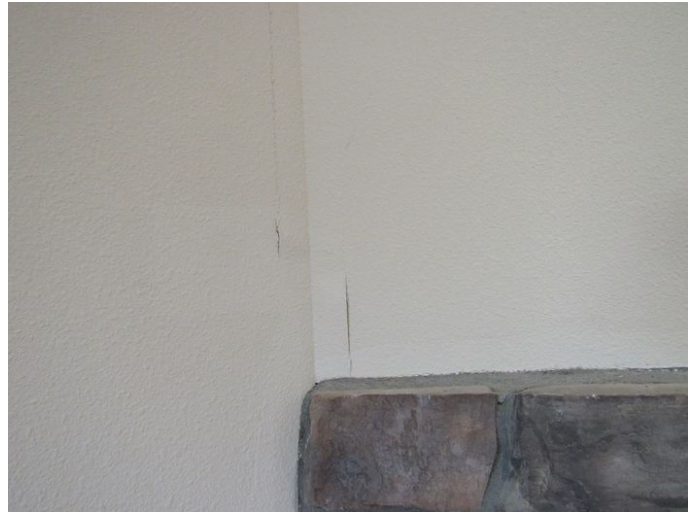
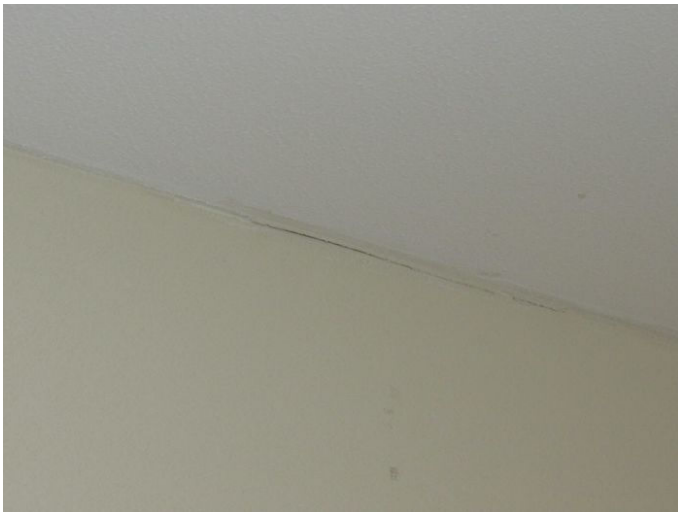
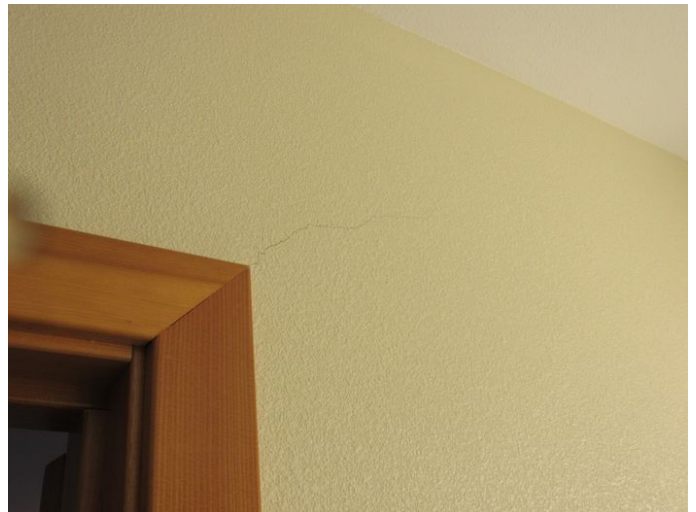
🔧 (I-3) Repair: The drywall / sheetrock finishes require some tune-up repair: See localized cracking, nail pops and minor cracks. A few 45 degree cracks at door frames inside some minor settlement. Much of the repair work looks cosmetic: see nail pops, opening tape seams and a hole in the wall - 2nd floor hallway. Repair sheetrock cracks and damage as needed.

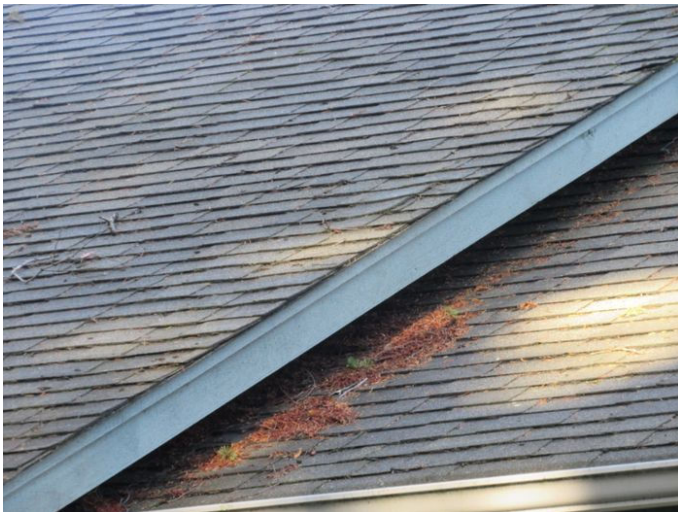
This roof installation predates the requirements for drip edge flashing - not worth repairing at this time.

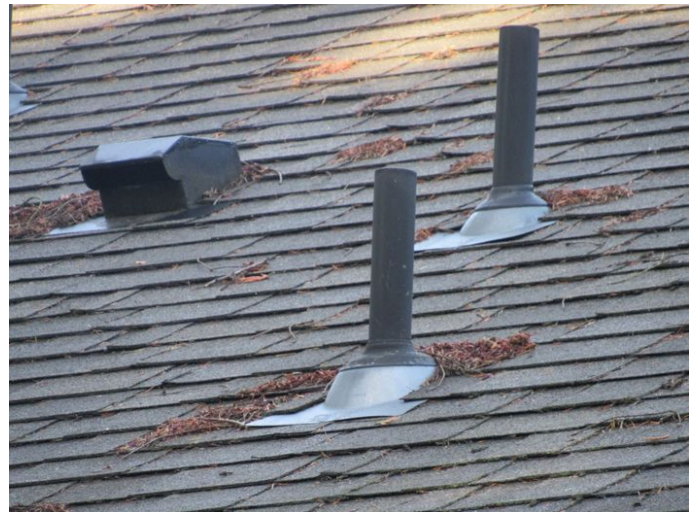
Organic debris should be removed from the roof

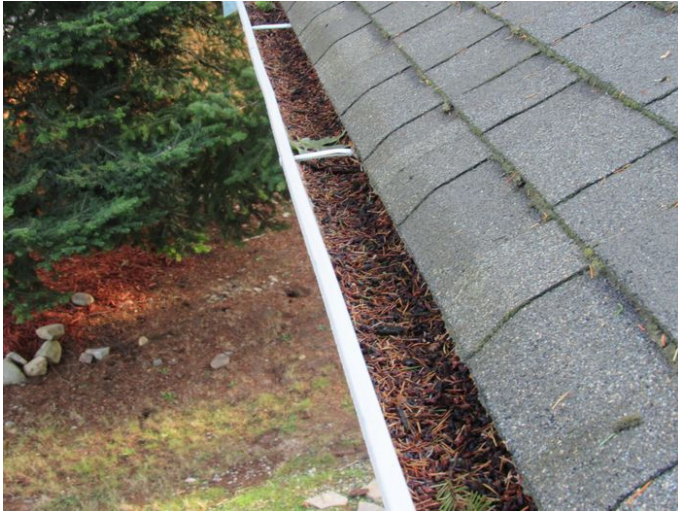
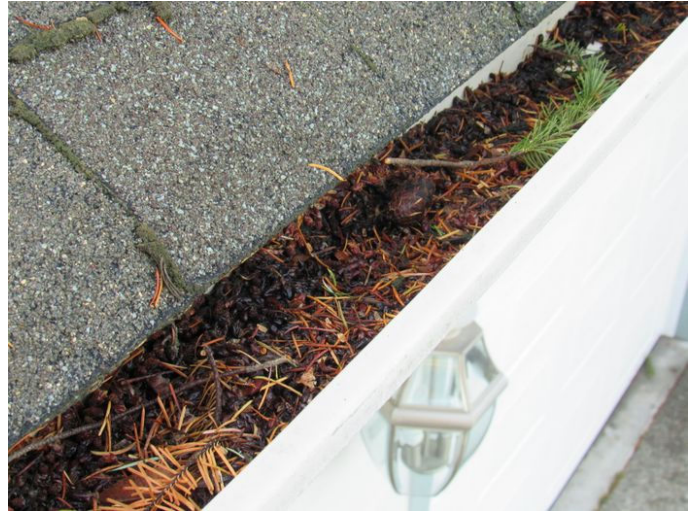
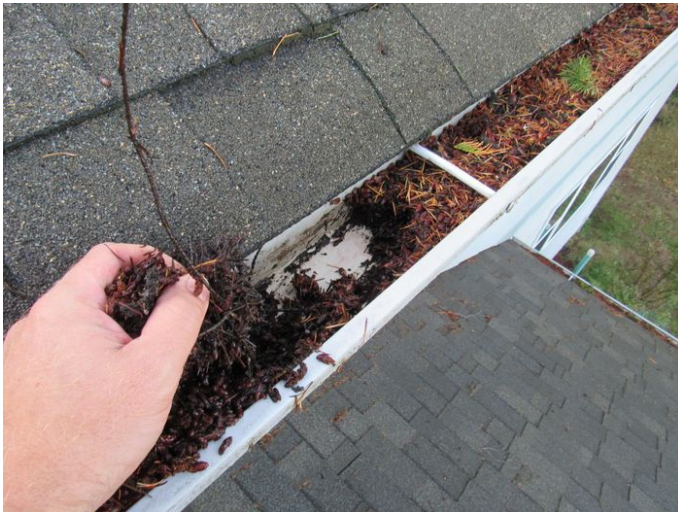
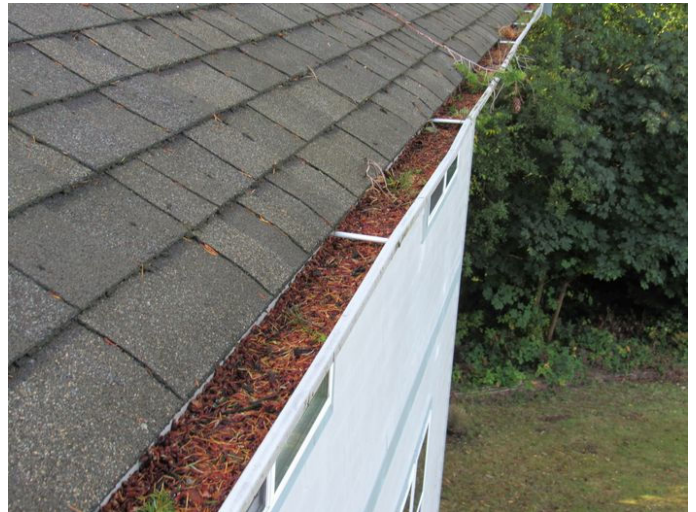
⚠️ **(RA-2) Major Concern:** The gutters are clogged with organic debris and require cleaning to ensure proper control of roof runoff. Clean the gutters and ensure they are unobstructed, leak free and properly sloped to drain. I list as a major concern due to urgency - they are very clogged and the rains are coming soon.

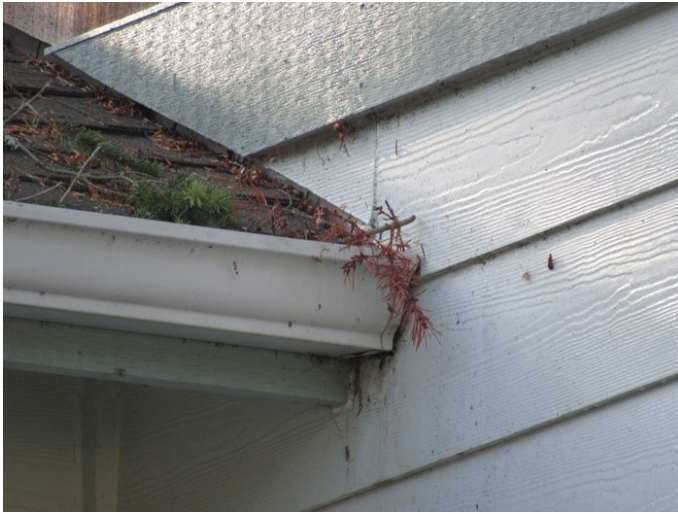
🔑 ⚠️ (EG-1) Repair: The gutters have been installed closer than 1 inch to the siding. The manufacturer of this siding recommends a 1 inch gap between the gutter and the siding. The current installation does not comply with recommended manufacturers installation requirements. Repair as needed to comply with installation requirements.

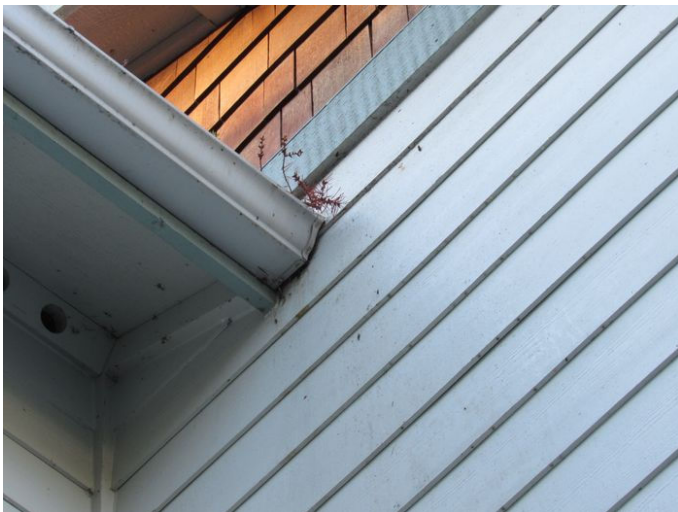
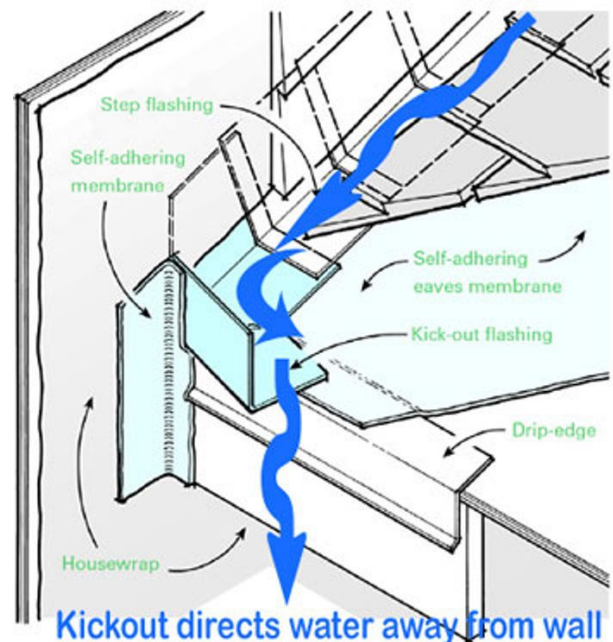
🔑 ⚠️ (EG-2) Repair: Inadequate kick-out flashings were noted between the roof and wall junctures. These are important to divert water away from the siding and onto the roof to prevent water from running behind the siding. Hire a qualified contractor familiar with siding installation to further evaluate and repair.

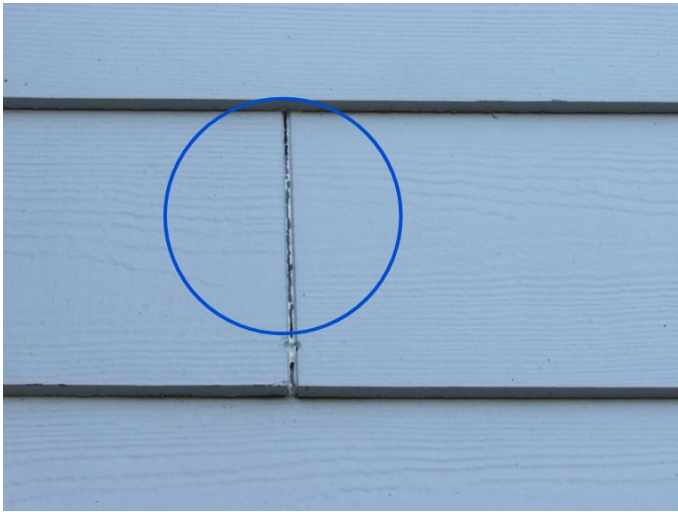
Missing back flashings at butt joints - these flashings can be retrofit on exposed sides of the building with metal flashing tabs or maintained with caulking.

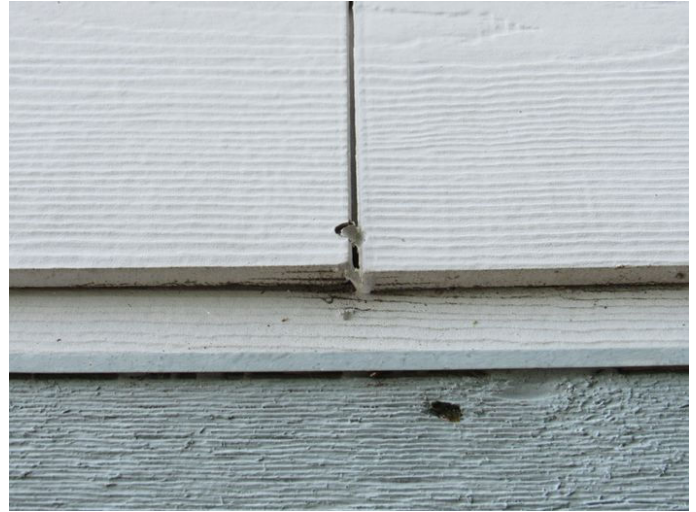
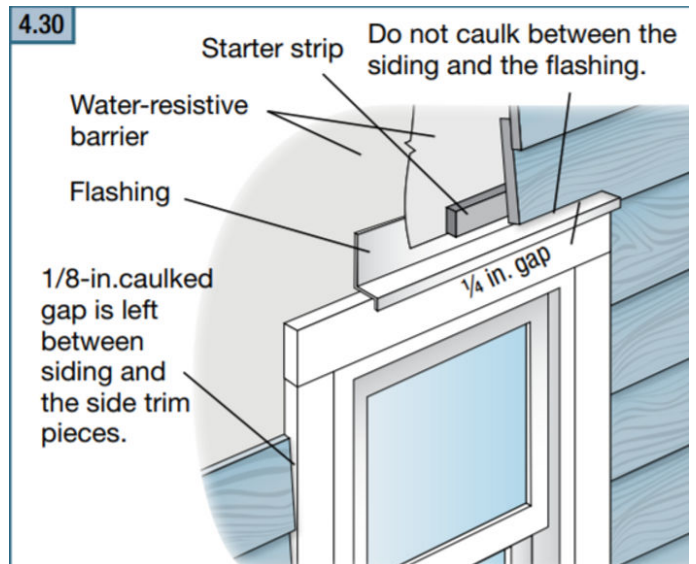
Siding run right to the horizontal flashing and sealed. This is not recommended but difficult to fix at this point.

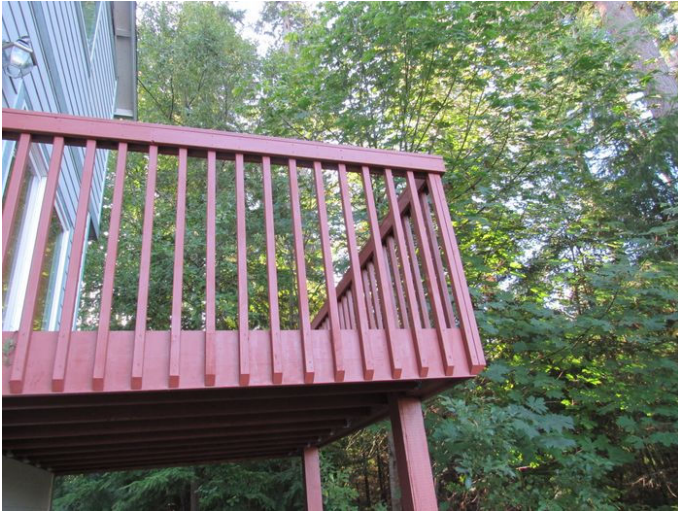
🔧 **(EG-5) Improve:** The deck guardrail is not using any 4x4 posts, just smaller spindles. Modern deck guardrail requirements recommend a 4x4 post at minimum intervals of 6 feet.

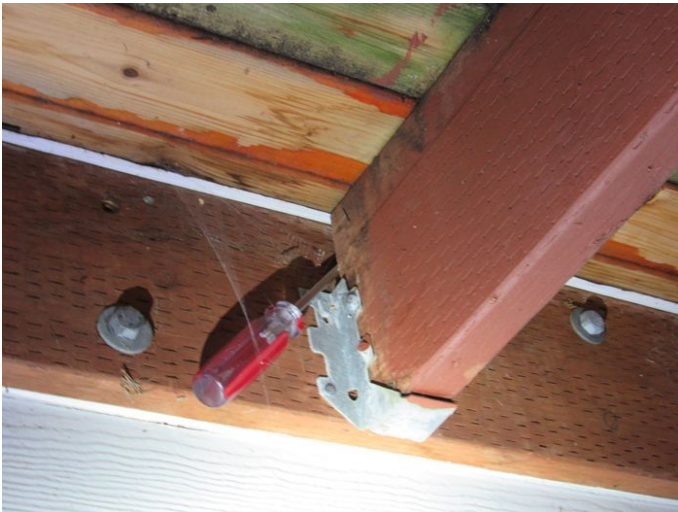
⚠️ (EG-6) Repair: Several of the deck joists are not well secured against the ledger board - it seems they were cut too short. This could be difficult to correct at this point. Have this further evaluated and repaired as recommended by a qualified contractor.

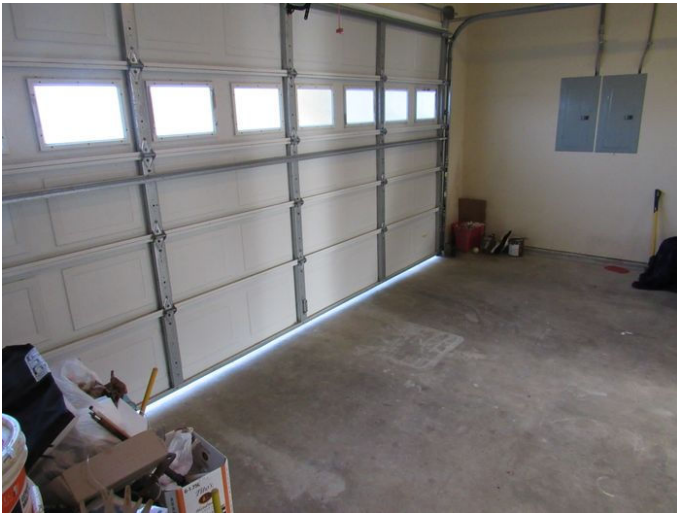
🔑 **(EG-7) Repair:** The automatic garage door opener for the large door is not performing as intended - the button for the door needs to be held down to get the door to operate. This could indicate the laser eyes require some adjustment. Have this door further evaluated and repaired as recommended by a specialist.

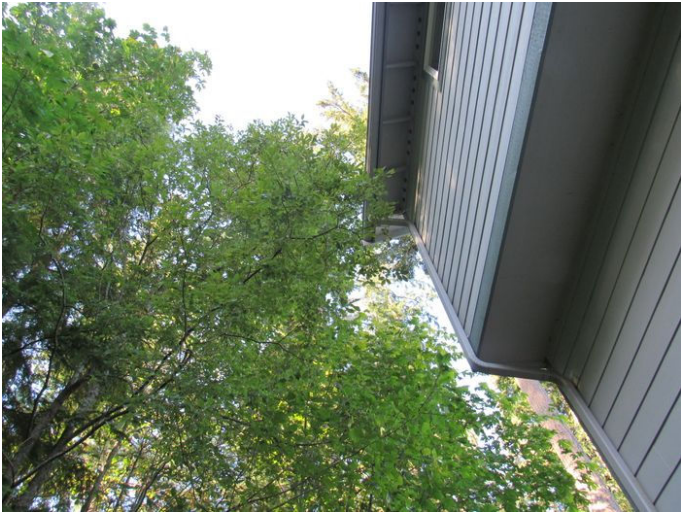
**(G-3) Repair:** All trees, branches and vegetation should be pruned at least six feet away from the building to eliminate a condition conducive to wood destroying organisms and a path for rodent entry.
