This report is prepared exclusively for **John Doe**  
Inspected On: **12-17-2021**

## 2022 Tiffin Allegro Red 37PA

**Inspected By:**

Wayne Kosters

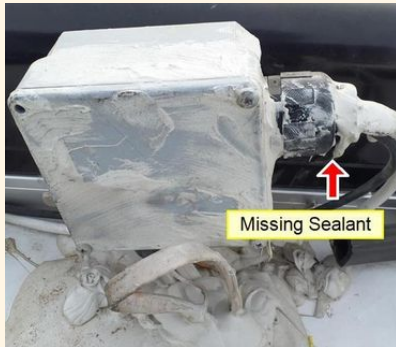
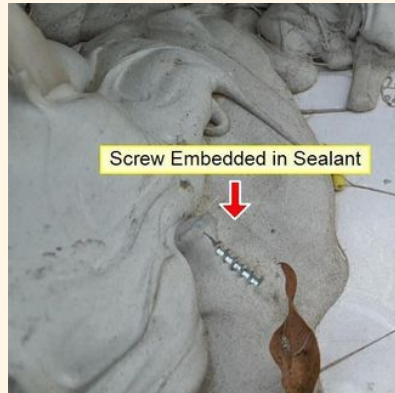
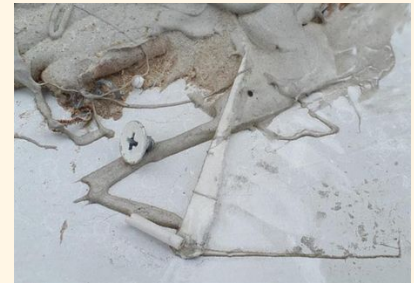
**RE-1 Roof Exterior - Roof:** The inspector observed gaps in the sealant on the electrical junction box on the roof front curbside. It is recommended that this be serviced by a qualified RV technician to prevent future water intrusion.

**🔧 (RE-1) Major Issue:** The inspector observed gaps in the sealant on the electrical junction box on the roof front curbside. It is recommended that this be serviced by a qualified RV technician to prevent future water intrusion.

*Curbside Roof Junction Box*

*Screw near Junction Box*

*Screwhead in Sealant*

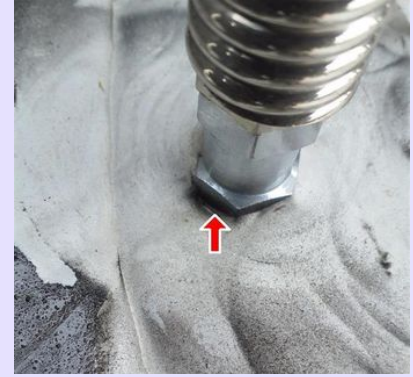
The inspector observed a gap at the base of the radio antenna on the curbside of the coach. It is recommended that this be serviced by a qualified RV technician.

*Curbside Antenna Sealant*

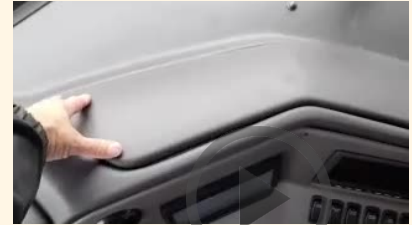
🔧 **MWCA-1 MH-Front Windshield and Cab Area:** The inspector observed that the trim behind the dash radios is loose and not well attached. It is recommended that this be serviced by qualified RV technician.

The inspector observed that the trim behind the dash radios is loose and not well attached. It is recommended that this be serviced by qualified RV technician.

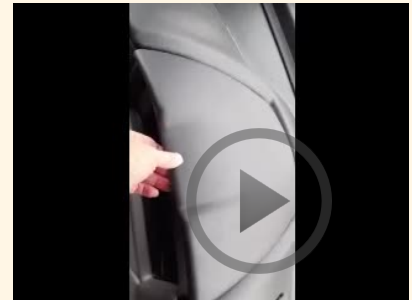
🔧 **MWCA-2 MH-Front Windshield and Cab Area:** The inspector observed that the dash trim piece above the engine instrument cluster is loose. It is recommended that this be serviced by qualified RV technician.

**🚩 (MWCA-2) Major Issue:**

The inspector observed that the dash trim piece above the engine instrument cluster is loose. It is recommended that this be serviced by qualified RV technician.

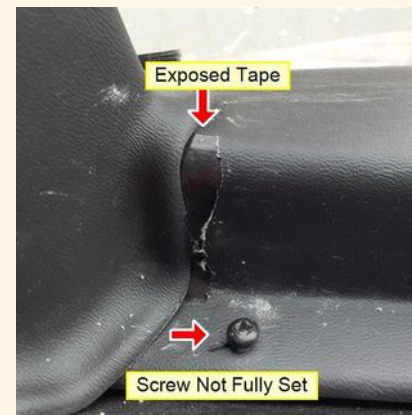
🔧 **MWCA-3 MH-Front Windshield and Cab Area:** The inspector observed that the screw closest to the street side of the windshield / dash trim is not fully set. The inspector also observes that there appears to be some tape from manufacturing that is still present. It is recommended that these be serviced by a qualified RV technician.

**🚩 (MWCA-3) Major Issue:**

The inspector observed that the screw closest to the street side of the windshield / dash trim is not fully set. The inspector also observes that there appears to be some tape from manufacturing that is still present. It is recommended that these be serviced by a qualified RV technician.

*Streetside Dash Trim*

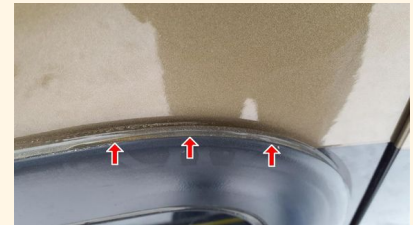
🔧 **ED-1 Entrance Doors - Door - Coach:** The inspector observed the gaps in the sealant of the entrance door front of the lower window . It is recommended that this be serviced by a qualified RV technician.

The inspector observed the gaps in the sealant of the entrance door front of the lower window . It is recommended that this be serviced by a qualified RV technician.

*Front Lower Door Window Sealant*

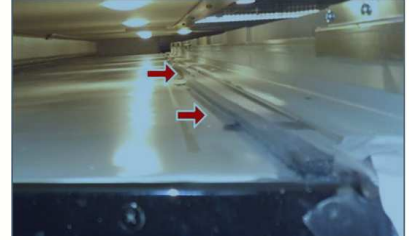
The inspector recommends verification of the strip placement on the top inside of the curbside front slideout by a qualified RV technician.

*Curbside Front Slideout Seal*

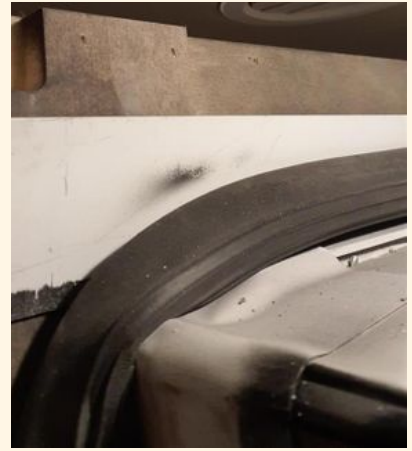
🔧 **S-2 Slideouts - Curbside Rear Slideout:** The inspector observed that the interior roof bulb seal may not seal the slideout when it is fully extended. It is recommended that this be serviced by a qualified RV technician.

The inspector observed that the interior roof bulb seal may not seal the slideout when it is fully extended. It is recommended that this be serviced by a qualified RV technician.

*Curbside Rear Inside Seal will miss the wall*

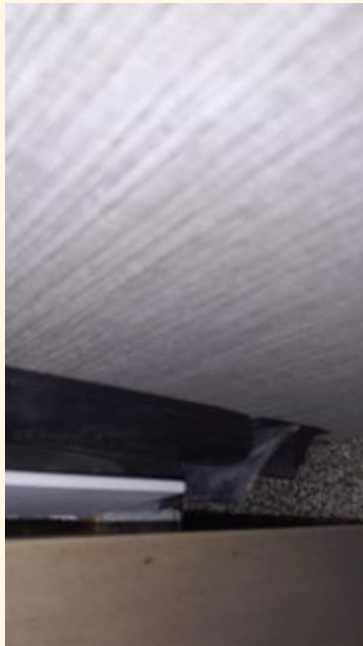
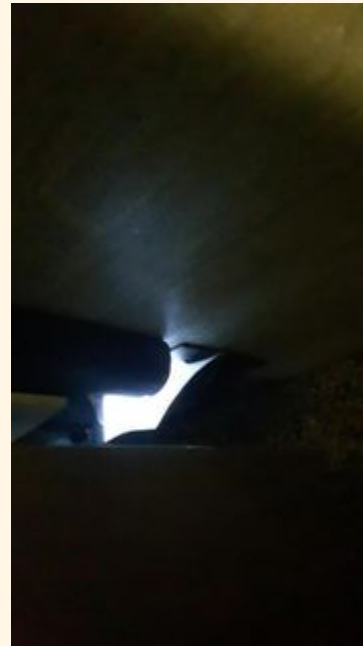
**⚠ (S-3) Major Issue: Rear Curbside Floor Seal:**

*Rear Curbside Rear Floor Seal*

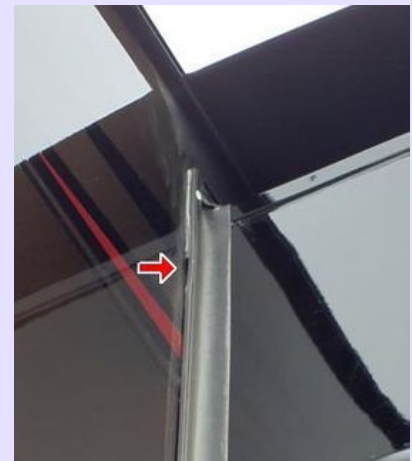
**🔧 (S-5) Minor Issue:**

The inspector observed a gap on the curbside rear slideout on the upper rear trim near the roof of the slideout. It is recommended that this be serviced by qualified RV technician.

*Upper Rear of Rear Curbside Slideout Seal*

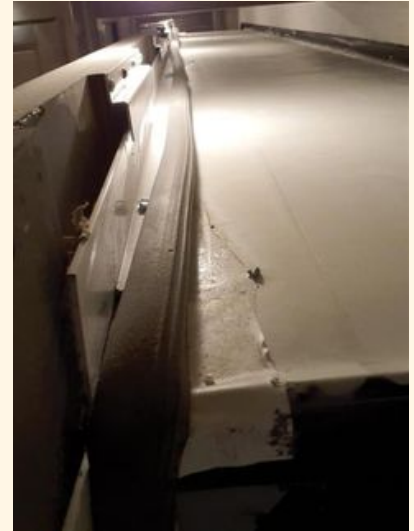
🔧 **S-6 Slideouts - Streetside Rear Slideout:** The inspector observed that the sweep behind the top trim molding is not even replaced, there are potential gaps when the slide out is extended. It is recommended that this be serviced by qualified RV technician

The inspector observed that the sweep behind the top trim molding is not even replaced, there are potential gaps when the slide out is extended. It is recommended that this be serviced by qualified RV technician

*Streetside Rear Slideout Gasket*

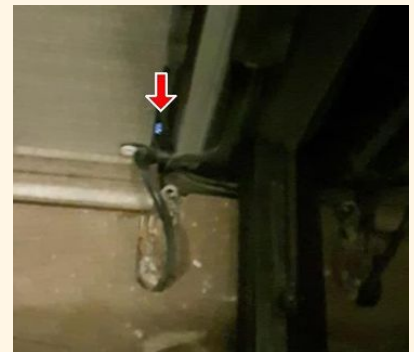
🔧 **S-7 Slideouts - Streetside Rear Slideout:** With the rear streetside slideout in there is a gap on the rear lower seal, outside light was observed. It is recommended that this be serviced by qualified RV technician to prevent future intrusion.

**🚩 (S-7) Major Issue:**

With the rear streetside slideout in there is a gap on the rear lower seal, outside light was observed. It is recommended that this be serviced by qualified RV technician to prevent future intrusion.

*Rear Curbside Slideout*

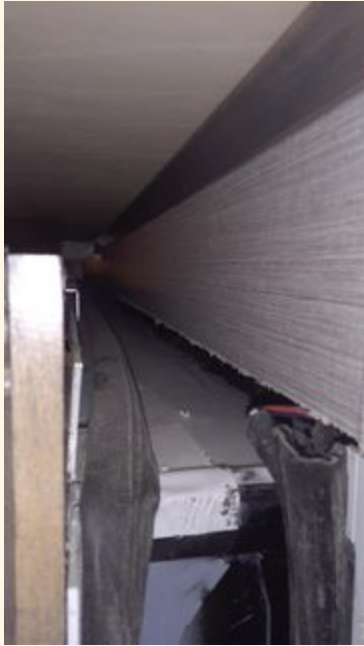
🔧 **S-8 Slideouts - Streetside Rear Slideout:** The inspector observed that the streetside

rear slideout does not have a inside sweep and bulb seal like the front slideout. It is recommended that a qualified RV technician contact the manufacture to verify if a sweep should be installed at the inside top of the coach wall.

**🚩 (S-8) Major Issue:** The inspector observed that the streetside rear slideout does not have a inside sweep and bulb seal like the front slideout. It is recommended that a qualified RV technician contact the manufacture to verify if a sweep should be installed at the inside top of the coach wall.

*Bulb Seal*

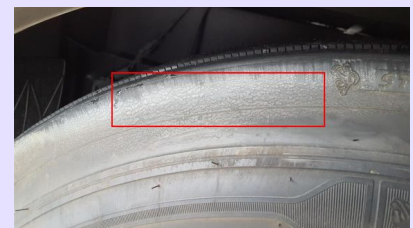
The inspector observed weather checking on the drive axle curbside outside tire near the tread. It is recommended that the tires be inspected by a qualified tire specialist.

*Curbside Outside Tire*

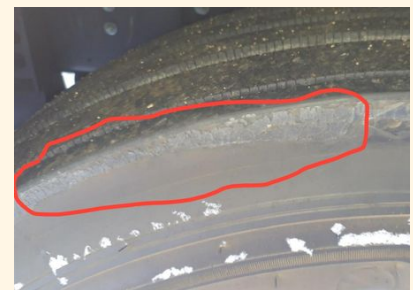
🔧 **TW-6 Tires and Wheels - Streetside Front-Tire/Wheel:** The inspector observed weather checking on the curbside front tire near the tread. It is recommended that the tires be inspected by a qualified tire specialist.

The inspector observed weather checking on the curbside front tire near the tread. It is recommended that the tires be inspected by a qualified tire specialist.

*Streetside Front Tire*

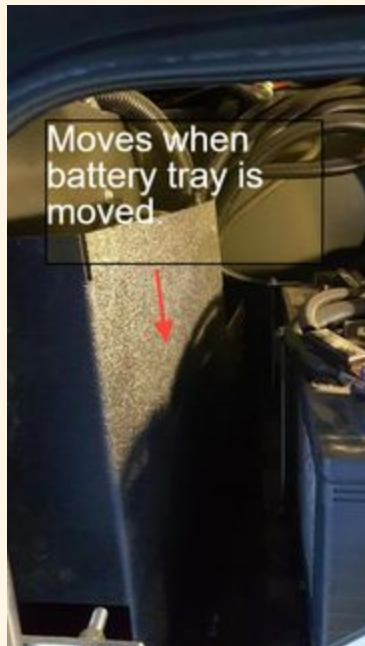
🔧 **ES1VA1VD-6 Electrical System 120 Volt AC and 12 Volt DC - 12 Volt DC House Battery:** The inspector observed that when the battery tray is pulled out the baffle along the left side of the battery tray is catching on the cables and is moving. It is recommended that this be serviced by a qualified RV technician.

**⚠️ (ES1VA1VD-6) Major Issue:** The inspector observed that when the battery tray is pulled out the baffle along the left side of the battery tray is catching on the cables and is moving. It is recommended that this be serviced by a qualified RV technician.

Battery Compartment Tray In

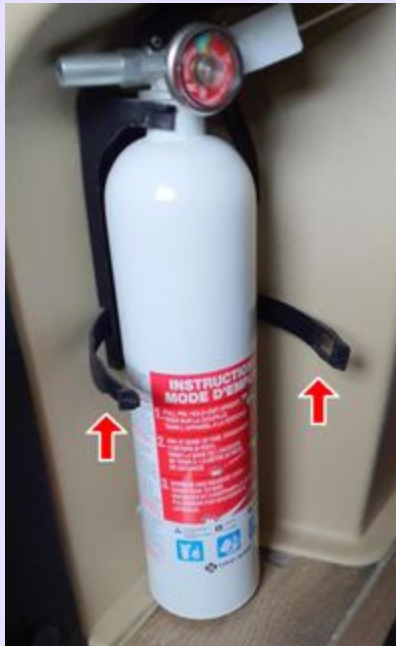
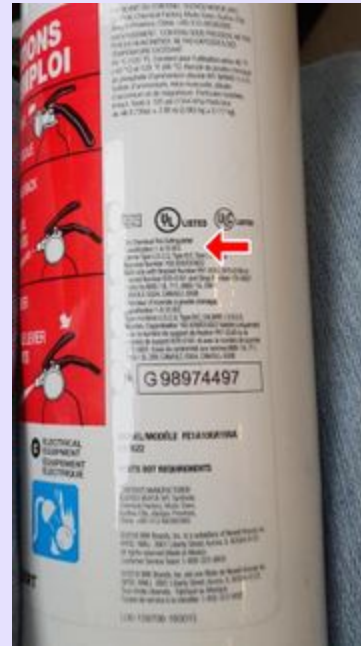
**(PTLC-6) Minor Issue:** The fire extinguisher is not securely mounted in its bracket. It is recommended that this be serviced by qualified RV technician.

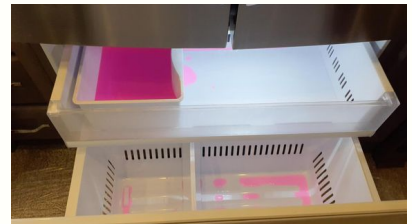
✧ **AK-2 Appliances: Kitchen - Refrigerator:** The inspector observed significant antifreeze in the freezer drawers.

The inspector observed significant antifreeze in the freezer drawers.

*Antifreeze From Winterization of Ice Maker*

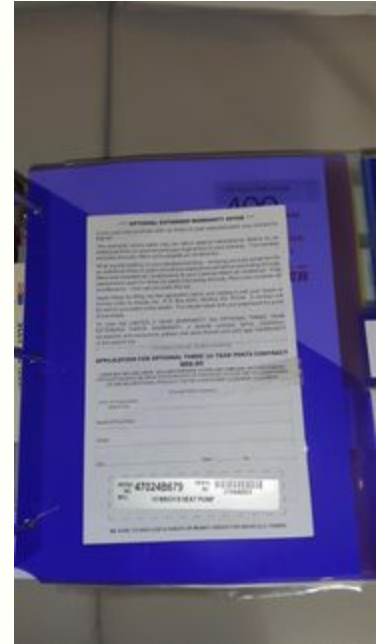
The inspector observed that the serial number of the single documented AC in the owner's manual does not match any of the AC units listed on the build sheet.

Owner's Manual AC Label

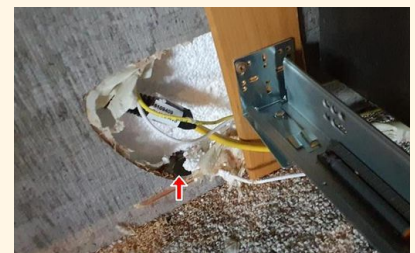
🔧 **I-4 Interior - Closets:** The inspector observed a hole behind the dinette lower rear cabinet. It is recommended that this be service by qualified RV technician.

The inspector observed a hole behind the dinette lower rear cabinet. It is recommended that this be service by qualified RV technician.

*Dinette Lower Rear*

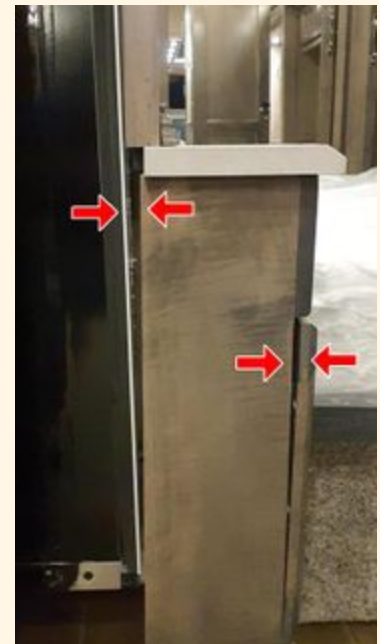
The inspector observed that the front bedside cabinet of the rear curbside slide out has gaps and is improperly finished. It is recommended that this be serviced by a qualified RV technician.

*Front Bedside Cabinet*

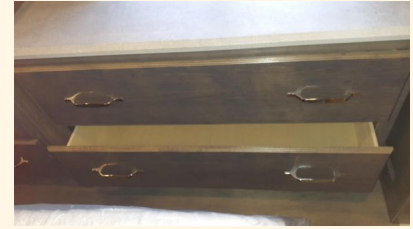
#### (I-9) Major Issue:

The inspector observed that the bedroom streetside drawer under the emergency window is not attached to the glides. It is recommended that this be serviced by a qualified RV technician.

*Lower Streetside Drawer*

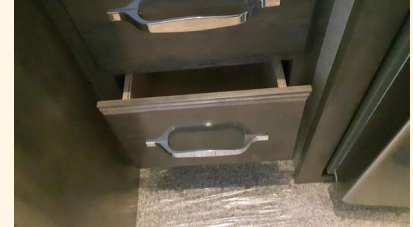
#### (I-10) Major Issue:

The inspector observed that the lower cabinet between the sink and fridge has an issue with a slide. It is recommended that this be serviced by qualified RV technician.

*Curbside Drawer Between Sink and Fridge*

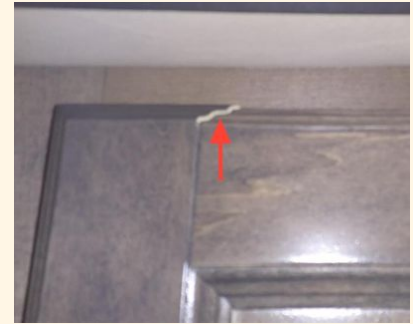
#### (I-11) Major Issue:

The inspector observed poor workmanship on the curbside rear slide out front cabinet top. It is recommended that this be serviced by qualified RV technician.

*Bedroom Curbside Front Cabinet*

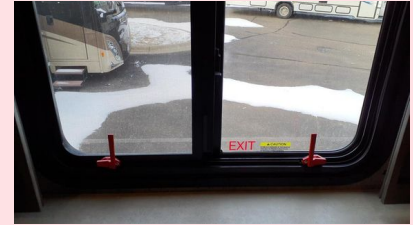
**I-12 Interior - Windows, Blinds and Shades:** The inspector was unable to open the emergency window in the bedroom area with reasonable force as required by the NFPA-1192 6.2.4.2 which states; 'No more than 20-lb of force (89 N) shall be required to open a means of escape.' It is recommended that this be serviced by a qualified RV technician before occupying the coach as this is a life safety issue.  
The customer was able to open the window by adding more force to open the window.

The inspector was unable to open the emergency window in the bedroom area with reasonable force as required by the NFPA-1192 6.2.4.2 which states; 'No more than 20-lb of force (89 N) shall be required to open a means of escape.' It is recommended that this be service by a qualified RV technician before occupying the coach as this is a life safety issue. The customer was able to open the window by adding more force to open the window.

*Bedroom Emergency Exit Window*

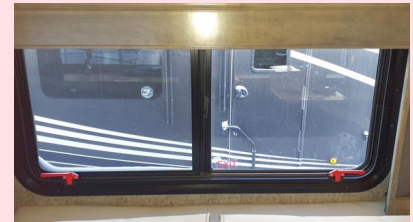
**I-13 Interior - Windows, Blinds and Shades:** The inspector was unable to open the emergency window in the living room area with reasonable force as required by the NFPA-1192 6.2.4.2 which states; 'No more than 20-lb of force (89 N) shall be required to open a means of escape.' It is recommended that this be serviced by a qualified RV technician before occupying the coach as this is a life safety issue.

**⚠️ (I-13) Life Safety Issue:**

The inspector was unable to open the emergency window in the living room area with reasonable force as required by the NFPA-1192 6.2.4.2 which states; 'No more than 20-lb of force (89 N) shall be required to open a means of escape.' It is recommended that this be service by a qualified RV technician before occupying the coach as this is a life safety issue.

*Emergency Exit Window*

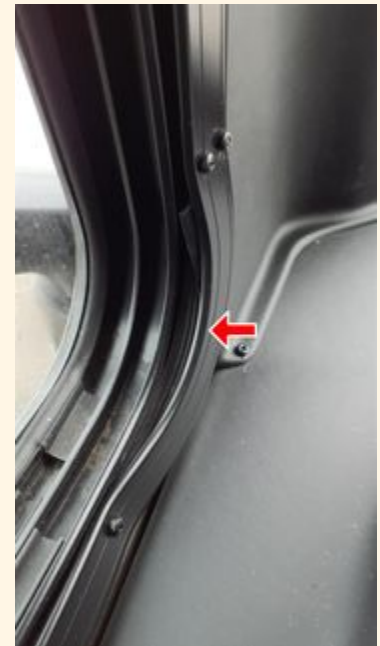
**🚧 (I-14) Major Issue:**

The inspector observed a large gap in the front of the driver's curbside window. It is recommended that this be serviced by qualified RV technician.

*Lower Front of Driver's Window Trim*

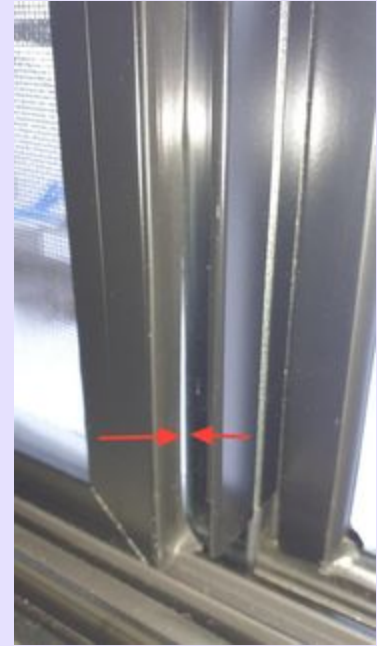
### 🔧 (I-15) Minor Issue:

The inspector observed a gap between the window and screen on the emergency exit window. It is recommended that this be serviced by the qualified RV technician.

*Emergency Exit Window Screen*

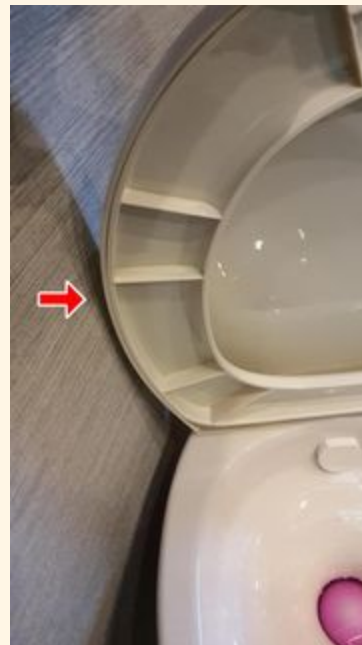
The inspector observed that the toilet seat cannot be raised as it interferes with the wall. It is recommended that this be serviced by qualified RV technician.

*Toilet Seat Cannot be Raised*

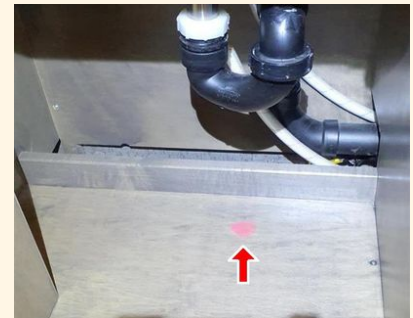
The inspector of observed a spot of antifreeze under the rear bathroom sink. It is recommended that this be serviced by a qualified RV technician.

*Under Rear Bathroom Sink*

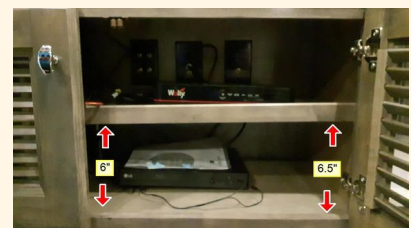
The electric equipment shelf under the bedroom TV is not level, 6" inches on the left, 6.5" on the right side. It is recommended that this be serviced by qualified our new technician.

*Equipment Shelf*

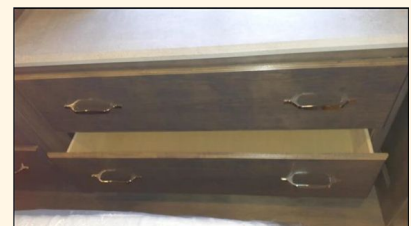
### 🚩 (F-2) Major Issue:

The inspector observed that the bedroom streetside drawer under the emergency window is not attached to the glides. It is recommended that this be serviced by a qualified RV technician.

*Lower Streetside Drawer*

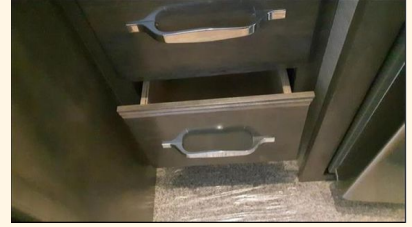
### (F-3) Major Issue:

The inspector observed that the lower cabinet between the sink and refrigerator has an issue with a slide. It is recommended that this be serviced by qualified RV technician.

*Curbside Drawer Between Sink and Fridge*

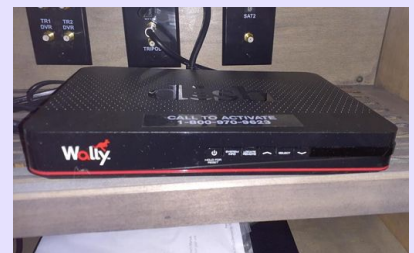
🔧 **(E-3) Minor Issue:**  
The inspector observed that the satellite receiver in the bedroom is not securely mounted. It is recommended that this be serviced by a qualified RV technician.

*Satellite Receiver*
