## 4-Point Inspection Form

Address Inspected: \_\_\_\_\_

Fair Winds Building Inspection Services

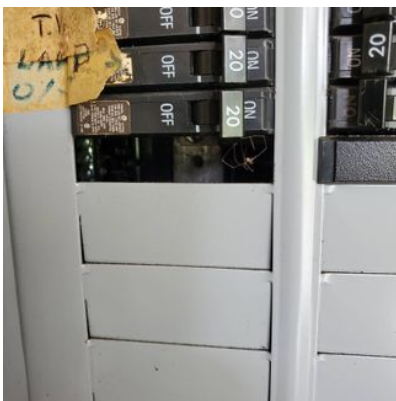
- ☐ Blowing fuses
- ☐ Tripping breakers
- ☒ Empty sockets
- ☐ Loose wiring
- ☒ Improper grounding
- ☐ Corrosion
- ☐ Over fusing

*Open socket at the main panel*

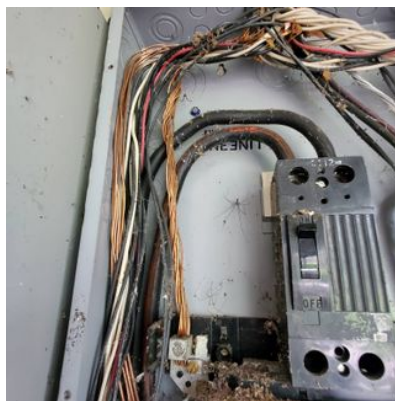
*Improper grounding inside the main panel*

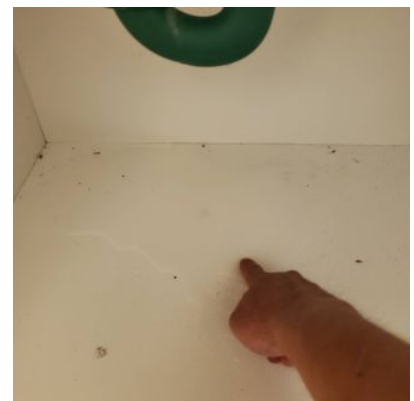
*Leaking pipe under the master bathroom lavatory*

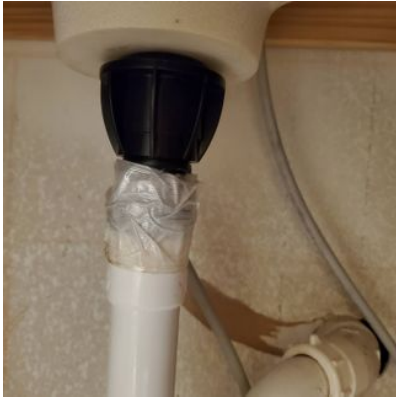
*Improper repair of a drain pipe under the guest bathroom lavatory*

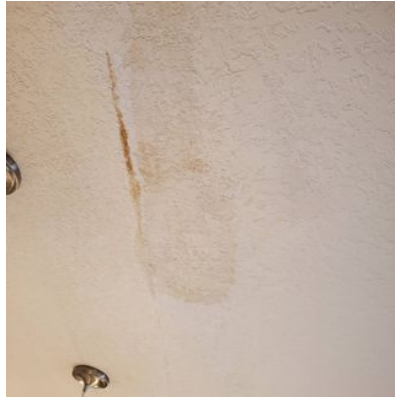
Interior ceilings ☒ Yes ☐ No

*Stain on the kitchen ceiling*

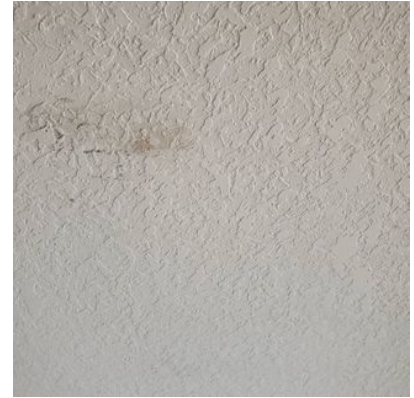
*Stain on the garage ceiling*

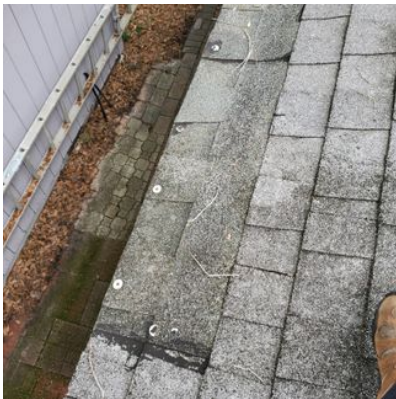
*Exposed fasteners on the right side of the roof*

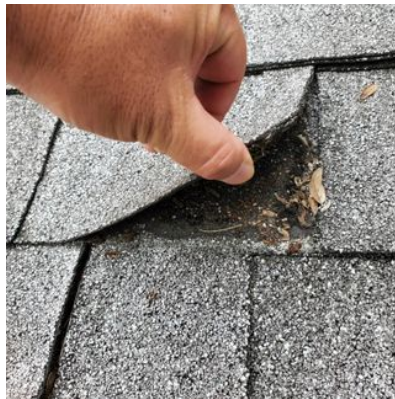
- ☐ Cracking - exposed fasteners  
☐ Cupping/curling See the photos in Hazards  
☐ Excessive granule loss and Deficiencies section at  
☐ Exposed asphalt the end of this report.  
☐ Exposed felt  
☒ Missing/loose/cracked tabs or tiles  
☐ Soft spots in decking  
☐ Visible hail damage

*Loose shingles at multiple locations*

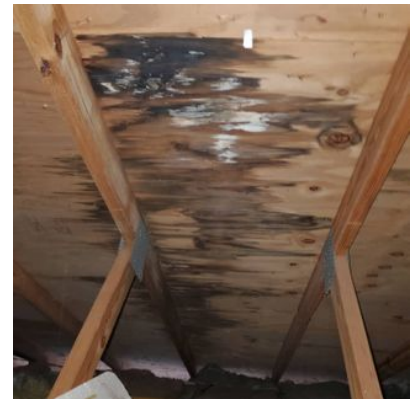
Attic/underside of decking ☒ Yes ☐ No

*Stain on the underside of roof decking above the garage*
