# 4-Point Inspection Form

Address Inspected: 4 Point Inspection, Greater Tampa, FL 33333

Actual Year Built: 1991

Fair Winds Building Inspection Services

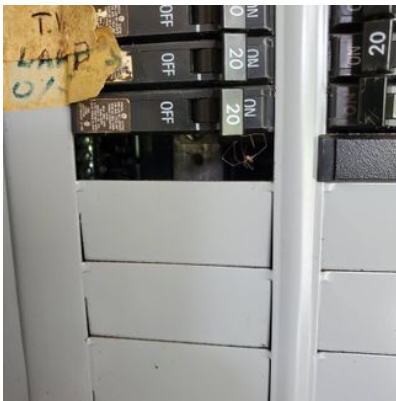
| <ul style="list-style-type: none"> <li><input type="checkbox"/> Blowing fuses</li> <li><input type="checkbox"/> Tripping breakers</li> <li><input checked="" type="checkbox"/> Empty sockets</li> <li><input type="checkbox"/> Loose wiring</li> <li><input checked="" type="checkbox"/> Improper grounding</li> <li><input type="checkbox"/> Corrosion</li> <li><input type="checkbox"/> Over fusing</li> </ul> | <ul style="list-style-type: none"> <li><input type="checkbox"/> Double taps</li> <li><input type="checkbox"/> Exposed wiring</li> <li><input type="checkbox"/> Unsafe wiring</li> <li><input type="checkbox"/> Improper breaker size</li> <li><input type="checkbox"/> Scorching</li> <li><input type="checkbox"/> Other (explain)</li> </ul> |

*Open socket at the main panel*

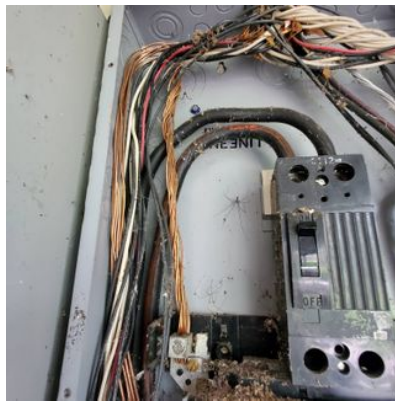
*Improper grounding inside the main panel*

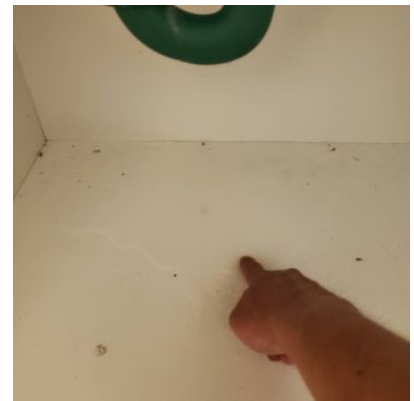
*Leaking pipe under the master bathroom lavatory*

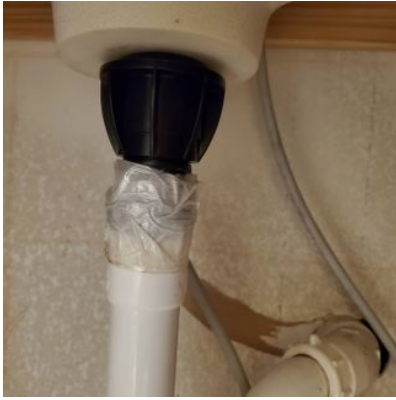
*Improper repair of a drain pipe under the guest bathroom lavatory*

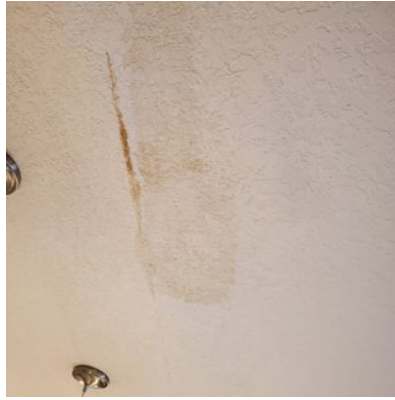
*Stain on the kitchen ceiling*

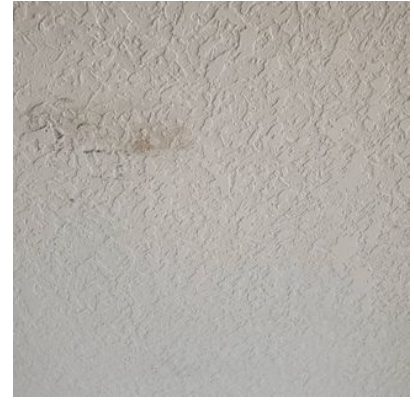
*Stain on the garage ceiling*

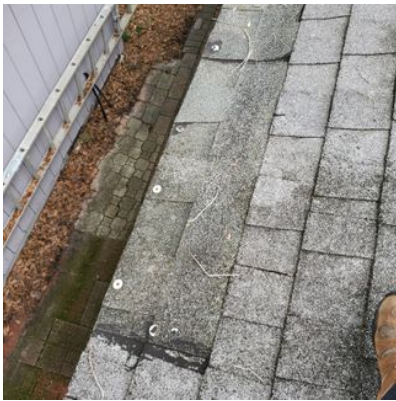
- Cracking - exposed fasteners  
 Cupping/curling See the photos in Hazards and Deficiencies section at the end of this report.  
 Excessive granule loss  
 Exposed asphalt  
 Exposed felt  
 Missing/loose/cracked tabs or tiles  
 Soft spots in decking  
 Visible hail damage

*Exposed fasteners on the right side of the roof*

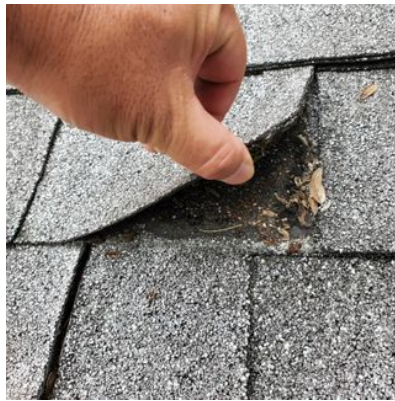
*Loose shingles at multiple locations*

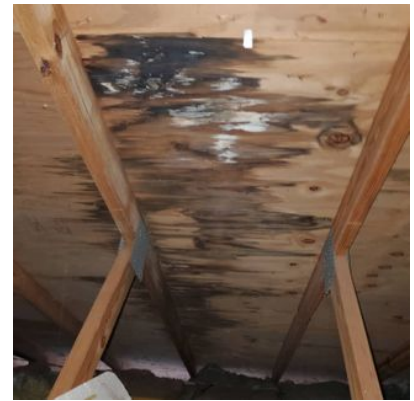
*Stain on the underside of roof decking above the garage*
