Inspection report for the property at  
1000 Sample Road, Seattle, WA

This report is prepared exclusively for **Sample Report**  
Inspected On: **05-23-2025**

Super Neato Inspections  
206.351.4100

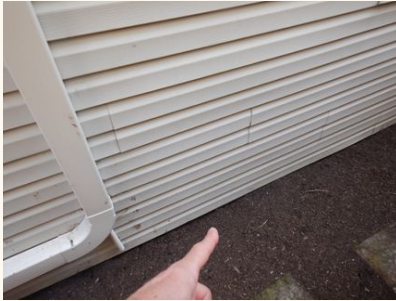
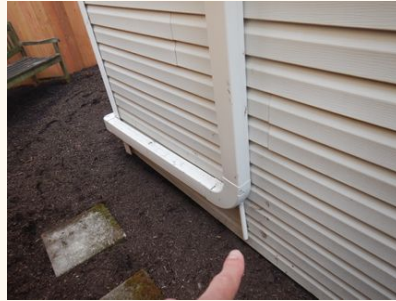
**G-1 Grounds - Drainage and Site:** Eliminate siding-to-soil contact to reduce the chances for deterioration, rot and pest damage and repair any hidden deterioration as needed - various sides. Hidden conditions may be present. Generally, a 6-inch clearance between soils and siding is

🔧 **(G-1) Repair (Minor):** Eliminate siding-to-soil contact to reduce the chances for deterioration, rot and pest damage and repair any hidden deterioration as needed - various sides. Hidden conditions may be present. Generally, a 6-inch clearance between soils and siding is recommended.

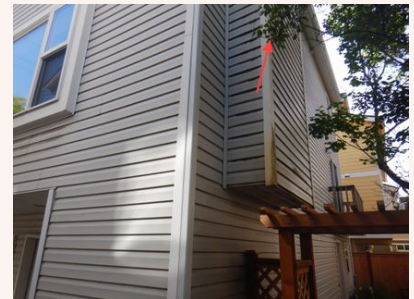
Pruning vegetation away from the house is recommended. Trees and large shrubs can provide rodent access to the roof, a minimum 6-foot clearance is recommended. All smaller vegetation should be kept 1-foot off the house to eliminate contact which could trap moisture against the building. This is not urgent however, occasional trimming of this one tree will be necessary.

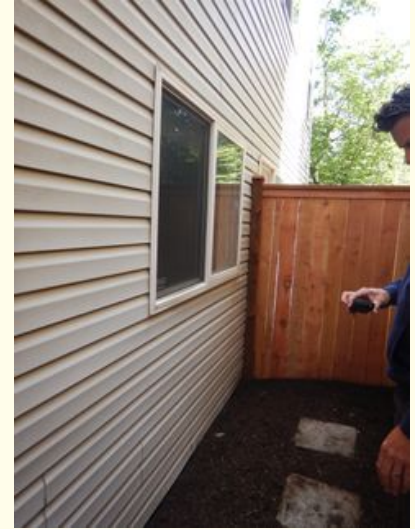
Eliminate wood / soils contact at the fencing to eliminate the future damage due to moisture contact and a condition conducive to wood destroying organism. The fence show in the picture as well as the fence to the west between homes.

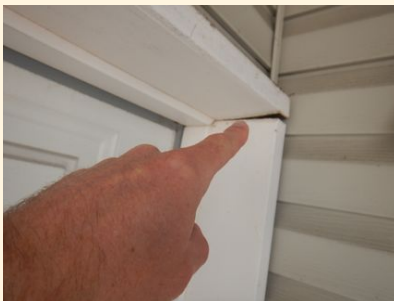
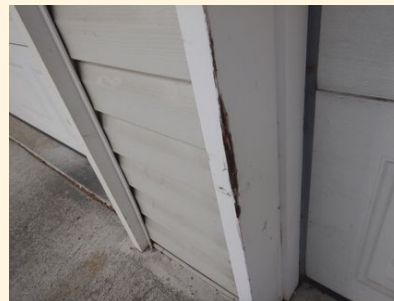
**ED-2 Exteriors and Decks - Siding and Trim:** Localized rot repairs are needed to the exterior trim and siding. Hire a licensed general contractor to further evaluate and repair the exterior siding system. Repair and replace all damaged and decaying exterior wood as needed. Please note that this condition can indicate additional concealed damage that is not visible to inspection. Examples of specific observations pictured below, but not limited to: various areas around building

**(ED-2) Repair (Moderate):** Localized rot repairs are needed to the exterior trim and siding. Hire a licensed general contractor to further evaluate and repair the exterior siding system. Repair and replace all damaged and decaying exterior wood as needed. Please note that this condition can indicate additional concealed damage that is not visible to inspection. Examples of specific observations pictured below, but not limited to: various areas around building

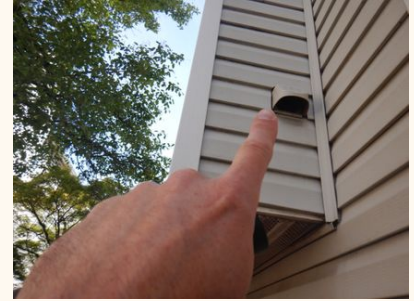
### ✂ (ED-3) Repair (Minor):

✂ **ED-3 Exteriors and Decks - Siding and Trim:** Inconsistent flashings were noted for the horizontal trim above windows and doors, horizontal junctures, and/or exhaust areas. This can lead to concealed water entry and damage to those horizontal junctures that have not been flashed, especially where exposed to the weather. A metal flashing shall be provided for areas like this that could allow water entry. Hire a licensed general contractor to further evaluate and repair to ensure reliable performance.

Inconsistent flashings were noted for the horizontal trim above windows and doors, horizontal junctures, and/or exhaust areas. This can lead to concealed water entry and damage to those horizontal junctures that have not been flashed, especially where exposed to the weather. A metal flashing shall be provided for areas like this that could allow water entry. Hire a licensed general contractor to further evaluate and repair to ensure reliable performance.

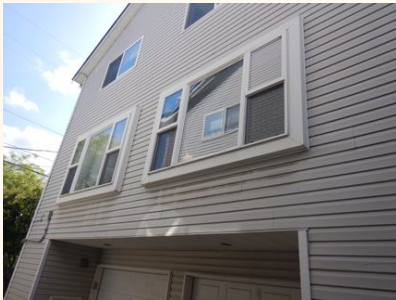
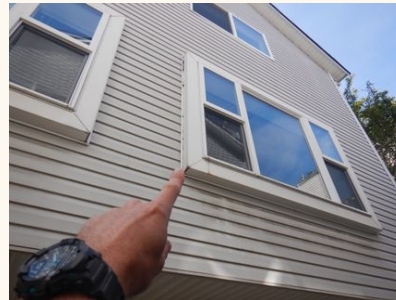
✂ **ED-4 Exteriors and Decks - Siding and Trim:** The exterior trim system here has been done as a picture framed or cap over trim, where the trim is not lead into the siding but laid over the top of the siding. This is a common practice, but is [sub-standard](#). All points subject to moisture entry shall be appropriately flashed. There is not a commonly accepted flashing detail for the "cap over detail" that I am aware of. The risk here is water can collect behind the trim and could leak into the siding where nails from the trim penetrate the siding. I would be most concerned about the exposed trim details on the weather side of the house. Have this further evaluated and repaired as recommended by a qualified contractor.

✂ (ED-4) Repair (Minor): The exterior trim system here has been done as a picture framed or cap over trim, where the trim is not lead into the siding but laid over the top of the siding. This is a common practice, but is [sub-standard](#). All points subject to moisture entry shall be appropriately flashed. There is not a commonly accepted flashing detail for the "cap over detail" that I am aware of. The risk here is water can collect behind the trim and could leak into the siding where nails from the trim penetrate the siding. I would be most concerned about the exposed trim details on the weather side of the house. Have this further evaluated and repaired as recommended by a qualified contractor.

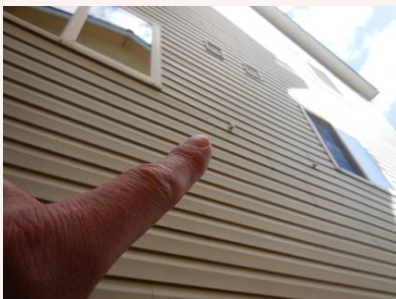
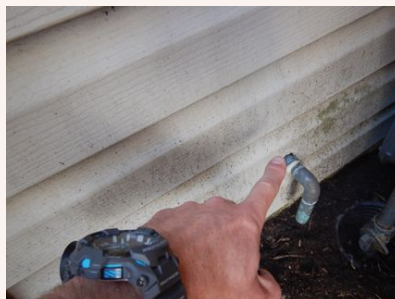
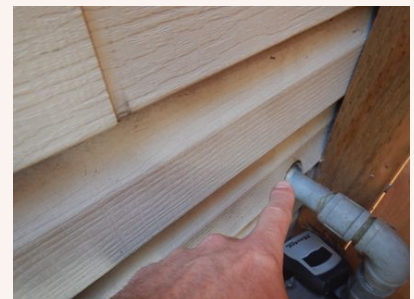
🔧 (ED-1) Recommended Maintenance: Localized caulking missing/failure was noted on the exterior - see siding and trim junctures and window frames and in some trim. Preventative caulking maintenance can help keep these areas weather proof and prevent water damage to materials. Have the exterior further evaluated and re-caulked and painted as needed.

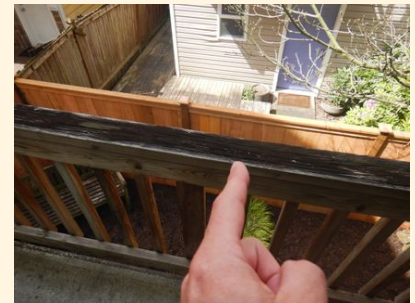
**ED-6 Exteriors and Decks - Decks, Porches and Balconies:** Wood decay/damage was found in parts of the guardrail system. This will require repair or replacement of all or part of the deck guardrail system in the near term. Budget to replace this railing system soon.

Wood decay/damage was found in parts of the guardrail system. This will require repair or replacement of all or part of the deck guardrail system in the near term. Budget to replace this railing system soon.

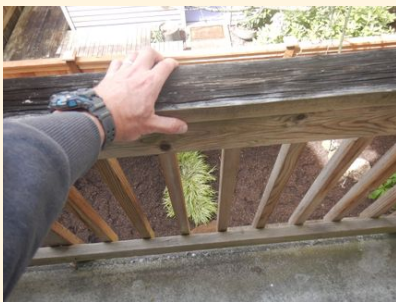
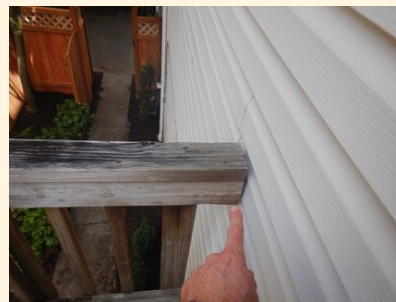
**ED-7 Exteriors and Decks - Decks, Porches and Balconies:** The deck handrail and guardrail is loose and may not be adequately prevent a falling adult. Hire a licensed general contractor to evaluate and repair / strengthen this deck guardrail system to ensure safe and reliable performance.

**🔧 (ED-7) Repair (Moderate):** The deck handrail and guardrail is loose and may not be adequately prevent a falling adult. Hire a licensed general contractor to evaluate and repair / strengthen this deck guardrail system to ensure safe and reliable performance.

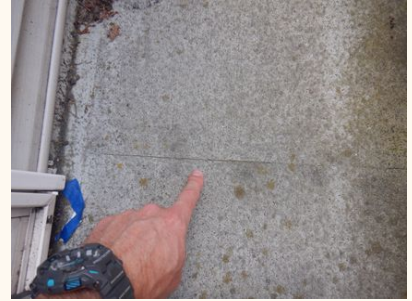
### 🔧 (ED-8) Repair (Minor):

✂ **ED-8 Exteriors and Decks - Decks, Porches and Balconies:** The decking membrane is damaged and at the end of its useful service life. Replace this membrane to prevent water damage to the decking. Hire a deck coatings / waterproofing specialist to further evaluate and repair.

The decking membrane is damaged and at the end of its useful service life. Replace this membrane to prevent water damage to the decking. Hire a deck coatings / waterproofing specialist to further evaluate and repair.

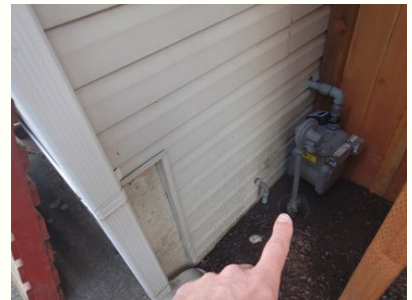
Gas meter and shut off location: West Side near driveway. Meters should be located in an area where they cannot be damaged by vehicles. This seems to be a reasonable distance but closer than most.

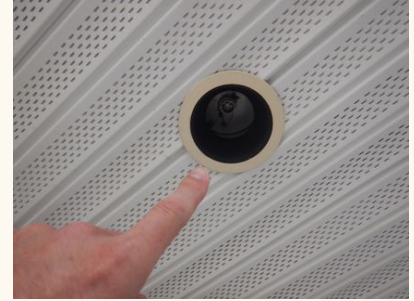
No light bulb in the fixture in the soffit above the garage entrance. Unable to test and verify if functioning.

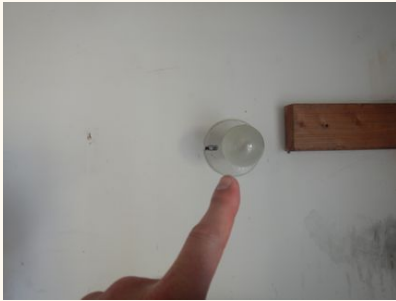
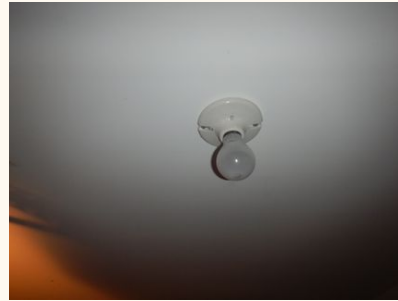
✂ **G1-2 Garage - Garage General:** Recommend installing a cover for this light bulb to prevent injury or electrical issues related to damage. Location under stairs in garage as well as ceiling.

🔧 (G1-2) Repair (Minor): Recommend installing a cover for this light bulb to prevent injury or electrical issues related to damage. Location under stairs in garage as well as ceiling.

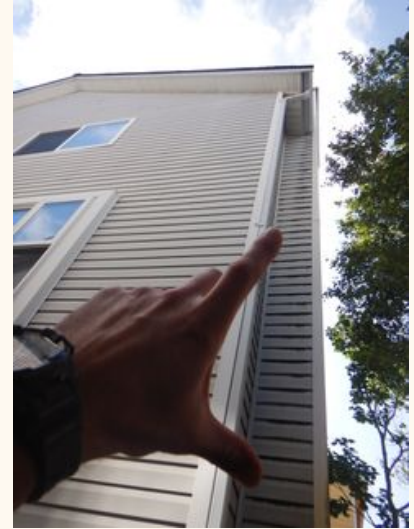
✂ **RCG-6 Roof, Chimney and Gutters - Gutters and Downspouts:** Corner leaking. This should be sealed/repared.

Corner leaking. This should be sealed/repaired.

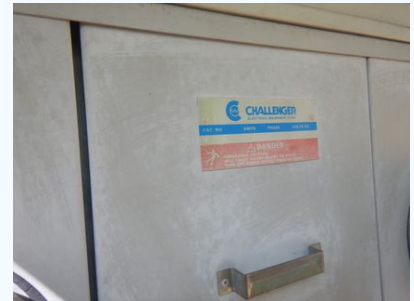
**(ES-1) Due Diligence:** Meters were not labeled. Inquire with Seattle City Light which meter is associated with the home.

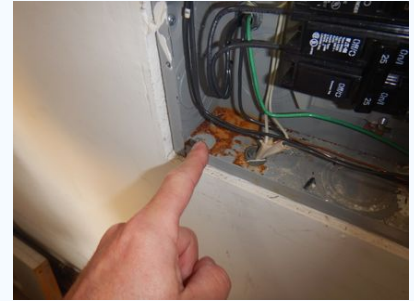
Dried rust was found inside the electrical panel. No additional moisture found. Recommend a licensed electrician confirm.

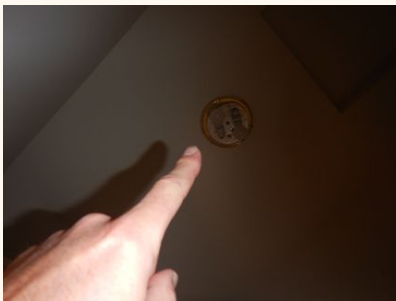
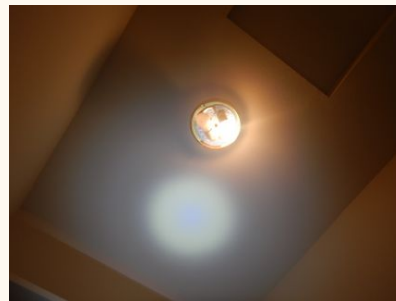
✂ **EDFW-1 Electric Distribution and Finish Wiring - Receptacles and Fixtures:** Install the missing light fixture cover in the Primary bedroom closet.

🔧 (EDFW-1) Repair (Minor): Install the missing light fixture cover in the Primary bedroom closet.

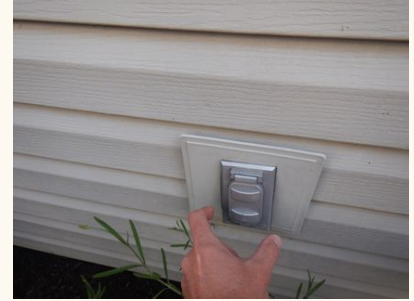
### 🔧 (EDFW-2) Repair (Minor):

✂ **EDFW-2 Electric Distribution and Finish Wiring - Receptacles and Fixtures:** The loose receptacles should be secured to prevent accidental damage to the wiring connections. Recommend a qualified electrician evaluate and remedy. Repair as needed. Location(s): Side exterior

The loose receptacles should be secured to prevent accidental damage to the wiring connections. Recommend a qualified electrician evaluate and remedy. Repair as needed. Location(s): Side exterior

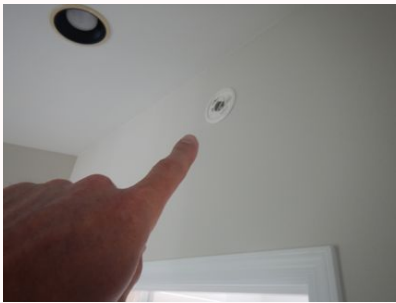
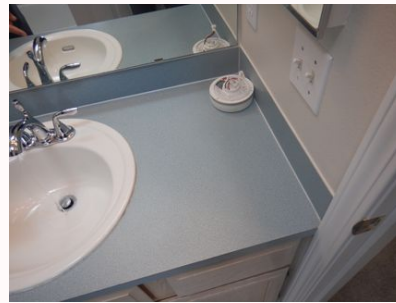
⚠️ (EDFW-3) **Safety Improvements:** *Some smoke alarms are missing.* Repair / replace the missing smoke alarms in the house so that there is an operating smoke alarm in every bedroom and on every floor and one outside of all sleeping areas. Locations:

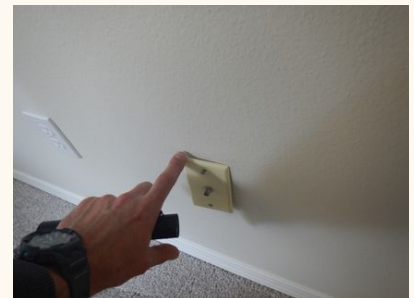
### 🔧 (EDFW-5) Repair (Minor):

✂ **EDFW-5 Electric Distribution and Finish Wiring - Low Voltage Wiring:** loose low volt receptacle.

loose low volt receptacle.

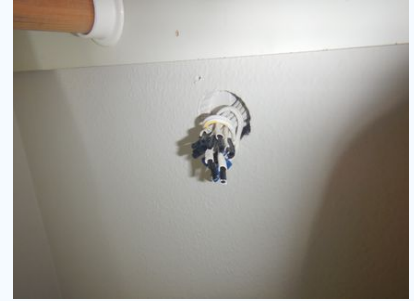
### 🔍 (EDFW-4) Due Diligence:

Recommend inquiring with seller about low volt wires in the downstairs closet.

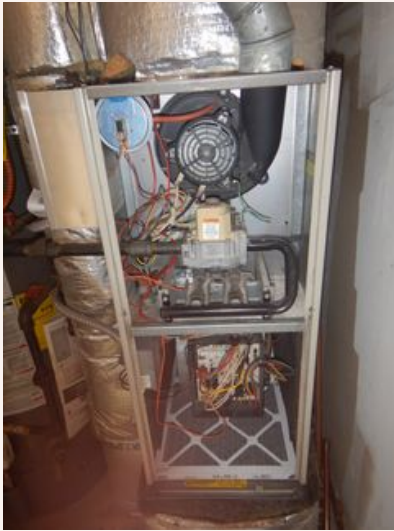
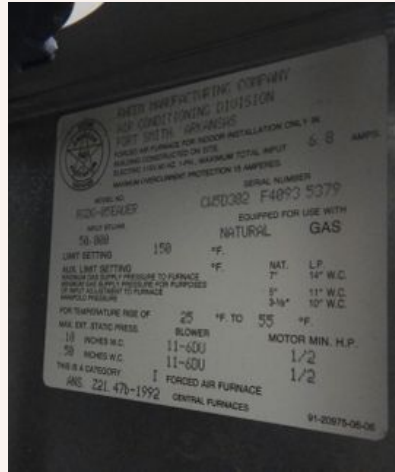
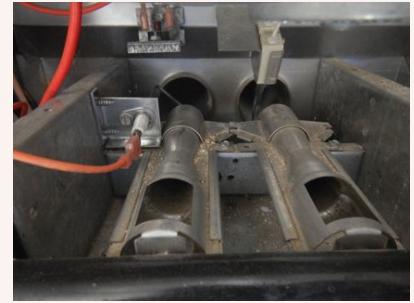
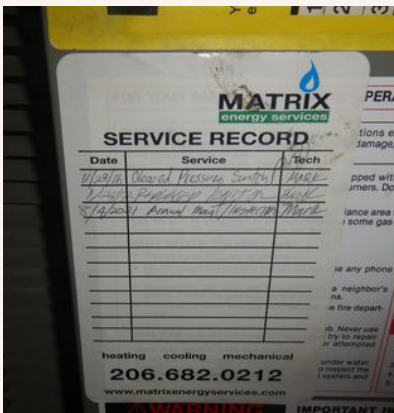
🔧 **(HCFV-2) Recommended Maintenance:** Annual servicing of central heating equipment is recommended for safe and reliable heat. Records indicate that this furnace has not been serviced in the last year. The furnace was tested during inspection and was operational. The design life of these forced air furnaces is 15-20 years. Hire a licensed heating contractor to service and further evaluate the furnace.

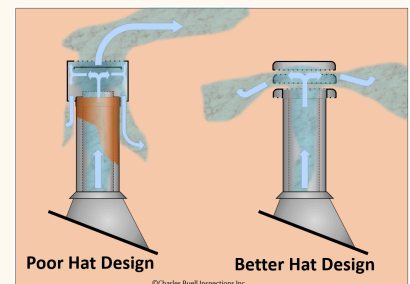
✂ **HCFV-4 Heating, Cooling, Fireplaces and Ventilation - Vents and Flues:** The metal flue for the furnace is corroded and requires repair or replacement. Have this further evaluated and repaired as recommended by a qualified heating contractor. Please note that often a poor cap design can result in premature deterioration of the flue.

**✂️ (HCFV-4) Repair (Minor):** The metal flue for the furnace is corroded and requires repair or replacement. Have this further evaluated and repaired as recommended by a qualified heating contractor. Please note that often a poor cap design can result in premature deterioration of the flue.

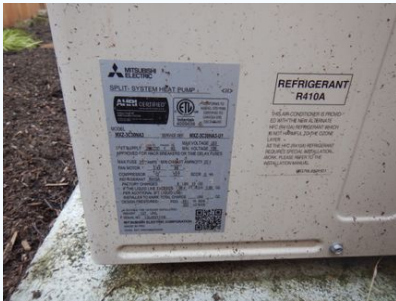
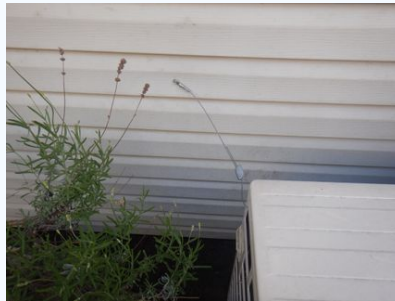
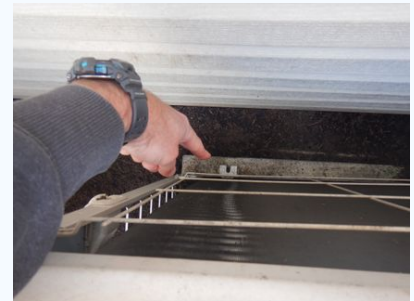
🔍 **(HCFV-5) Due Diligence:** A Mitsubishi ductless mini split system was manufactured in 2001 and has been secured to the wall with small straps. Mounting bolts were found on the front of the unit but not on the rear. Bolts are recommended to be installed at the next servicing of this equipment as they would likely hold better in an earthquake. Recommend having a licensed HVAC contractor install these for you.

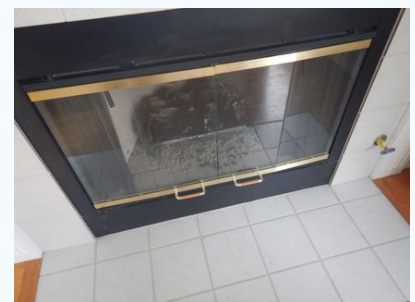
🔍 **(HCFV-7) Due Diligence:**  
The gas log fireplace was shut down and was not operated. I recommend servicing and making this unit operational.

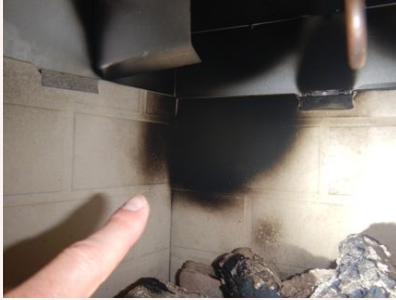
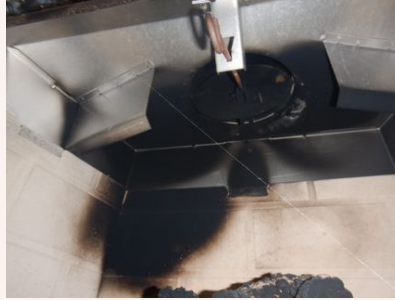
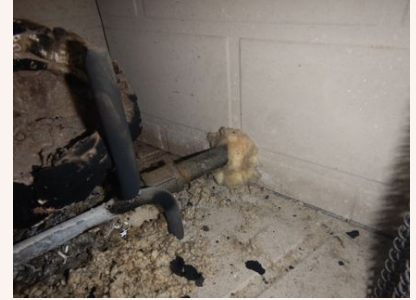
**🔧 (HCFV-8) Recommended Maintenance:** Annual servicing of the fireplace by a qualified gas appliance specialist is recommended to ensure safe and reliable performance.

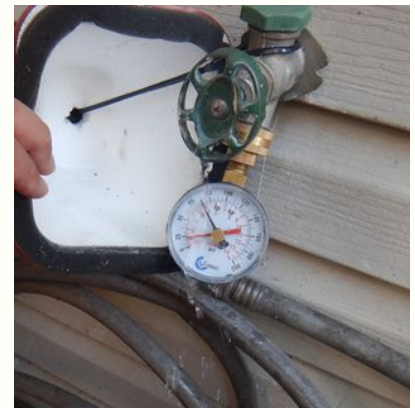
This shows the water pressure tested during inspection. 70psi was observed at the external hose bib.

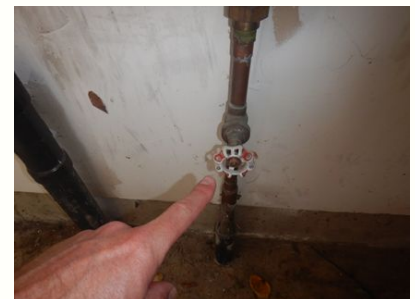
### ☆ (P-2) Note:

This shows the main water shut off located in the garage West wall.

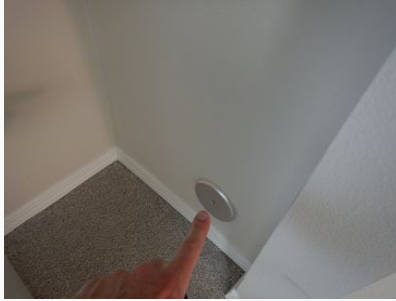
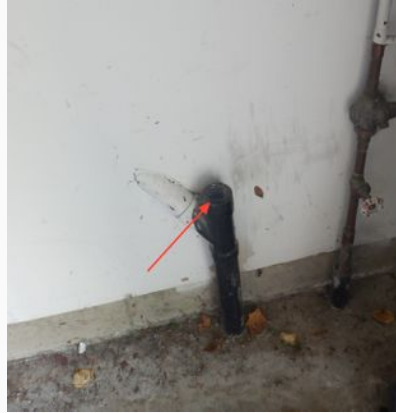
*This shows the location of the sewer cleanout found during inspection - basement closet as well as one in the garage.*

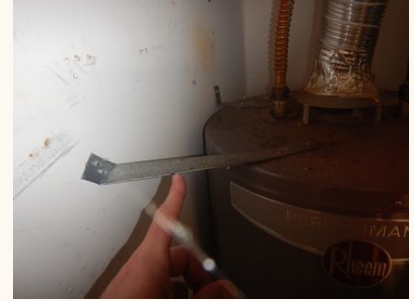
✂ **P-5 Plumbing - Water Heater:** Install listed seismic straps to support the water heater in the event of an earthquake; none were noted during inspection - the current tank employs old braces for support. These are no longer standard as they have been deemed inadequate to protect the water heater in the event of a seismic event.

Install listed seismic straps to support the water heater in the event of an earthquake; none were noted during inspection - the current tank employs old braces for support. These are no longer standard as they have been deemed inadequate to protect the water heater in the event of a seismic event.

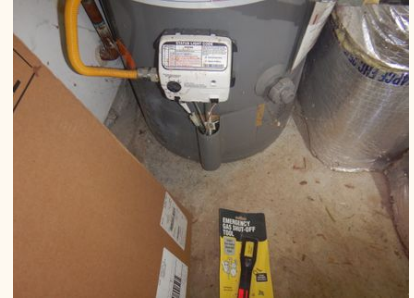
#### ✂ (P-6) Repair (Minor):

✂ **P-6 Plumbing - Water Heater:** Install a foam pad below the water heater to prevent corrosion of the tank and to reduce heat loss to the cold concrete slab. They are recommended for gas water heater installed on concrete.

Install a foam pad below the water heater to prevent corrosion of the tank and to reduce heat loss to the cold concrete slab. They are recommended for gas water heater installed on concrete.

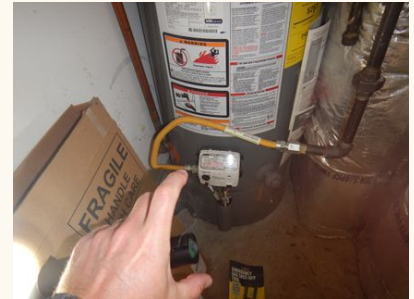
#### ✂ (P-7) Repair (Minor):

No drain pan has been installed below the water heater here. A drain pan is recommended under water heaters that are located in finished spaces or where a leak could damage finishes. Consider a pan with a moisture alarm and a flood-safe device.

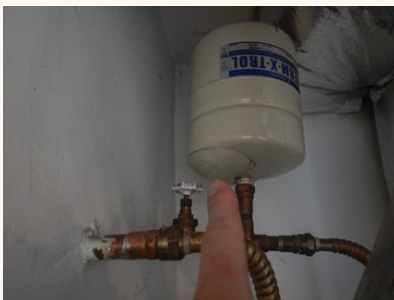
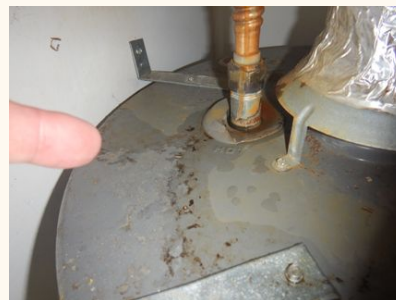
✂ (P-8) Repair (Minor): The expansion tank for the water heater is corroded. This should be replaced in the near term to ensure reliable performance.

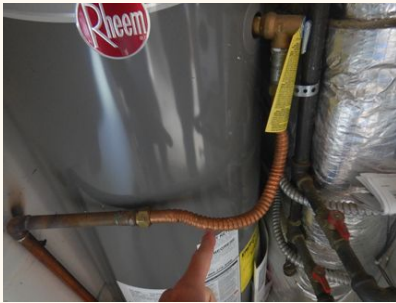
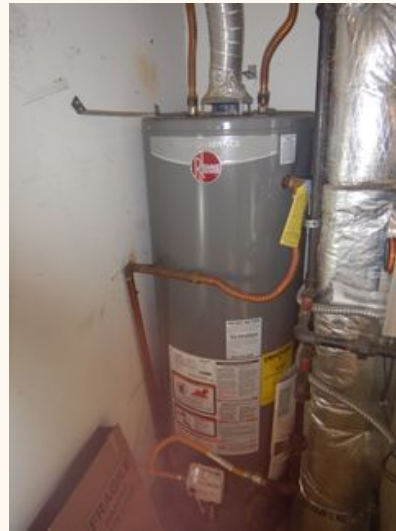
✂ (P-9) **Repair (Minor):** The discharge tube for the water heater [temperature and pressure relief valve](#) (TPRV) is plumbed using a corrugated supply connector. Though this is very common, **this restricts the diameter of the opening** and is unsafe and not recommended - see attached link. Ideally, the discharge tube for a relief valve:

I recommend having this relief valve discharge tube further investigated and repaired as recommended by a licensed plumber.

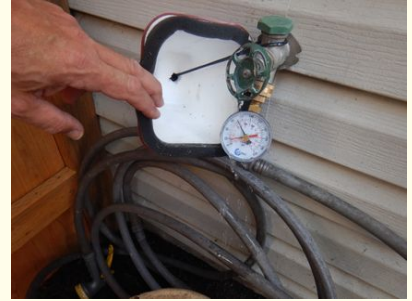
Exterior hose bibs require back-flow prevention or a vacuum breaker to prevent water from irrigation being sucked into the house. The house bibs on this house do not appear to be equipped with either. Have this further evaluated and repaired as recommended by a licensed plumbing contractor.

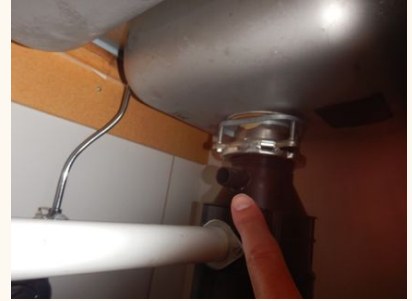
No drain line was found in the kitchen sink cabinet or connected to the disposal. Recommend a licensed plumber evaluate the dishwasher for proper drainage.

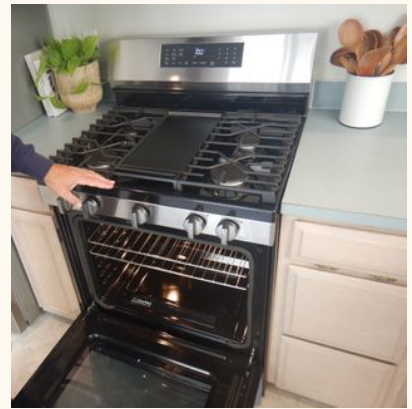
An anti-tip device is needed to prevent this range from tipping during operation of the oven door. This is a small clip that secured the back adjustable feet of the range to the floor.

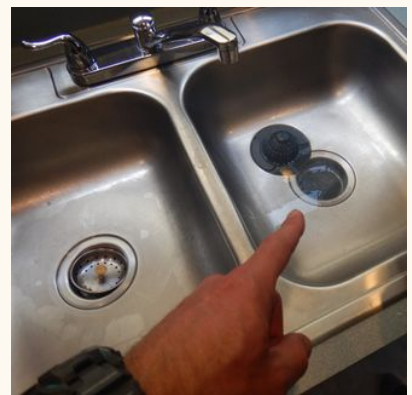
The kitchen sink disposer was tested and not responding to testing during inspection. The disposer did not come on and water was backing up out of the drain. Have this further evaluated and repaired by a licensed plumber.

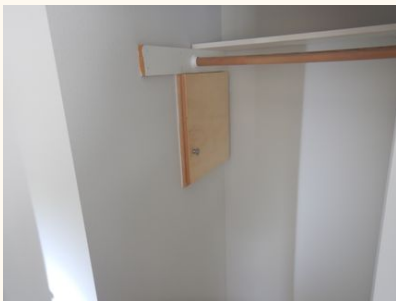
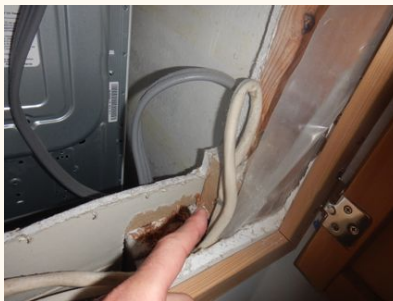
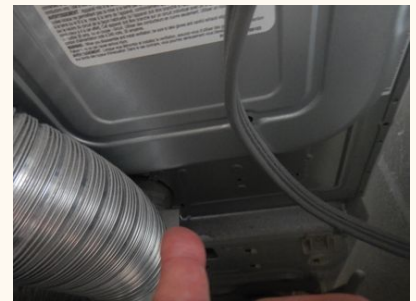
**(LF-2) Repair (Minor):** The dryer exhaust duct is done is corrugated vent pipe. This is not recommended as the corrugations can trap lint which can become a fire hazard. Some types of corrugated vent pipe can be used for the transition duct directly behind the dryer, but in concealed spaces such as behind walls and in attics and crawl space, corrugated exhaust vent pipe is not recommended. Use smooth wall metal pipe only and if the exhaust duct is run outside the thermal envelope, the exhaust duct should be insulated to reduce risks of condensation. Recommend having a licensed installer add a mechanical connection from the duct to the dryer to prevent the duct coming loose.

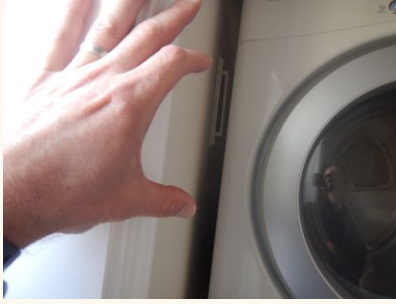
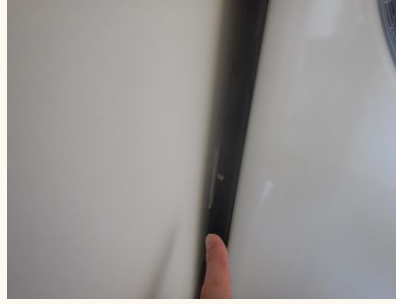
**(LF-3) Repair (Minor):** Laundry vent and switch located in cramped space. Hard to operate and may have reduced performance.

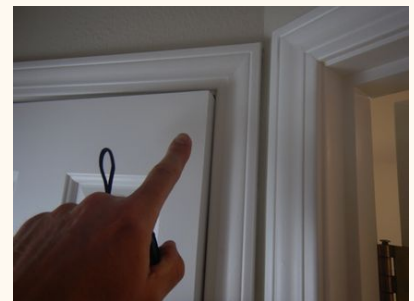
Adjustment to the the basement closet door is needed as the door wedges into the jamb and is difficult or unable to close properly.

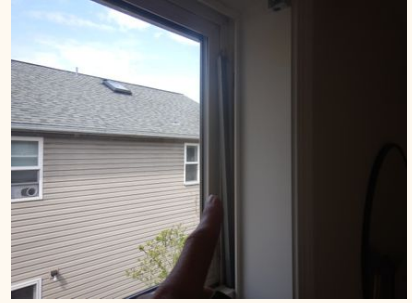
The sash support springs or window balancers that help the single hung windows to move up and down are disconnected in the primary bedroom and need to be re-secured so the window will operate smoothly. Repair these balancers for proper operation of the windows.

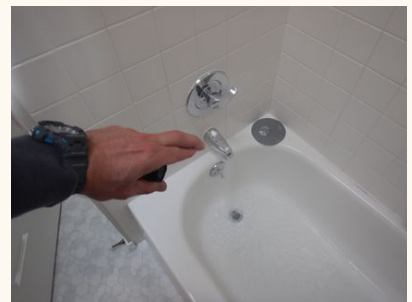
The mixing valve in the hallway bath is installed so that hot and cold are backwards. This can lead to confusion when turning on and off the water and should be repaired.

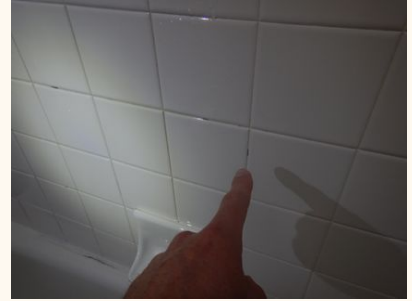
### 🔧 (HB-3) Repair (Minor):

Small areas of incomplete/deteriorated grout was noted in the hallway bath shower surround. Reliable grouting of shower surrounds is critical for the tile to perform reliably. Have the tile further evaluated and repaired as recommended by a qualified tile setter.

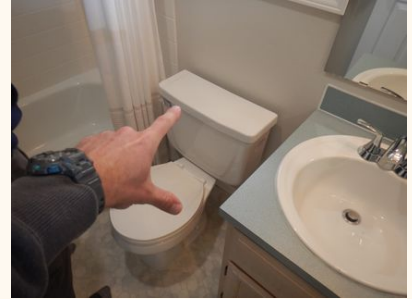
The toilet in the basement bathroom appears to keep running after flushing. This can often be stopped by jiggling the handle. This is not satisfactory. Hire a plumber to further evaluate and repair this toilet to prevent water waste.

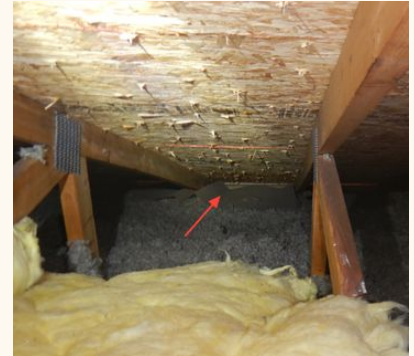
The cardboard baffles are designed to keep insulation away from vents to insure these vents communicate/ventilate. These are falling down in places. This could block proper air flow. Secure loose baffles to ensure they perform as intended.

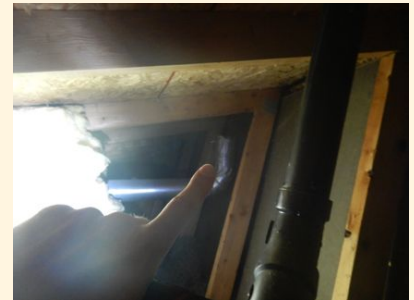
**A-4 Attic - Attic Fan Exhaust Vents:** The exhaust ductwork for the hallway bathroom fan is disconnected in the attic and requires repair to ensure fan exhaust is properly venting to the exterior. Having exhaust fans venting into the attic can cause lead to seasonal condensation and moisture controls problems and could damage the attic building materials. Repair to ensure proper discharge of air to the exterior and be sure exhaust ductwork is insulated to R-8 or better to reduce risks of seasonal condensation.

The exhaust ductwork for the hallway bathroom fan is disconnected in the attic and requires repair to ensure fan exhaust is properly venting to the exterior. Having exhaust fans venting into the attic can cause lead to seasonal condensation and moisture controls problems and could damage the attic building materials. Repair to ensure proper discharge of air to the exterior and be sure exhaust ductwork is insulated to R-8 or better to reduce risks of seasonal condensation.
