Inspection report for the property at

Slightly Complex Ave Neat Custom Home, USA

This report is prepared exclusively for **Custom House** On: **2018-02-25**

ICN#: 10296AR0011

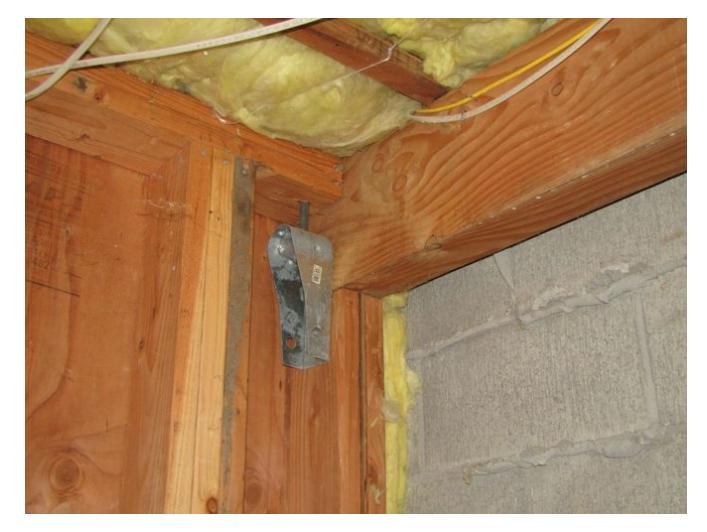
🕉 (SB-1) Note: Evidence of seismic retrofitting protection was noted.

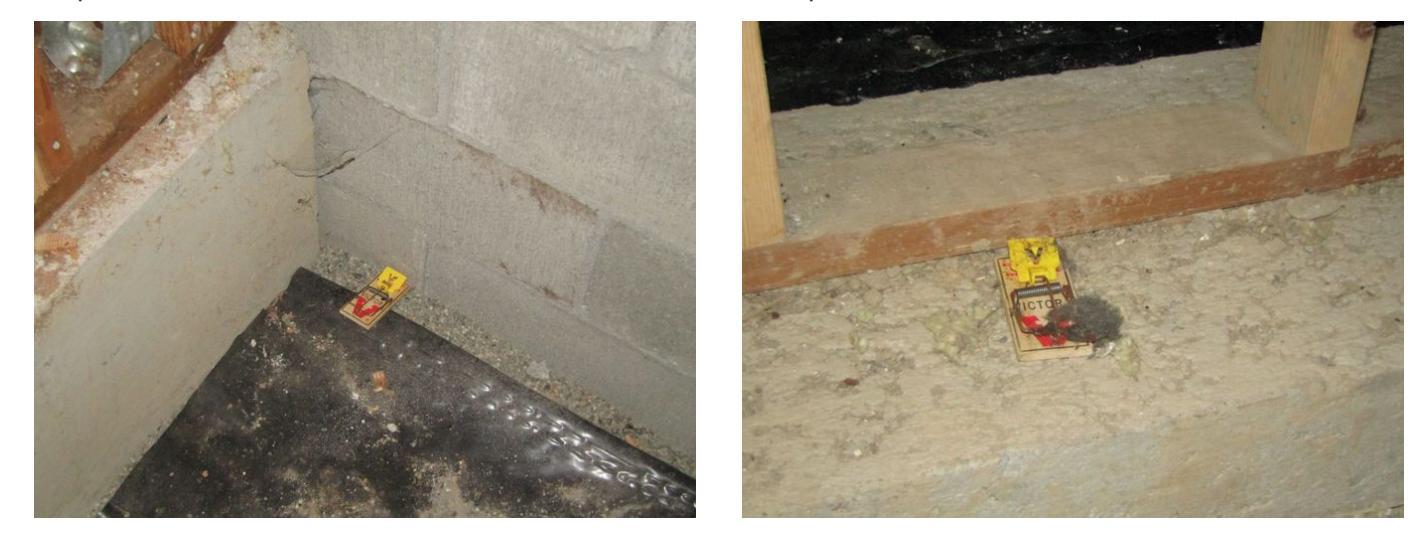
(PWDO-1) Monitor: Rodent traps were noted in the crawl space. This is evidence of prior rodent problems. I recommend disclosing the extent and scope of prior rodent control work. Unless noted elsewhere in this report, no fresh evidence of rodents was visible at the time of inspection. I did see an old dead one under the older p[art of the house.

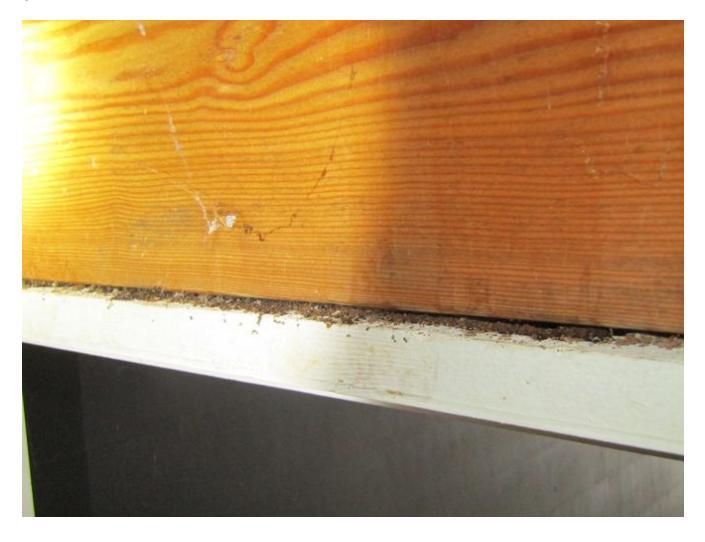
✔ ♥ (PWDO-3) Due Diligence (WDO): Localized moisture ant frass was noted during inspection today - see above door to the newer crawl space. Moisture ants are a wood destroying organism that are indicative of a moisture problem. They will often form nests and tunnels and can damage structural wood. Repairs need to be made to eliminate wet wood and repair all hidden damage to the building. Once the source of moisture is removed and all wood is repaired the ants should go away. During inspection today I found no live ants suggesting this may be an older water problem. But I am concerned this is related to the other red flags in that east wall by the covered porch. Additional evaluation is needed.

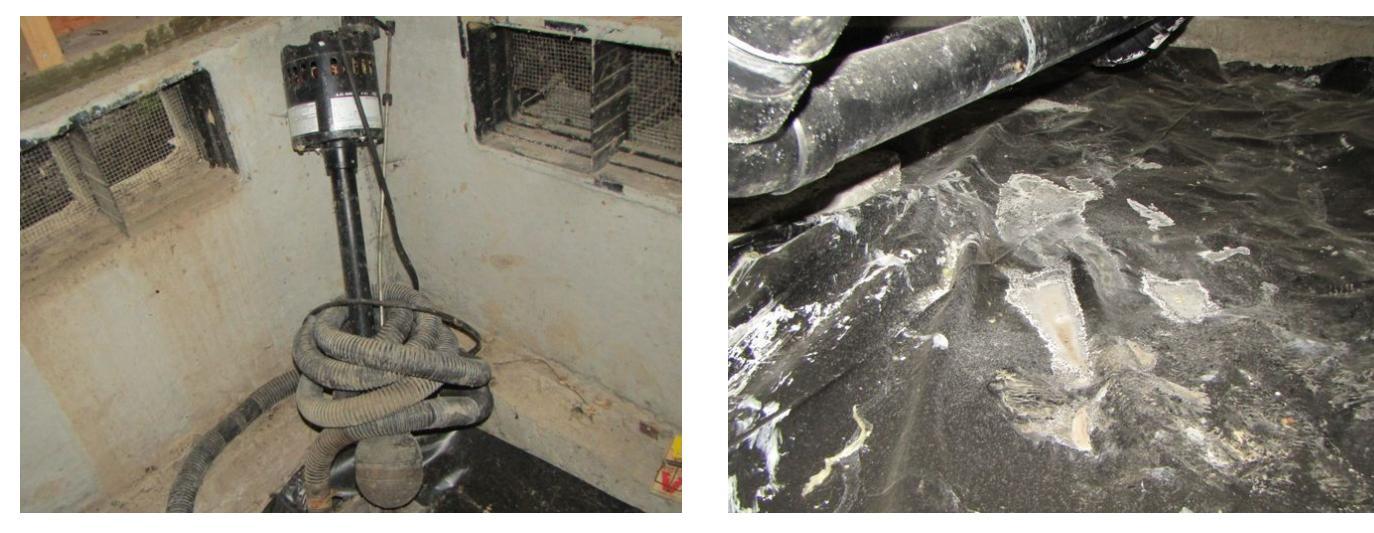
(CS-2) Monitor: I noted an old sump pump below the old part of the house and a few moisture stains. No water was note during inspection. This may be old - from before the remodel work was done.

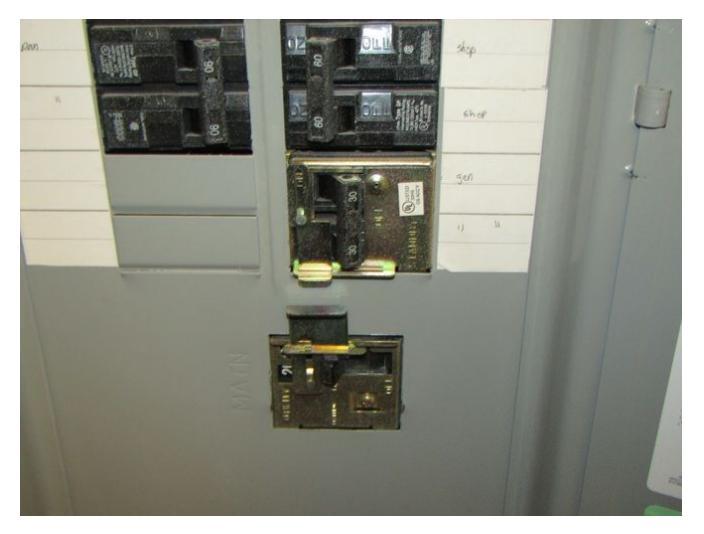
(E-1) Note: I was unable to get the dead front cover of the electric panel fully open today. The generator transformer made removal of the cover difficult - removal of the transformer switch risks damaging or loosening the breakers.

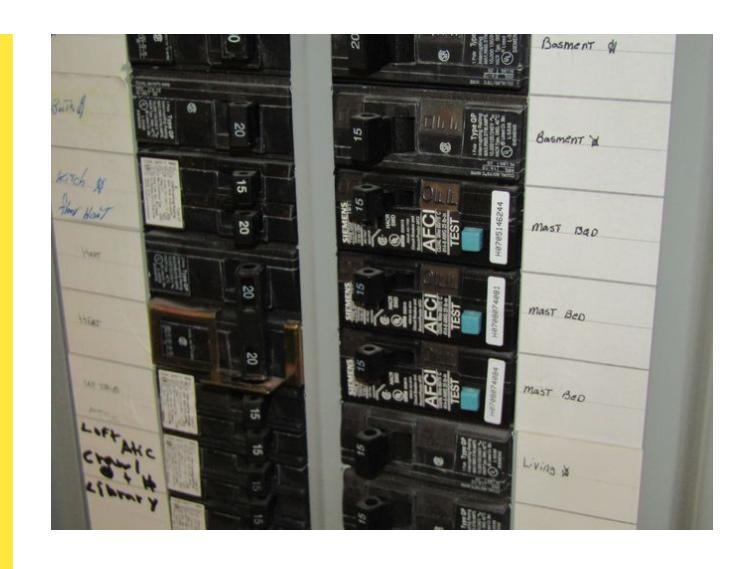
(E-2) Improve: The arc fault protection breakers in this panel are an older "branch feeder" model AFCI. These are first generation technology and they will not perform as reliably as new versions of arc fault protection known as "Combination" AFCI. Updating is recommended. Consult with a licensed electrician about updating to a combination AFCI where arc fault protection is desired and please note that our standards of where arc fault protection is required has changed over the years. How far you wish to go with updating is discretionary.

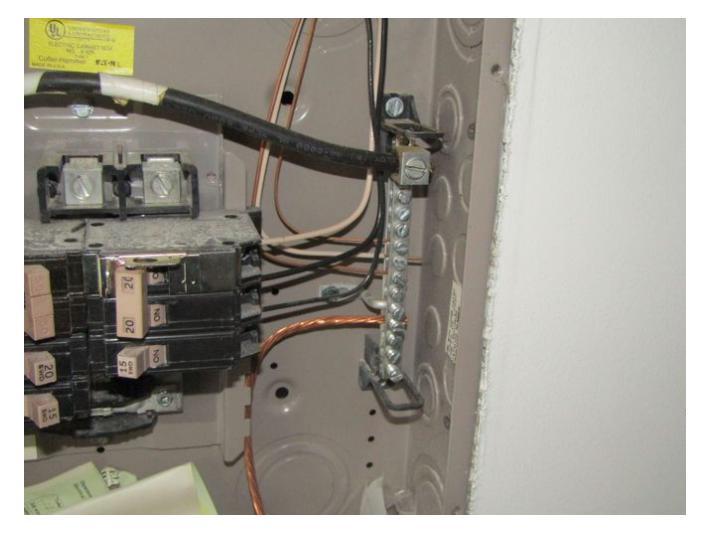
(E-3) Electrical: The wiring to the sub-panel in the garage has been done to an older standard. The neutrals should be on a floating bus bar and should be separated from the equipment grounds to eliminate stray voltage. Hire a licensed electrician to further evaluate and repair this condition.

(E-3) Repair: The wiring to the sub-panel in the garage has been done to an older standard. The neutrals should be on a floating bus bar and should be separated from the equipment grounds to eliminate stray voltage. Hire a licensed electrician to further evaluate and repair this condition.

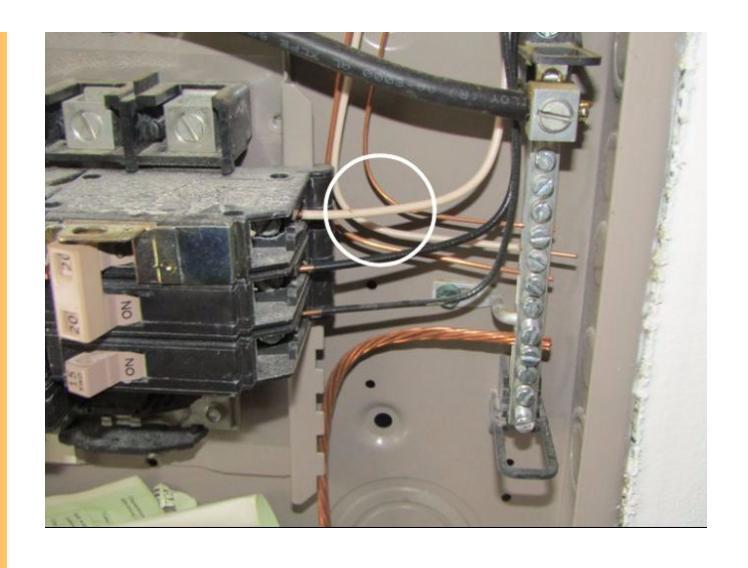
(E-4) Repair: The white-insulated conductors in the sub-panel that are being used as hots have not been correctly identified. These conductors should be colored black or red or wrapped in appropriate tape to insure proper identification inside the panel.

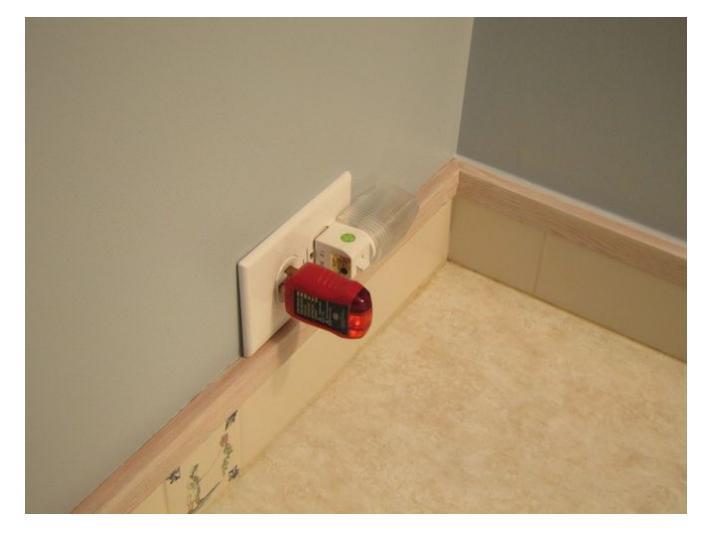
(E-5) Electrical: The loose receptacle in the family bath should be secured to prevent accidental damage to the wiring connections.

(E-5) Repair: The loose receptacle in the family bath should be secured to prevent accidental damage to the wiring connections.

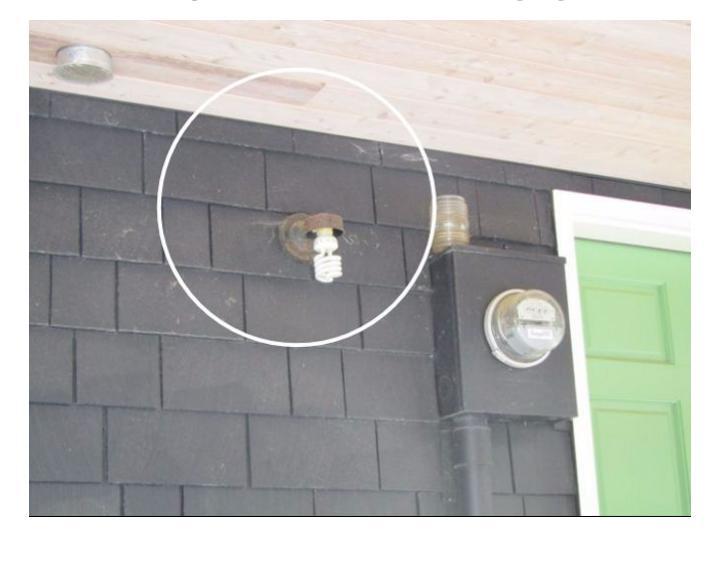
F (E-6) Electrical: Install the missing light cover to the back door exterior light.

7 (E-6) **Repair:** Install the missing light cover to the back door exterior light.

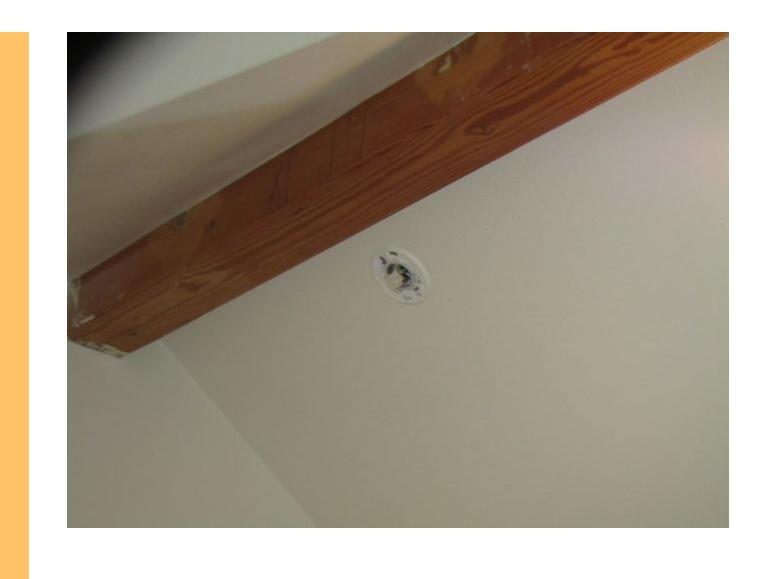
(E-8) Electrical: A missing smoke alarm was noted at the time of inspection - see loft. Replace all missing smoke alarms.

(E-8) Repair: A missing smoke alarm was noted at the time of inspection - see loft. Replace all missing smoke alarms.

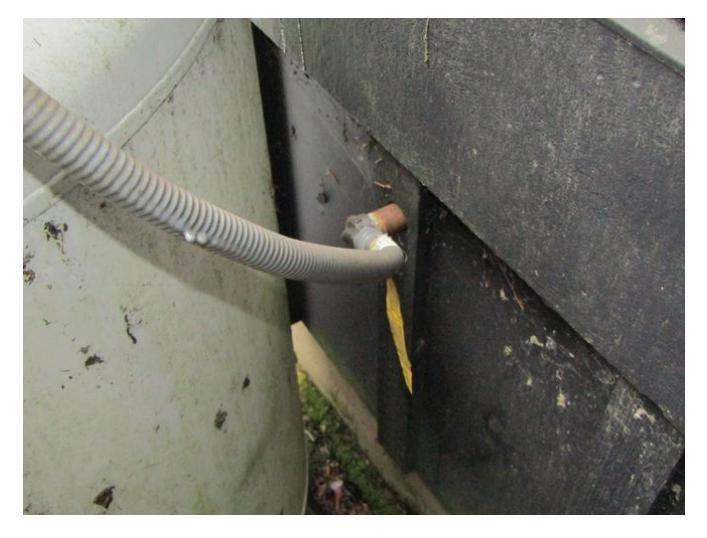
(E-9) Electrical: The 2009 edition of NFPA 54, National Fuel Gas Code, includes new requirements for bonding CSST gas piping systems to the grounding conductor of the building's electrical system, to reduce the possibility of damage by lightning strikes by reducing the electrical potential between metallic objects and building systems, including gas distribution. I did not find bonding or grounding at the metal gas pipe where it enters the building. Have this further investigated by a qualified electrician and repaired as recommended.

(E-9) Repair: The 2009 edition of NFPA 54, National Fuel Gas Code, includes new requirements for bonding CSST gas piping systems to the grounding conductor of the building's electrical system, to reduce the possibility of damage by lightning strikes by reducing the electrical potential between metallic objects and building systems, including gas distribution. I did not find bonding or grounding at the metal gas pipe where it enters the building. Have this further investigated by a qualified electrician and repaired as recommended.

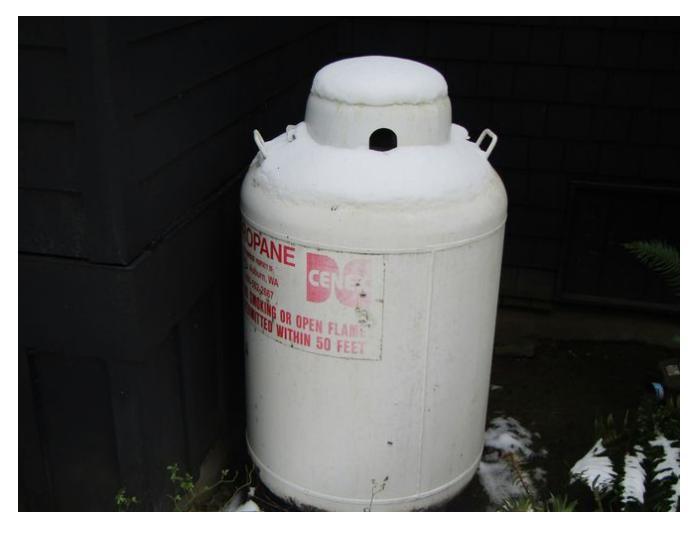
(FSD-1) Improve: The propane tank for the home has not been strapped or braced to secure the tank in the event of an earthquake. This is not required but seems a logical safety improvement. I recommend bracing this tank for improved safety.

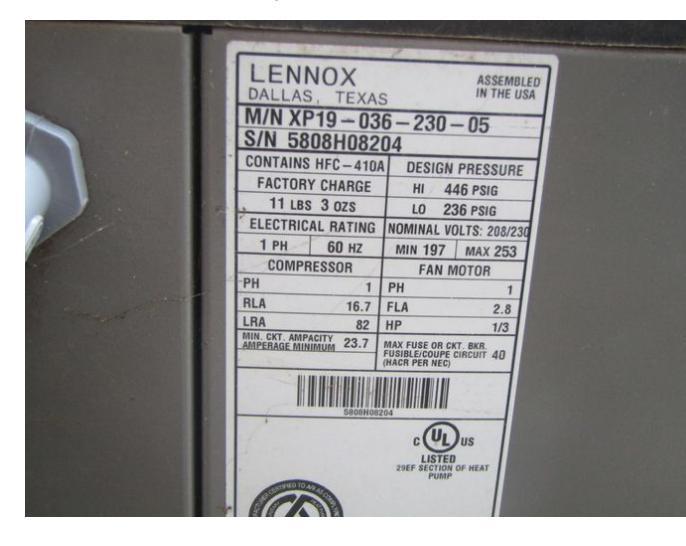
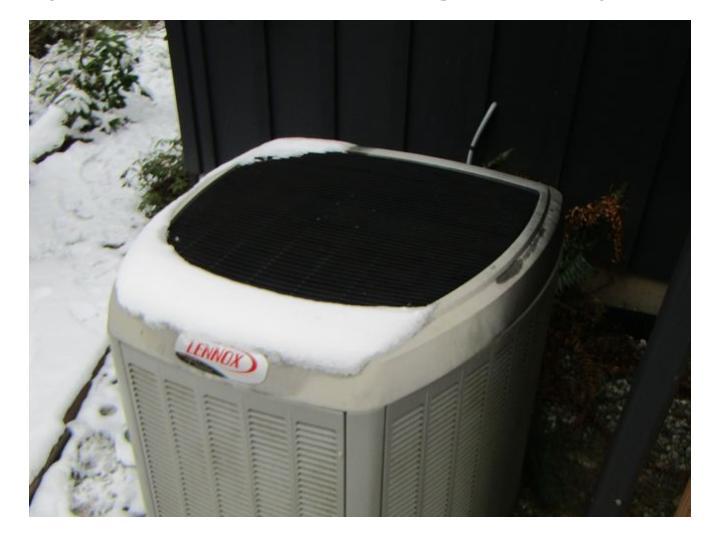
(HCF-4) Heating, Cooling and Fireplaces: This heat pump was operating at the time of inspection. Heat pumps have fairly unpredictable service lives that can range from as little as 7 to as many as 30 years. The unit was working and making heat today even in cold temperatures. The system seemed to be keeping up well with the thermostat. The outdoor unit was making a bit of a noise as though the fan is loose. I recommend having this system serviced and have the outdoor unit fan evaluated. At the time of inspection the filter was clean. The system was tested in heating mode only.

(HCF-4) Repair: This heat pump was operating at the time of inspection. Heat pumps have fairly unpredictable service lives that can range from as little as 7 to as many as 30 years. The unit was working and making heat today even in cold temperatures. The system seemed to be keeping up well with the thermostat. The outdoor unit was making a bit of a noise as though the fan is loose. I recommend having this system serviced and have the outdoor unit fan evaluated. At the time of inspection the filter was clean. The system was tested in heating mode only.

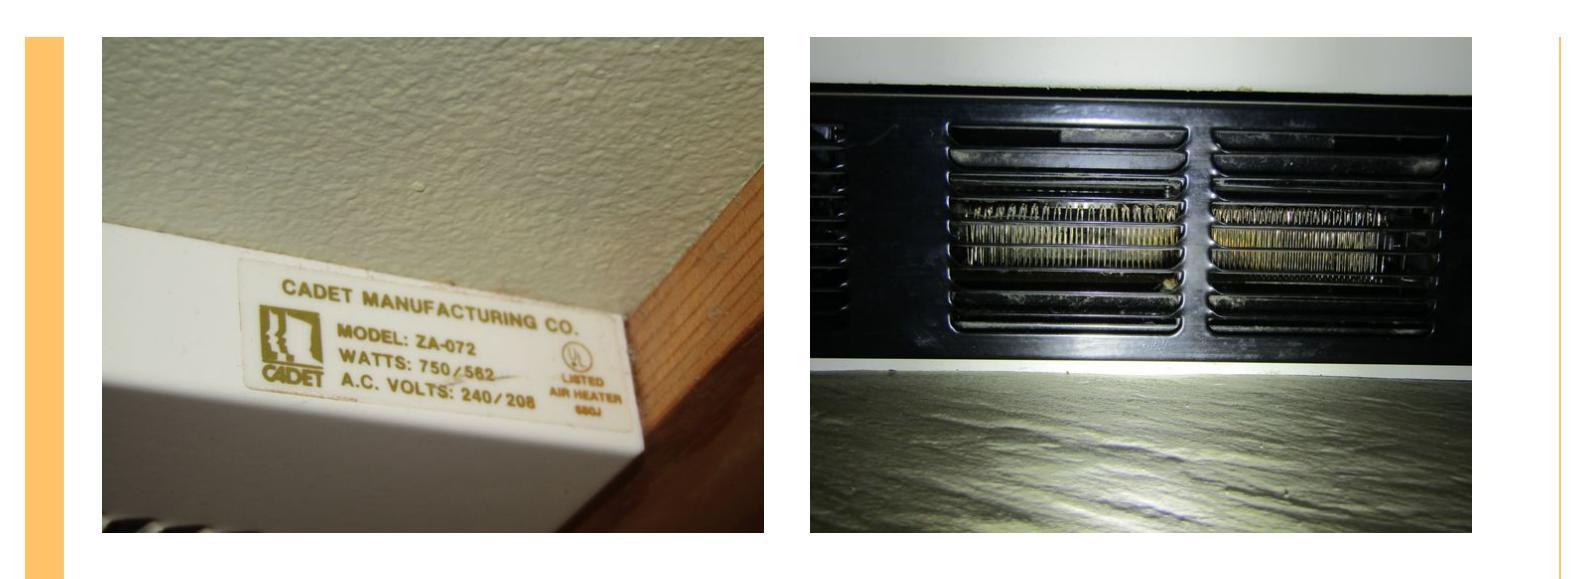
(HCF-5) Heating, Cooling and Fireplaces: A <u>recalled model of Cadet heater was noted</u>. I counted three on the 2nd floor - in bedrooms and the toe kick in the bathroom. ZA models. *All recalled Cadet heaters should be repaired or replaced* as recommended by the Cadet Recall. These heaters are a latent fire hazard until serviced or replaced. For more information on the Cadet recall call 800-567-2613.

(HCF-5) Repair: A <u>recalled model of Cadet heater was noted</u>. I counted three on the 2nd floor - in bedrooms and the toe kick in the bathroom. ZA models. *All recalled Cadet heaters* **should be repaired or replaced** as recommended by the Cadet Recall. These heaters are a latent fire hazard until serviced or replaced. For more information on the Cadet recall call 800-567-2613.

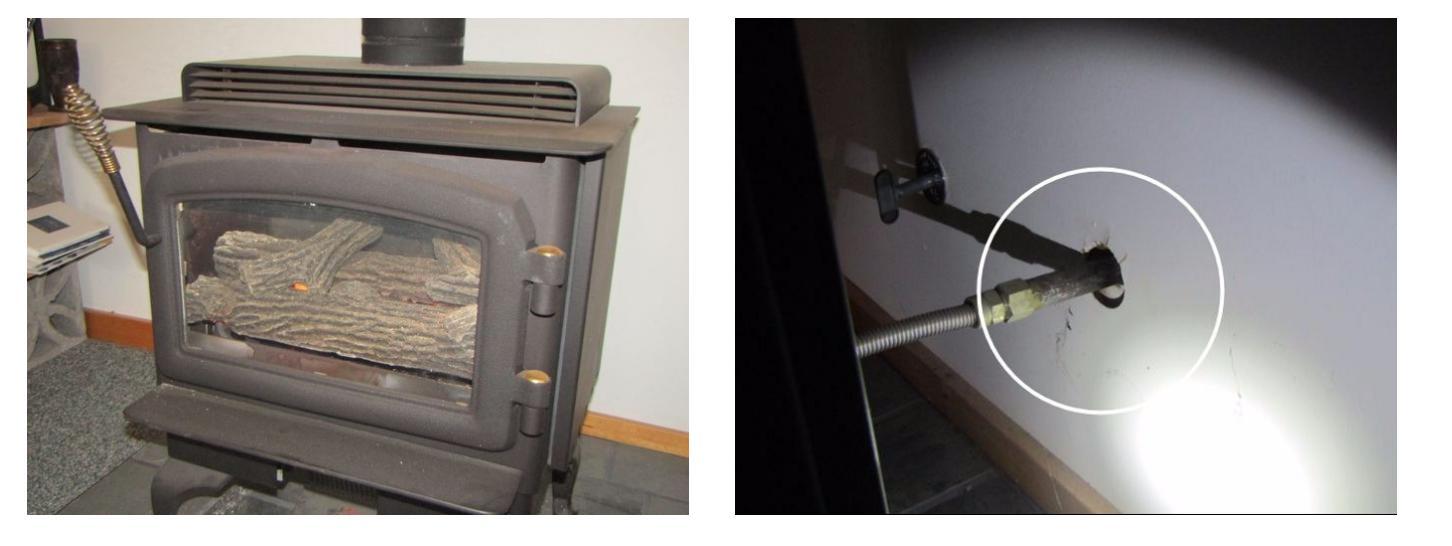
(HCF-6) Repair: Seal up the hole in the wall behind the gas pipe at the propane furnace in the garage office. Also, install a CO alarm for this space.

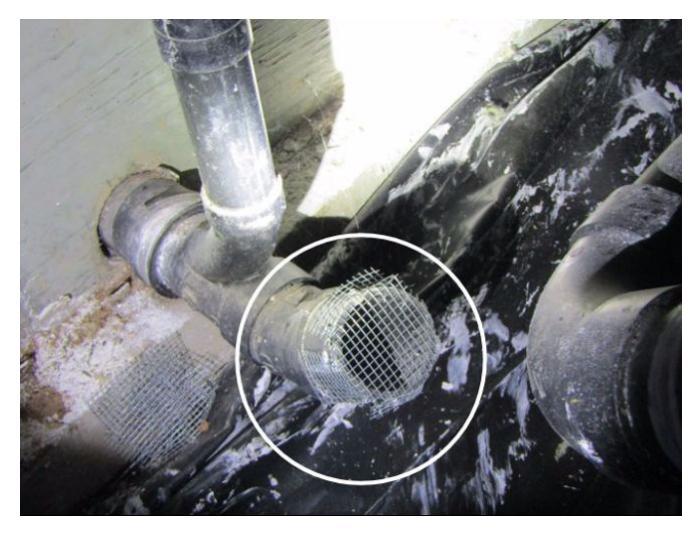
(P-5) Plumbing: Some older-looking waste piping in the old part of the crawl space is screed off. I did not smell any sewer gas, so this may be disconnected from a sewer line. Just in case, I recommend capping so this pipe is properly sealed.

(P-5) Repair: Some older-looking waste piping in the old part of the crawl space is screed off. I did not smell any sewer gas, so this may be disconnected from a sewer line. Just in case, I recommend capping so this pipe is properly sealed.

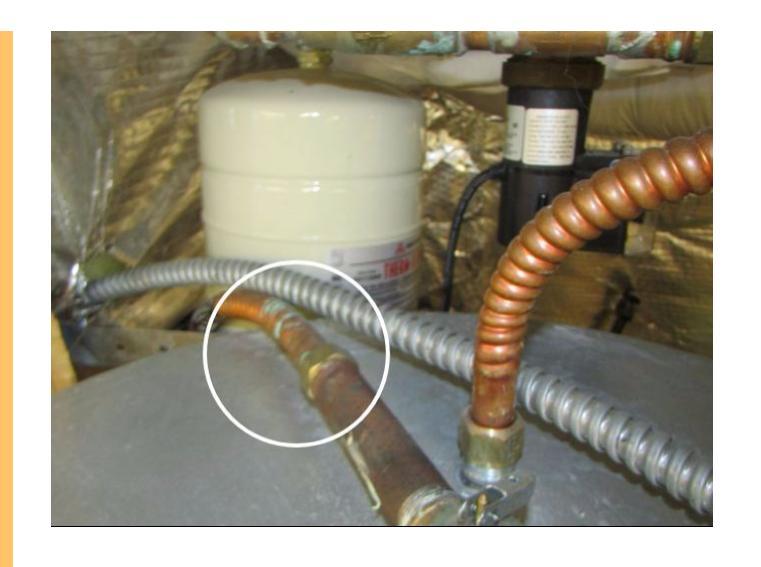
(P-6) Plumbing: The discharge tube for the water heater relief valve is using a supply connector. This restricts the diameter of the opening and is unsafe and non-standard. Hire a licensed plumber to further evaluate and repair.

(P-6) Repair: The discharge tube for the water heater relief valve is using a supply connector. This restricts the diameter of the opening and is unsafe and non-standard. Hire a licensed plumber to further evaluate and repair.

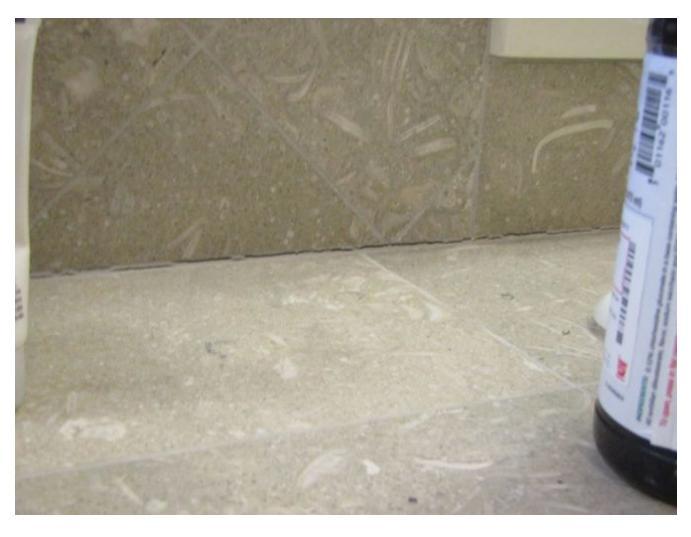
(MB-1) Repair: Use caulking to seal between the backsplash and sink behind the bath sink. Also be sure the sink to countertop juncture is well sealed.

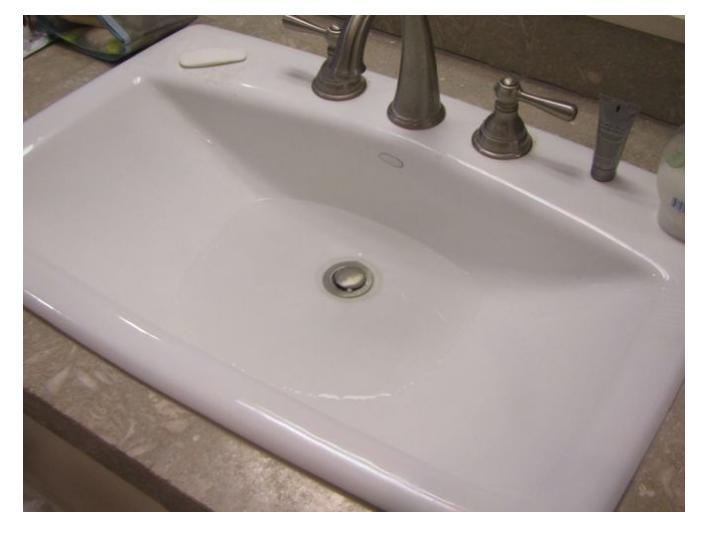
(MB-2) Master Bathroom: A slow drain was noted at the left side master bathroom sink indicating that the drain may be obstructed. Repair as needed so drain keeps up with supply.

(MB-2) Repair: A slow drain was noted at the left side master bathroom sink indicating that the drain may be obstructed. Repair as needed so drain keeps up with supply.

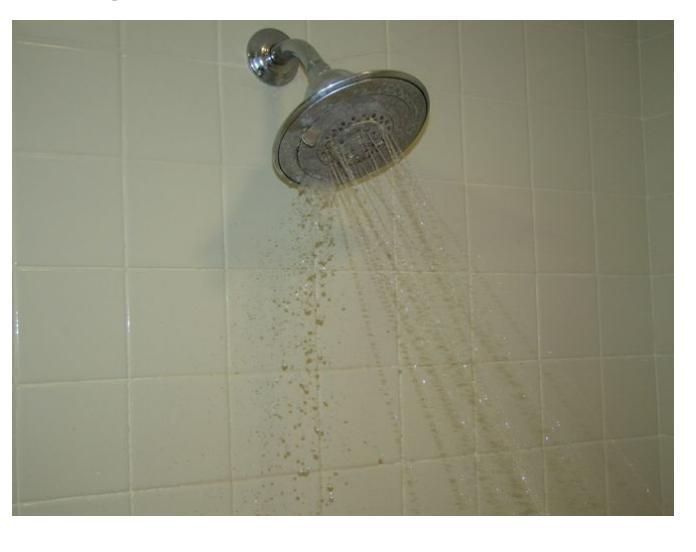
(MB-3) Master Bathroom: The shower head in the master bath is leaky and requires repair to prevent wasting water and to control water flow.

(MB-3) Repair: The shower head in the master bath is leaky and requires repair to prevent wasting water and to control water flow.

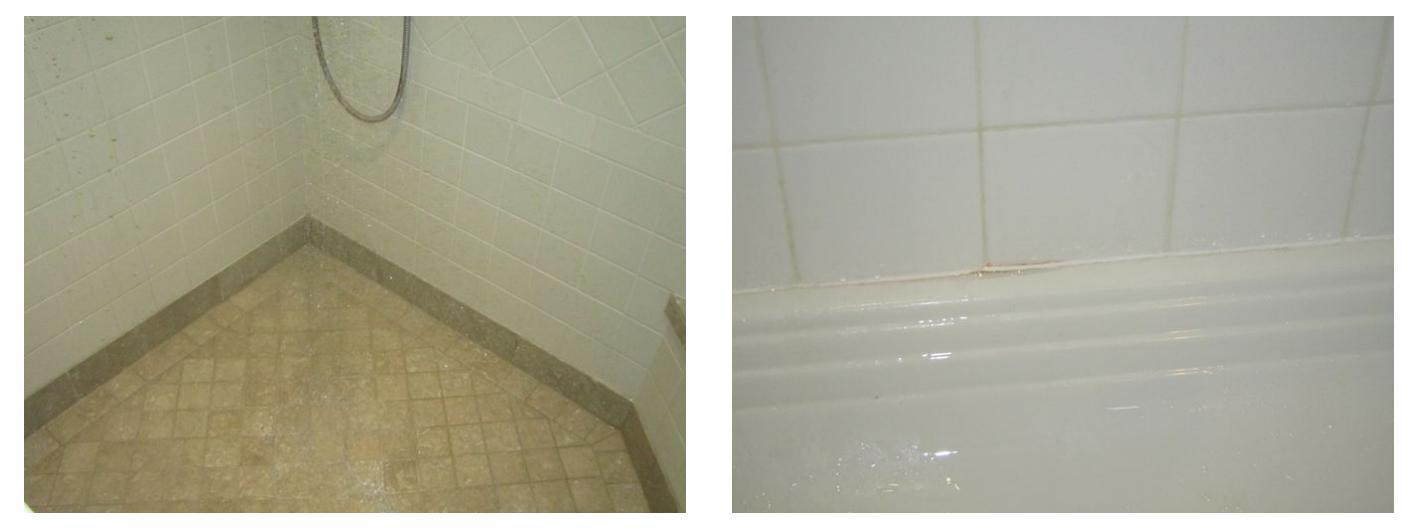
(MB-4) Master Bathroom: The tile and grout should be cleaned and sealed with grout sealer to prevent water damage to the tile - see especially inside shower surrounds in bathrooms. This should be a routine procedure with tile unless epoxy grout was used. If this is not done in epoxy grout plan on cleaning and sealing tile grout inside the shower surround annually to prolong the useful life of the tile.

(MB-4) Repair: The tile and grout should be cleaned and sealed with grout sealer to prevent water damage to the tile - see especially inside shower surrounds in bathrooms. This should be a routine procedure with tile unless epoxy grout was used. If this is not done in epoxy grout plan on cleaning and sealing tile grout inside the shower surround annually to prolong the useful life of the tile.

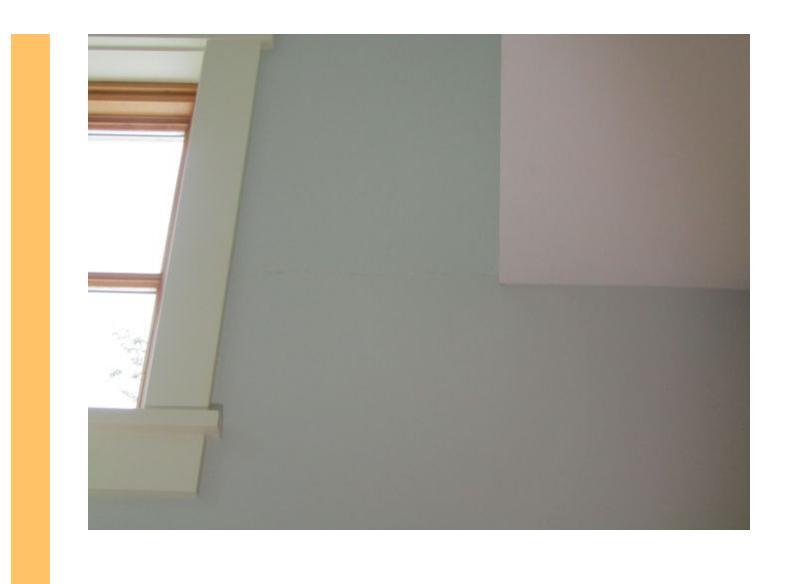
(I-1) Interior: Cracks were noted in the walls - see south side in master bedroom. Cracking can be due to routine settlement or moderate seasonal expansion and contraction of the home. It can also be related to workmanship and nailing of framing and drywall. The seasonal types of cracking can be most problematic as they will tend to re-open after repair. Repair and paint cracks as needed and monitor.

(I-1) Repair: Cracks were noted in the walls - see south side in master bedroom. Cracking can be due to routine settlement or moderate seasonal expansion and contraction of the home. It can also be related to workmanship and nailing of framing and drywall. The seasonal types of cracking can be most problematic as they will tend to re-open after repair. Repair and paint cracks as needed and monitor.

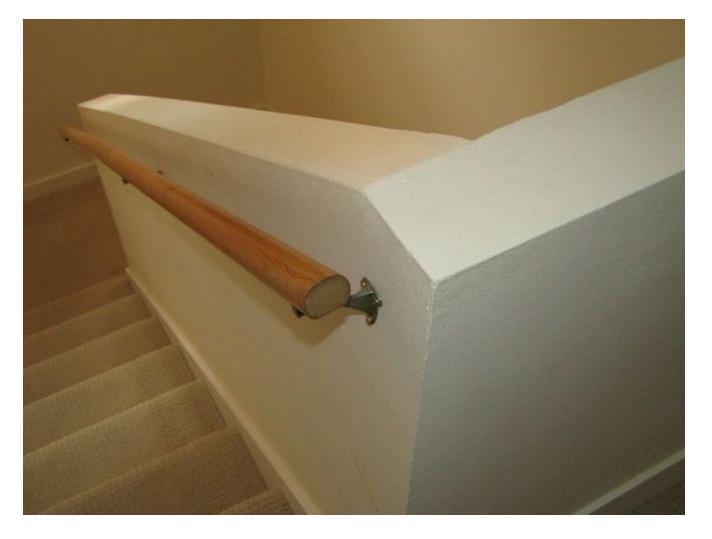
% (I-2) **Improve:** The ends of the hand rail should return into the wall to prevent clothing or accessories from catching on the end of the railing and creating a trip hazard.

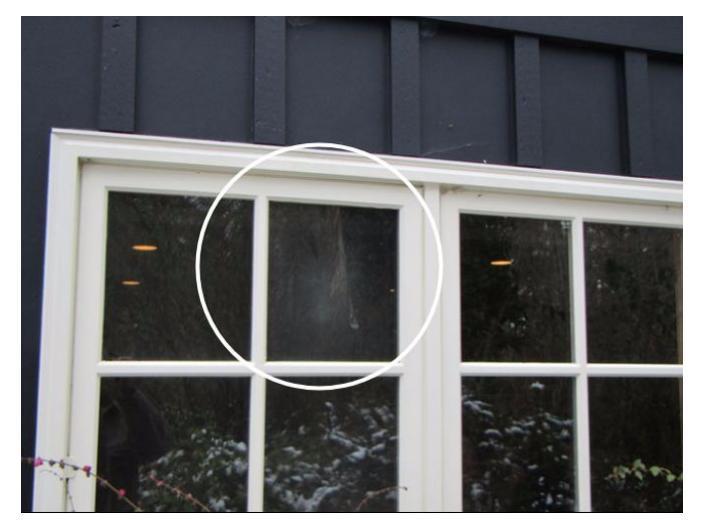
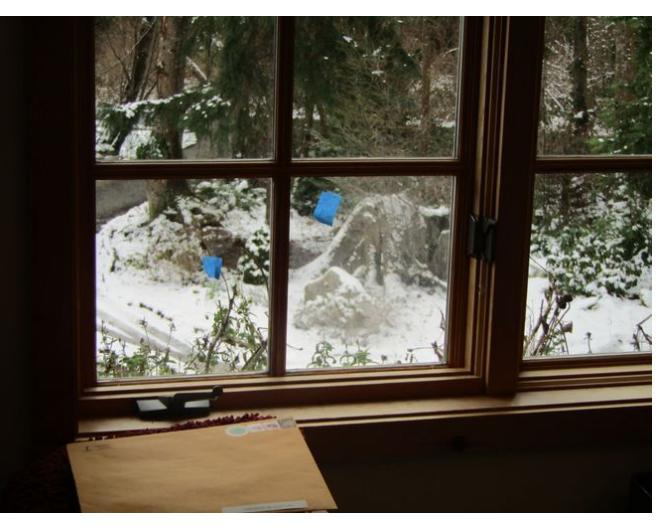
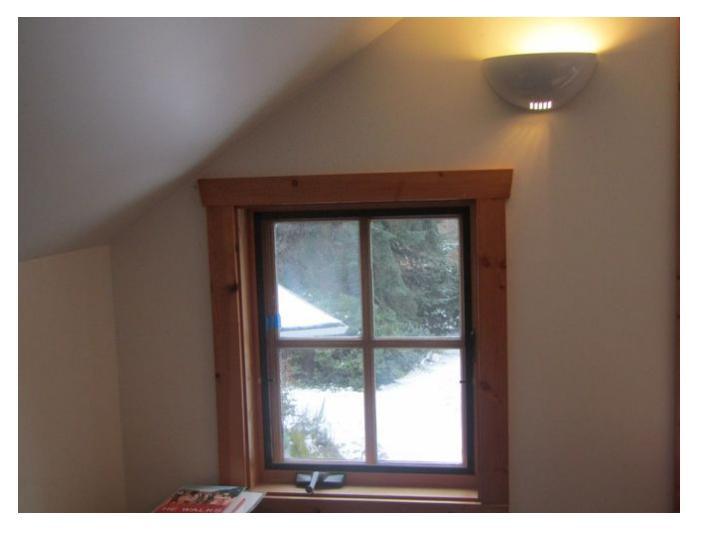
(I-3) Interior: Multiple lost seals were noted in the glazing. This has resulted in fogging between the panes of glass that cannot be cleaned without glazing repair or replacement. Hire a glass replacement company to further evaluate and replace all windows with lost seals. I list as a major concern as this can be expensive to correct.

Window Glazing Double pane Interior Window Frame Wood Window Styles Casement, Fixed pane (I-3) Major Concern: Multiple lost seals were noted in the glazing. This has resulted in fogging between the panes of glass that cannot be cleaned without glazing repair or replacement. Hire a glass replacement company to further evaluate and replace all windows with lost seals. I list as a major concern as this can be expensive to correct.

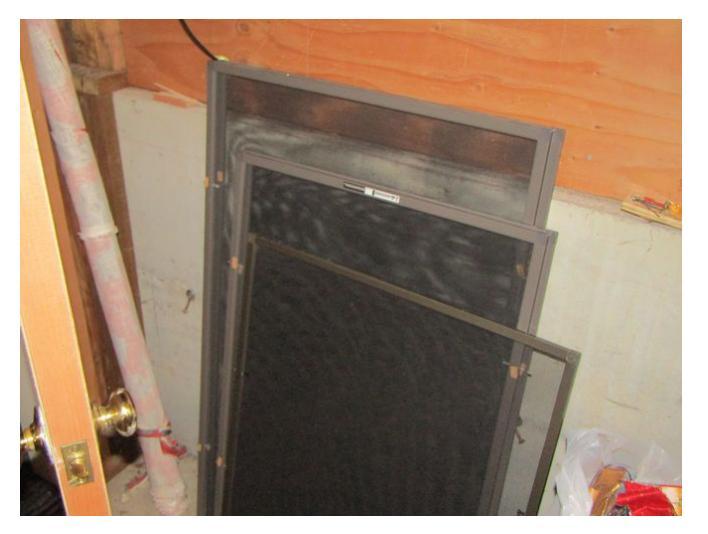
(I-4) Interior: Some window screens were noted in the basement. Inquire with the seller if these go to the windows that do not have screens.

(I-4) Repair: Some window screens were noted in the basement. Inquire with the seller if these go to the windows that do not have screens.

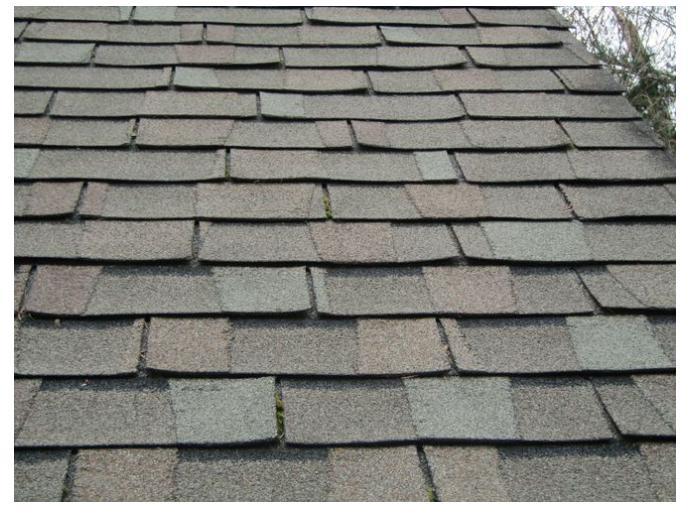
(RA-1) Roof/Attic: The garage roof covering is close to the end of its reliable service life. The average life of these roofs is 18-22 years and that is how old this roof looks. Hire a licensed roofing contractor to further evaluate and replace this roof soon to insure reliable roofing performance. During roof replacement, I always recommend doing a complete tear off, evaluating the roof decking for damaged or soft boards, evaluating roof venting and indoor fan terminations and replacing all flashings. I could not find leaks at the time of inspection, indicating that the roof has performed well to date.

(RA-1) Major Concern: The garage roof covering is close to the end of its reliable service life. The average life of these roofs is 18-22 years and that is how old this roof looks. Hire a licensed roofing contractor to further evaluate and replace this roof soon to insure reliable roofing performance. During roof replacement, I always recommend doing a complete tear off, evaluating the roof decking for damaged or soft boards, evaluating roof venting and indoor fan terminations and replacing all flashings. I could not find leaks at the time of inspection, indicating that the roof has performed well to date.

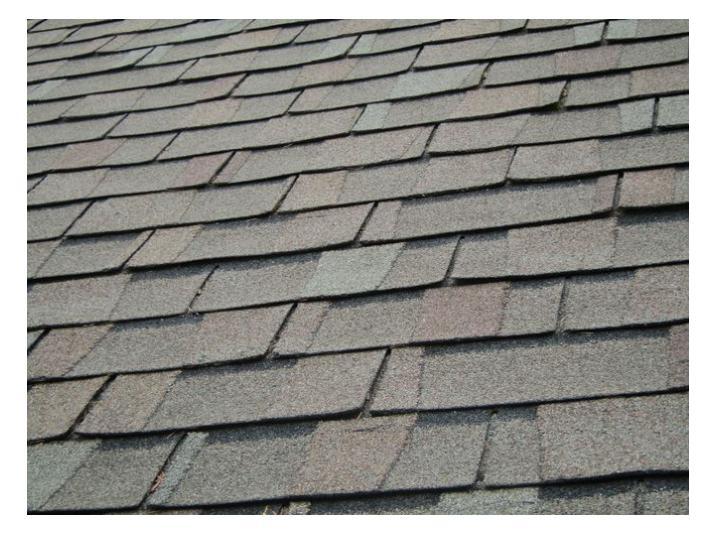
Shingles are curing at the edges indicting the shingles are old and starting to dry out.

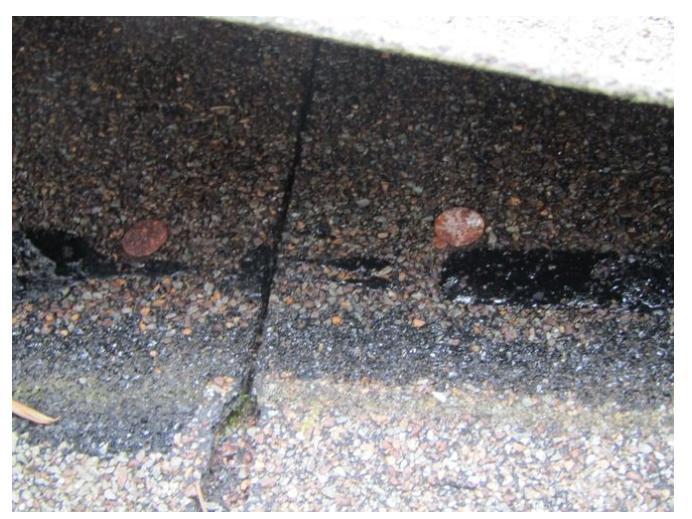
Incorrect nailing location where I spot checked: nails should be below the tar strip.

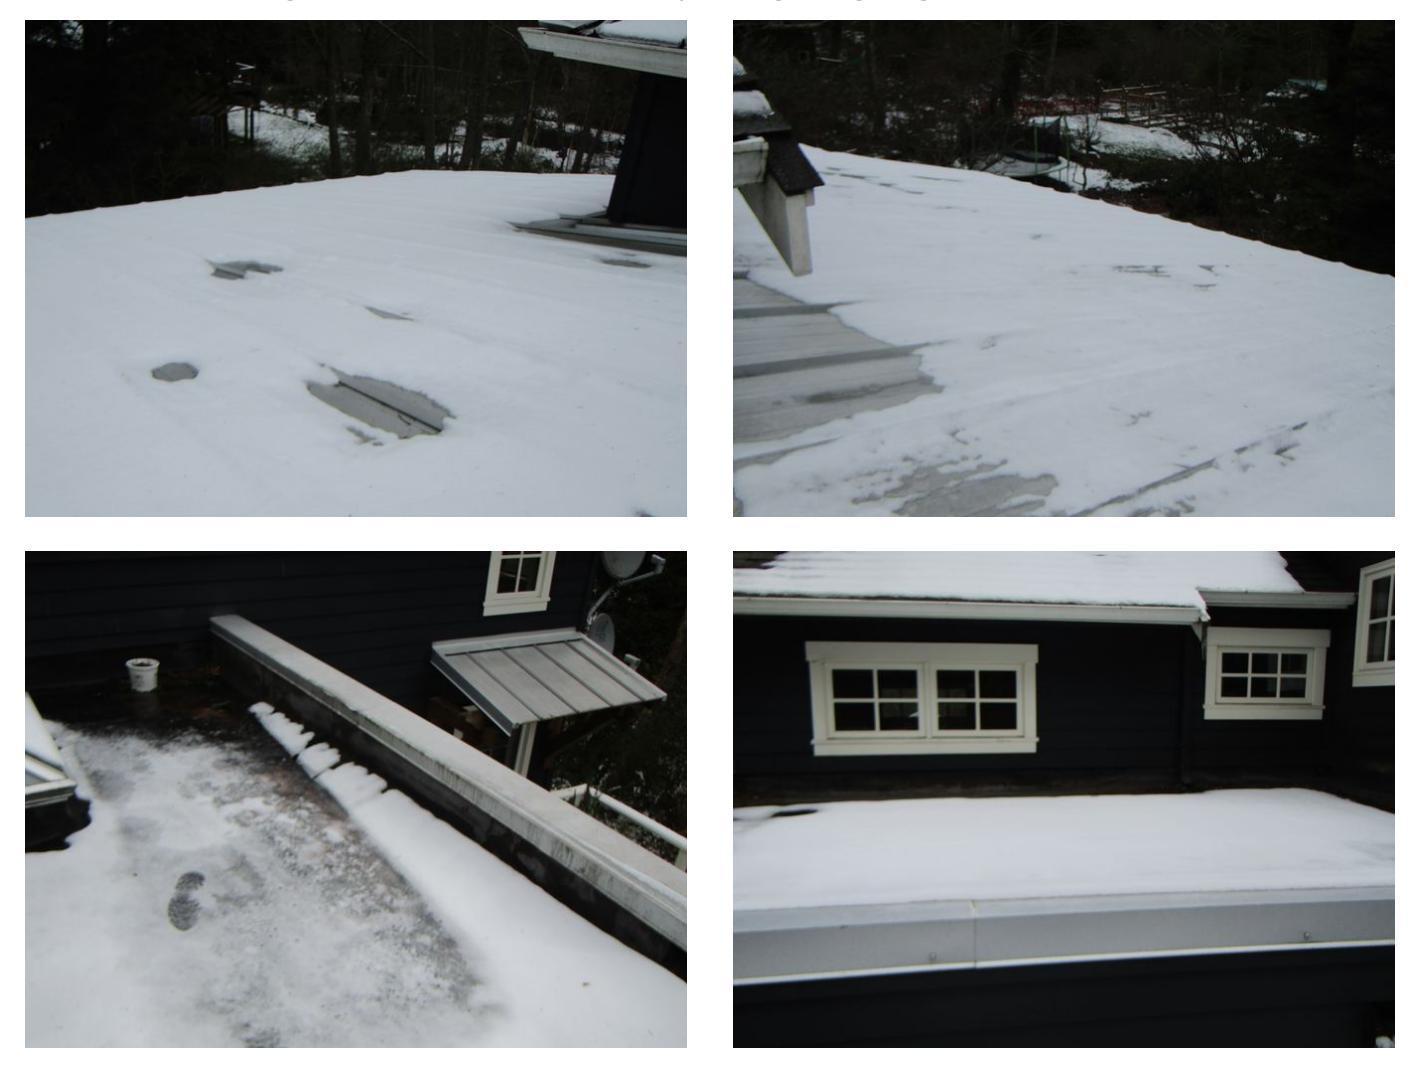
(RA-2) Note: The roof for the garage and the house was not fully visible for inspection today due to snow and ice cover. I recommend having the roof inspected at a later time when the snow has cleared off. logical time would be when updating the garage roof.

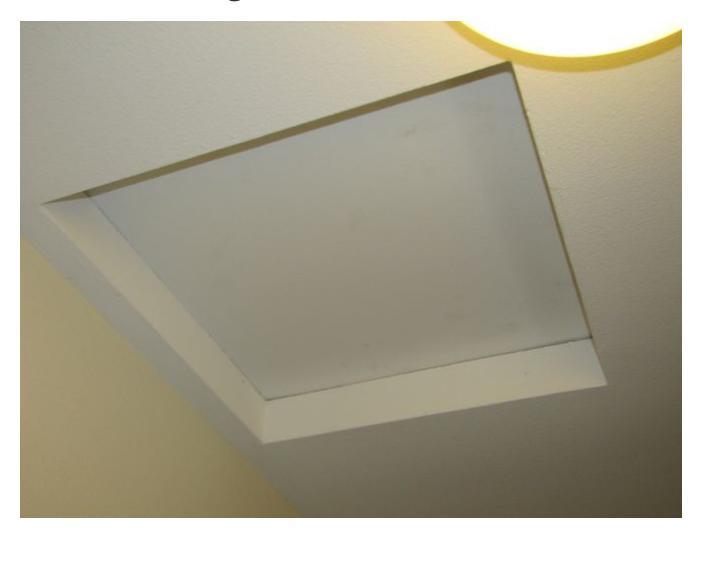
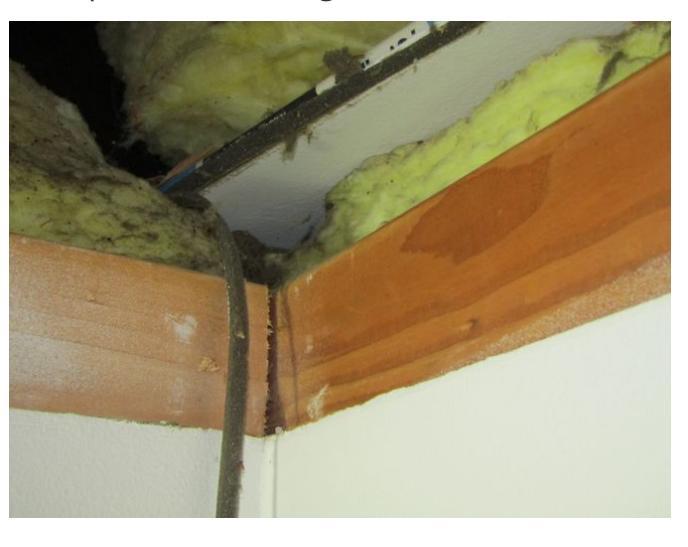
(RA-3) Repair: The weather strip for the attic access hatches is not seated properly and the hatch is leaking air. This should be better air sealed to prevent heat migration into the attic.

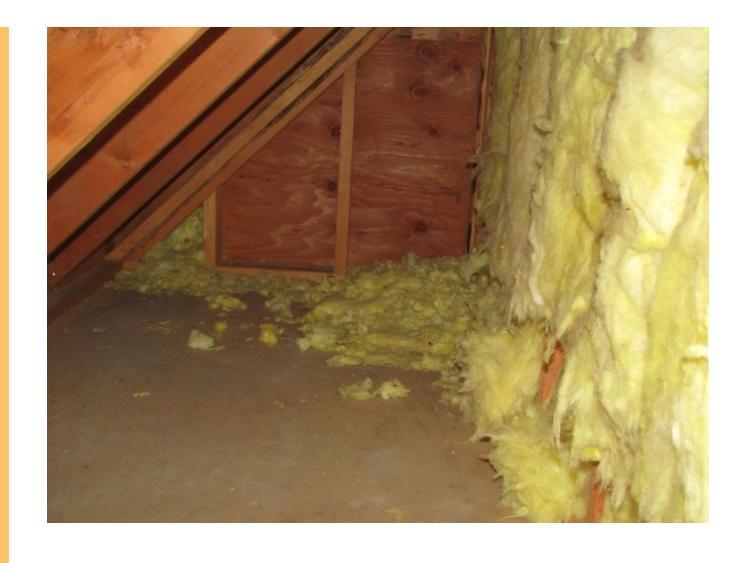
(RA-4) Repair: The attic insulation in the garage is rodent-damaged and incomplete. Remove all contaminated insulation and complete repairs to fans, wiring, ventilation.... Once repairs are complete re-insulate to modern standard or to best possible levels. Be sure to seal up all air leakage points during repairs and prior to insulating to modern standard be sure all rodent issues have been resolved and all projects like wiring and bath fans have been completed.

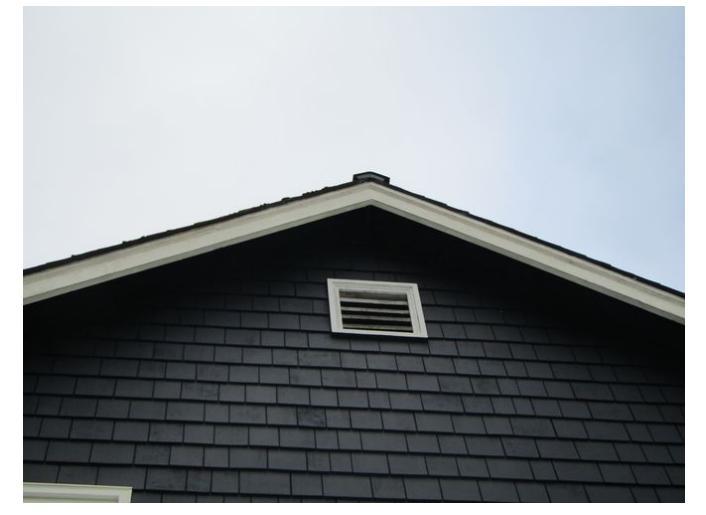
(RA-5) Monitor: The attic and roof cavity ventilation look to be non-standard. Proper attic ventilation is important for the roofing materials to perform as intended and to reduce chances for condensation problems and heat build-up in the attic. The problem here is the use of ridge vents and gable vents. Most ridge vent manufacturers recommend ridge and soffit vents only to get convective ventilation across the roof decking; the gable wall vents can disrupt this convective air flow. No evidence of problems from this configuration was noted to date and depending on occupant behavior this may not ever cause a problem. I would leave as is, especially as the rooffline has been remodeled. It seems to be performing well to date. Monitor.

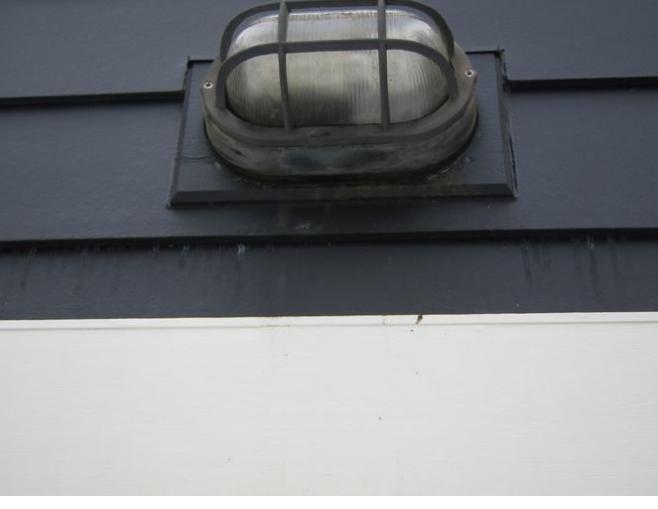
High moisture meter readings where paint was bubbling

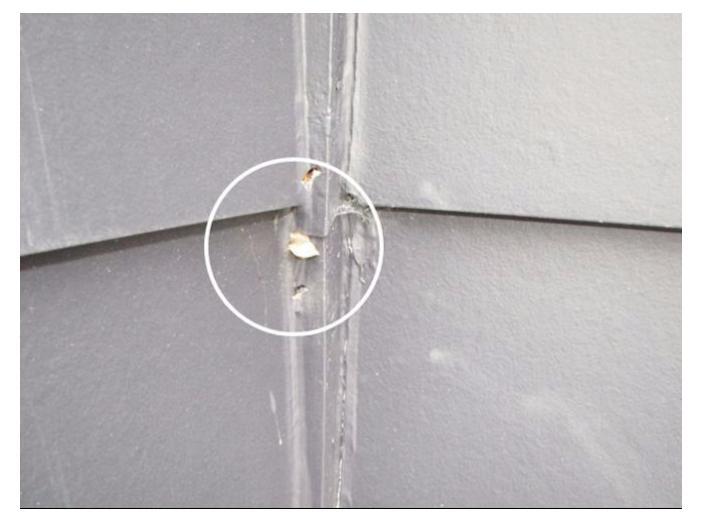
Water stains indicate possible water behind siding

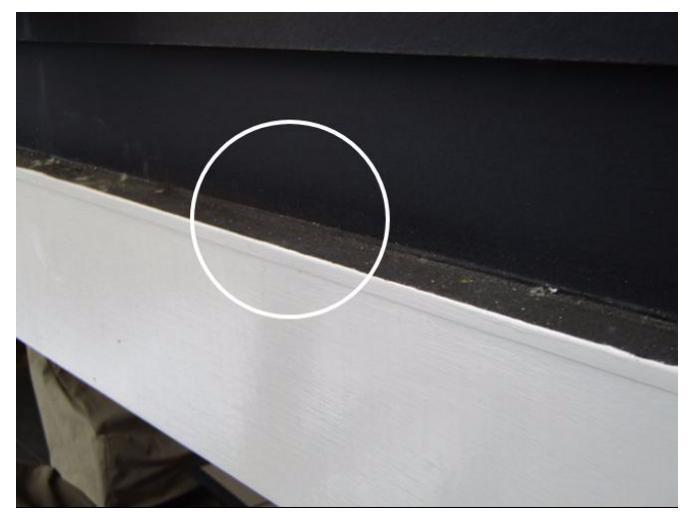
Fungus growing at inside corner
