Inspection report for the property at

Slightly Complex Ave Neat Custom Home, USA

This report is prepared exclusively for **Custom House** On: **2018-02-25**

ICN#: 10296AR0011

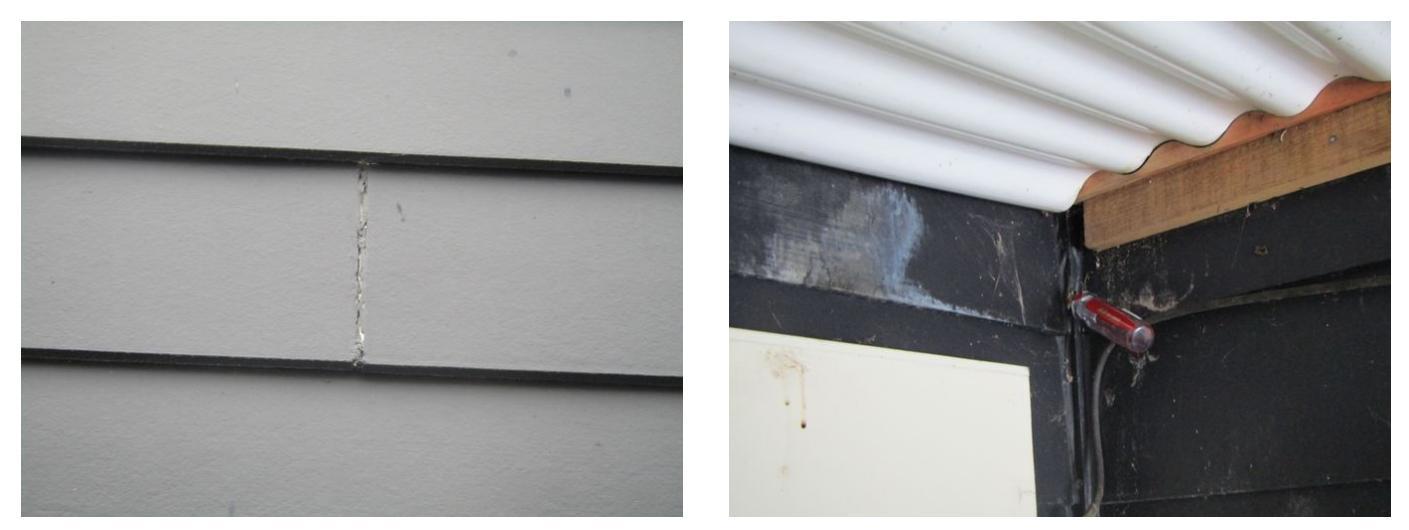
Siding run right to the horizontal flashing and sealed. This is not recommended but difficult to fix at this point.

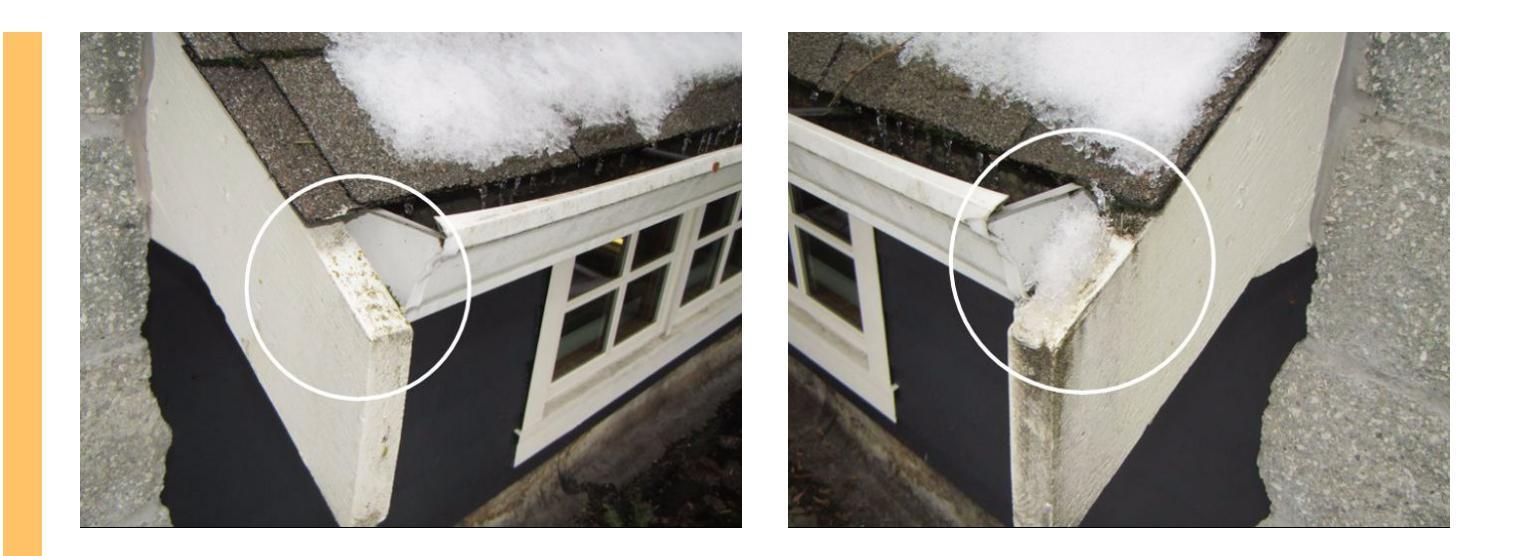
F *(EG-4)* **Exterior/Garage:** Install diverter shingles or flashings above the exposed fascia, next to the gutters to protect this wood from rot and decay.

G C EG-4) Repair (WDO): Install diverter shingles or flashings above the exposed fascia, next to the gutters to protect this wood from rot and decay.

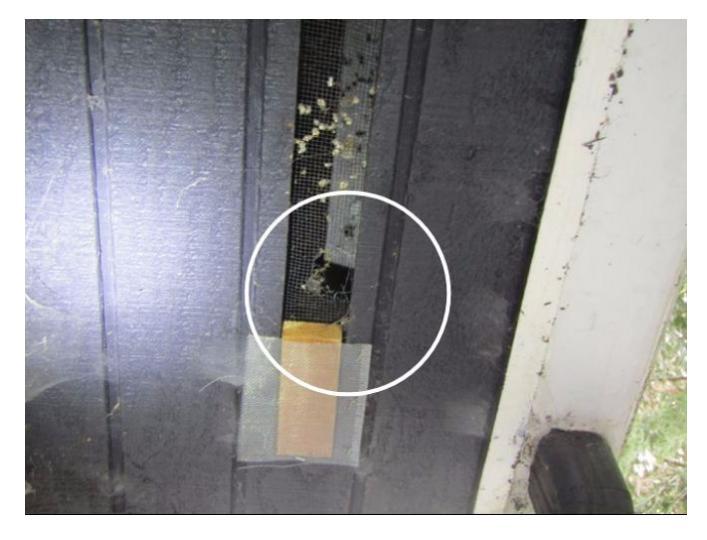
(EG-5) Repair: Several areas of soffit vent screen were noted to be loose, missing and in need to repair to prevent bird and rodent entry - see SW corner of garage.

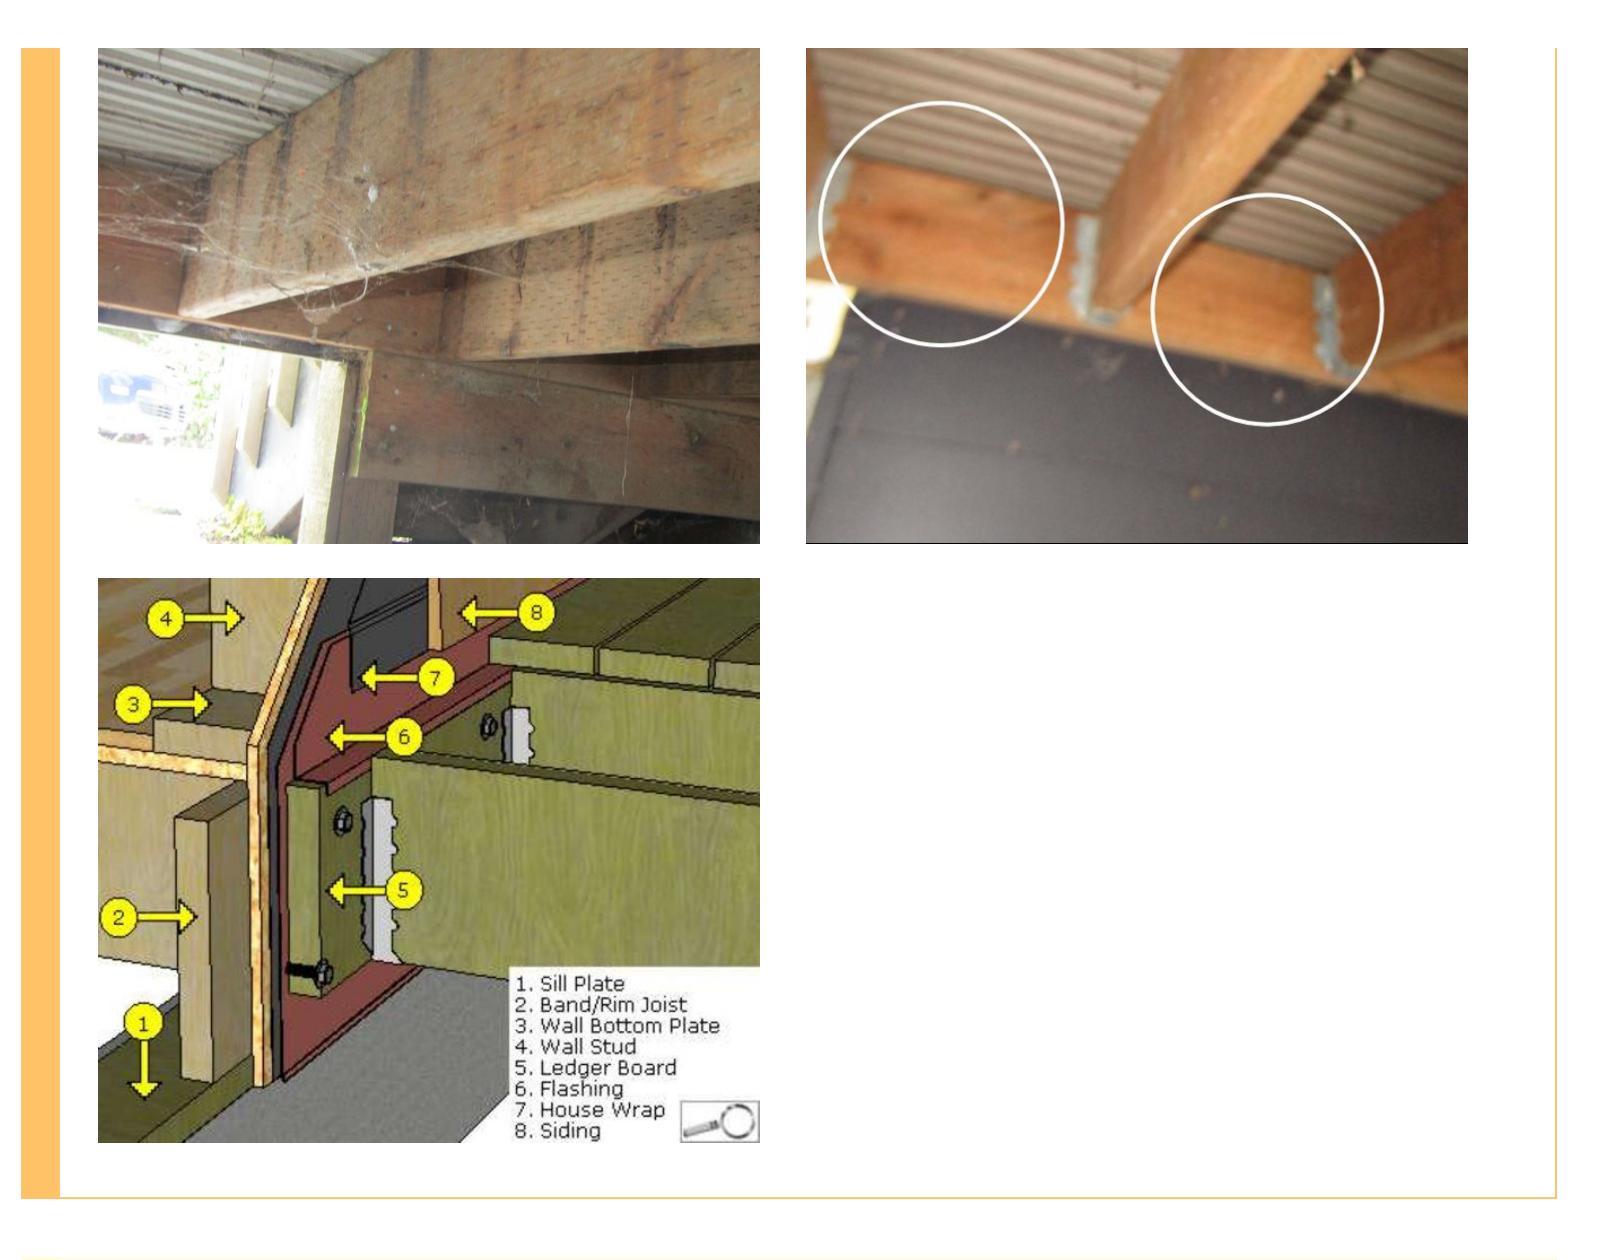
(EG-8) Repair: Hire a qualified contractor to make some tune-up repairs to the decks. A few sections of decking are missing bolts to secure the ledger board to the house. I also noted missing hangers for the joists at the ramp that leads between the garage and the house.

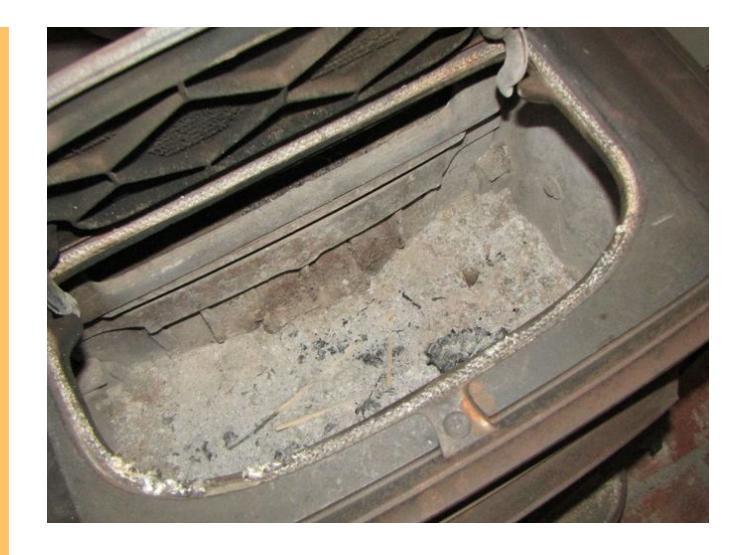
(EG-12) Repair: A level II cleaning and inspection is recommended for the chimney flues. Regular cleaning and inspection is recommended for safe and reliable operation of the chimney. Chimney flues are not visible and are beyond the scope of a home inspection. Hire a licensed chimney sweep to clean and further evaluate the flues; if this has been recently done, please disclose for buyers.
