**Orca Inspection Services LLC**

# Inspection report for the property at 76423 Football Road USA

This report is prepared exclusively for **Russell Wilson** On: **2018-10-01**

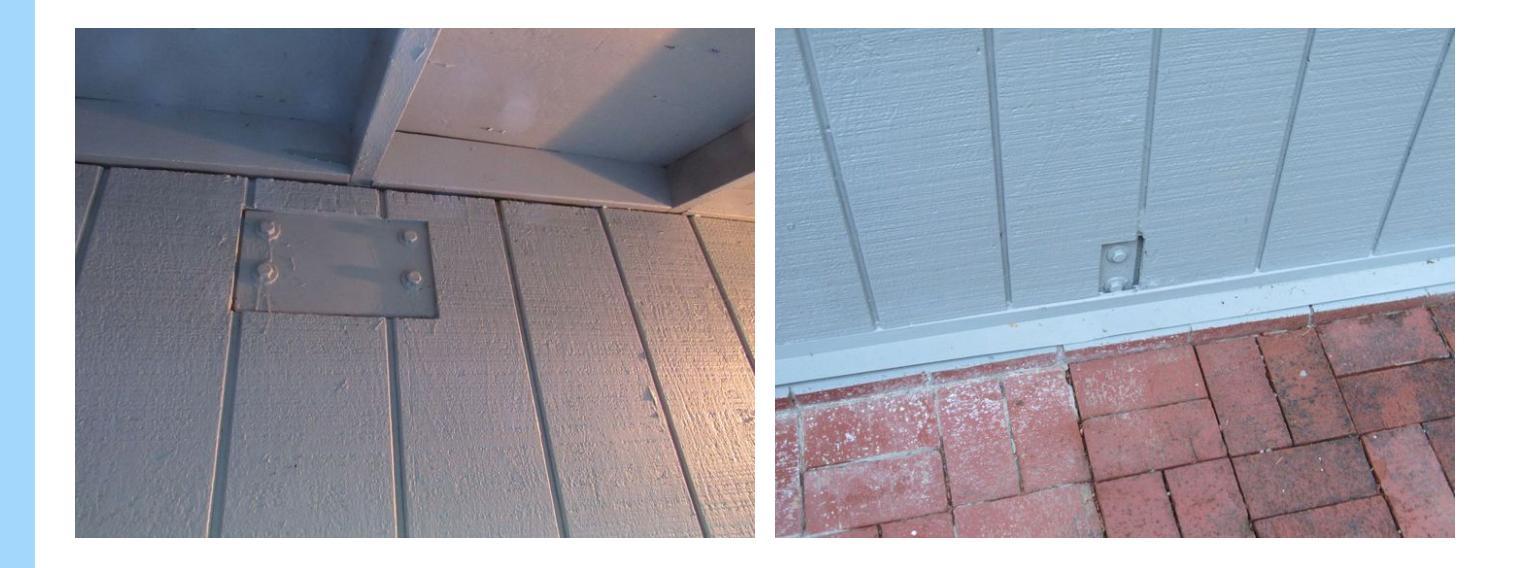
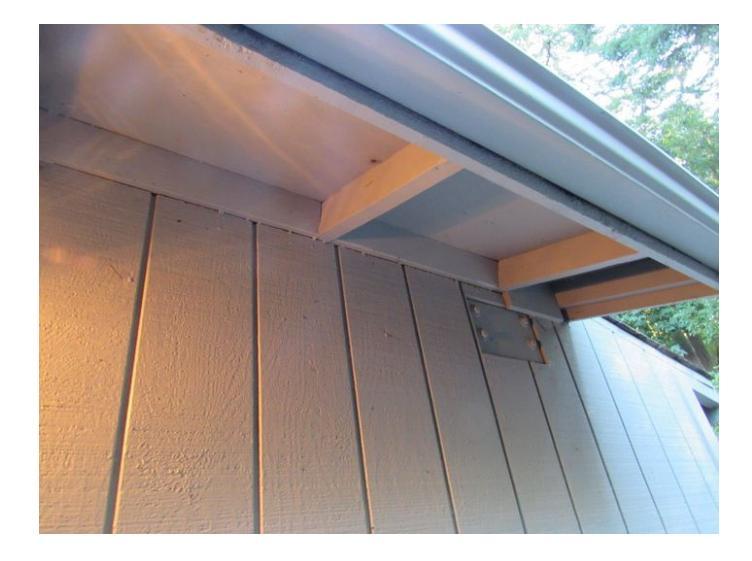
Wall Framing Not visible Wall Insulation Not visible Wall Sheathing Not visible Floor Framing Not visible Sub-Floor Material Not visible Ceiling Framing Not visible **(SB-1) Due Diligence:** This house has a studio space that appears to be an enclosed carport. I would inquire with the seller for any permits for this work. This may be an unpermitted structure. It has many non-standard features such as the door below the deck, inadequate clearance to grade and no soffit ventilation for the roof cavity. I recommend repairing the soffit venting. The rest of the non-standard configurations could be difficult tot correct.

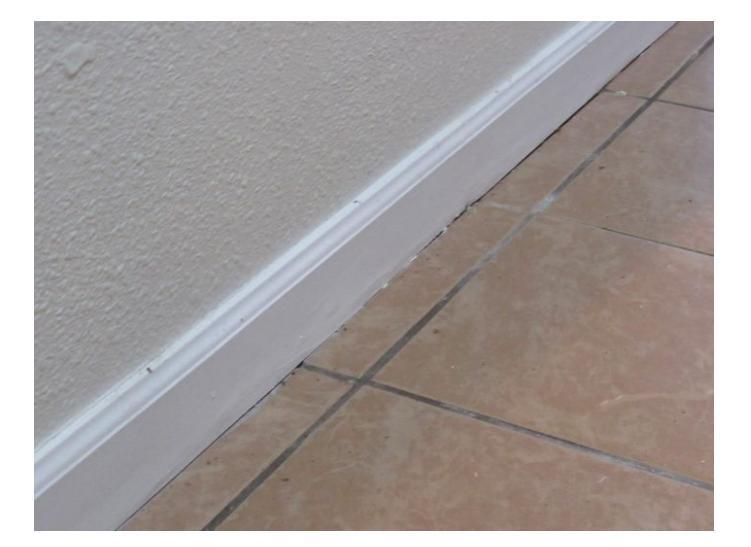
Water stains on the baseboard - laundry room

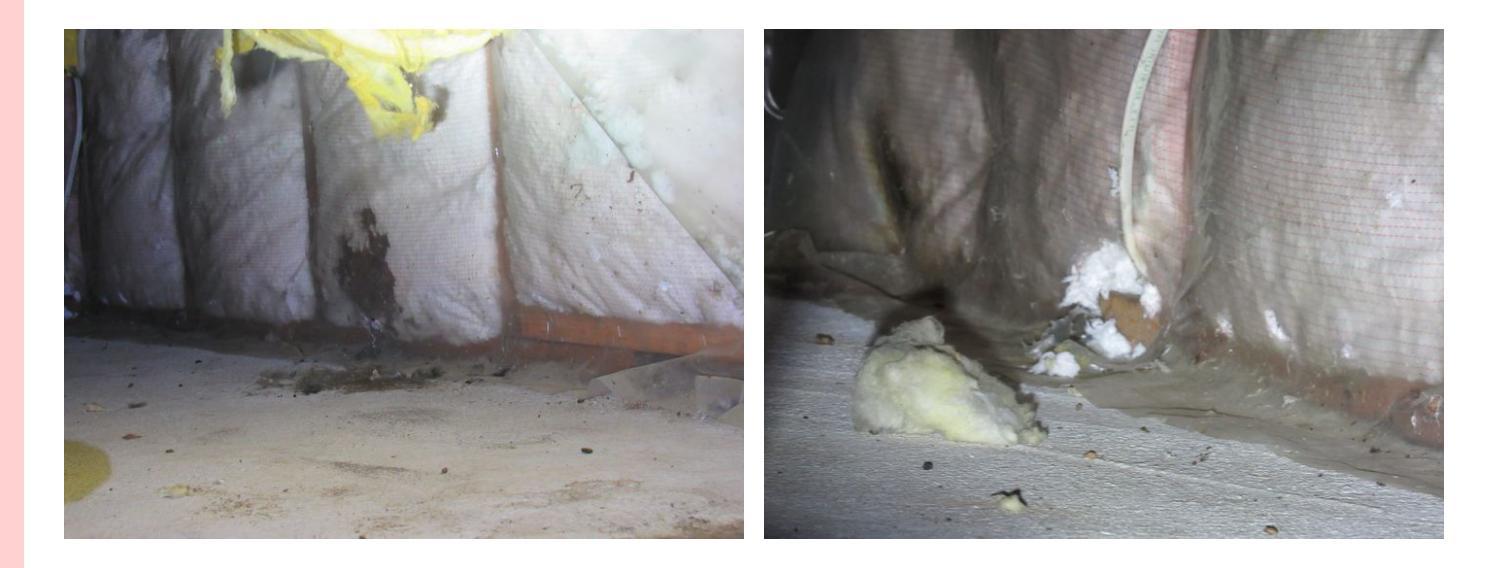
(PWDO-1) Major Concern: Extensive rodent contamination was noted in the crawl space below the house and in the attic above the house. Hire a rodent control specialist to eliminate and seal all openings and set and monitor traps. Once all rodents have been sealed out all contaminated insulation and construction materials should be remediated. On-going baiting and trapping as well as control of vegetation and elimination of food sources on the exterior of the home are often needed to prevent rodent problems / infestations. Keeping all trees pruned 6 feet off the house is recommended.

Burrowing holes noted in the insulation in the basement as well as a strong odor

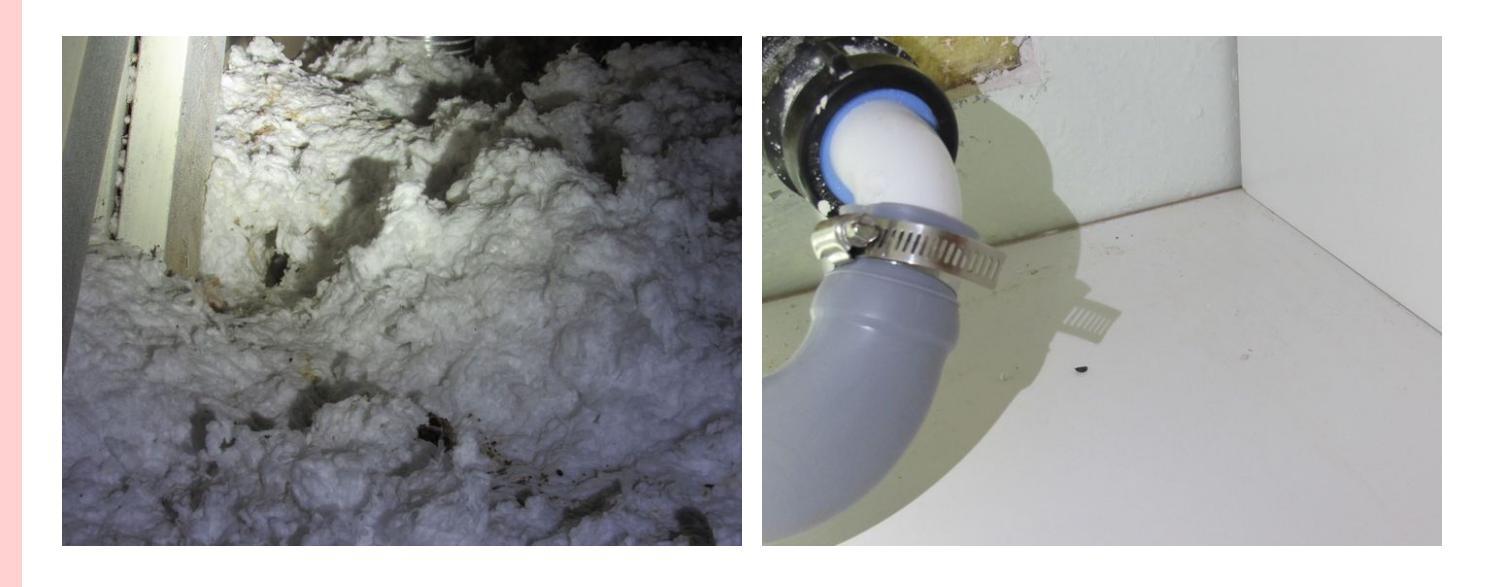
Debris from rodents and possible entry point Rodent feces above studio here at the studio

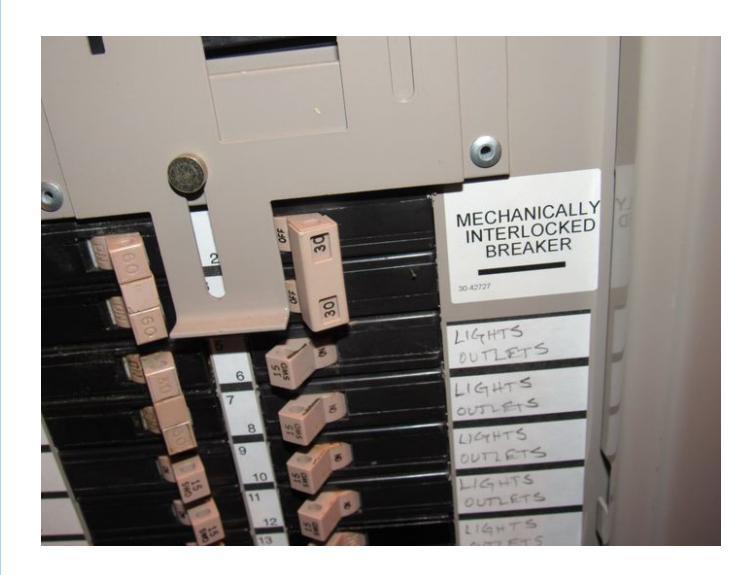
**(E-3) Due Diligence:** This home has a 30-amp transfer switch for a <u>generator for back-up</u> <u>electric power supply</u>. Generator systems are beyond the scope of this inspection. I recommend inquiring with the seller for more information regarding operation and maintenance of this system. Generators need to be run and serviced regularly to ensure reliable operation

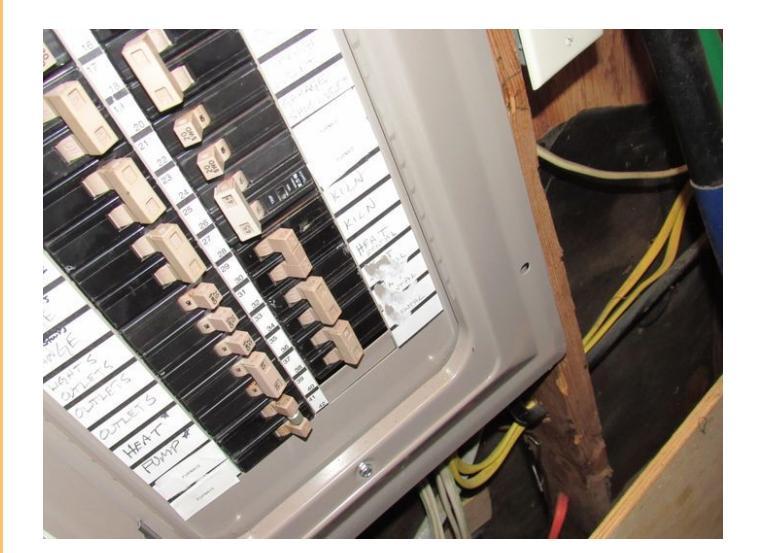
**(E-4) Repair:** Several of the circuits at the bottom right side of the panel were shut off. I wonder if these were for older electric heaters that have been replaced by the heat pump?

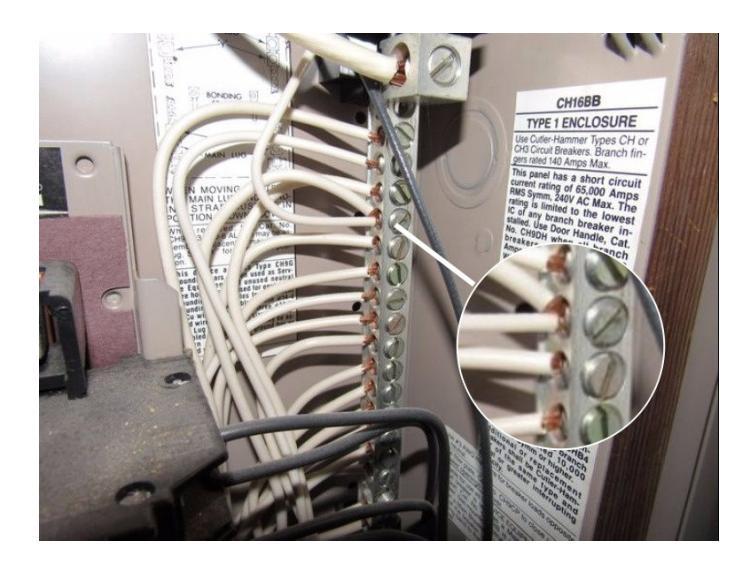
Sub-panel Sub-panel Main Conductor Copper, #6, 60 amps Sub--Panel Amperage 60 Sub-Panel Location Next to main panel **(E-5) Repair:** Hire a licensed electrician to correct the double tapped neutrals in the subpanel. This condition risks poorly protected circuits and as such is a latent fire hazard.

Double tapped neutral

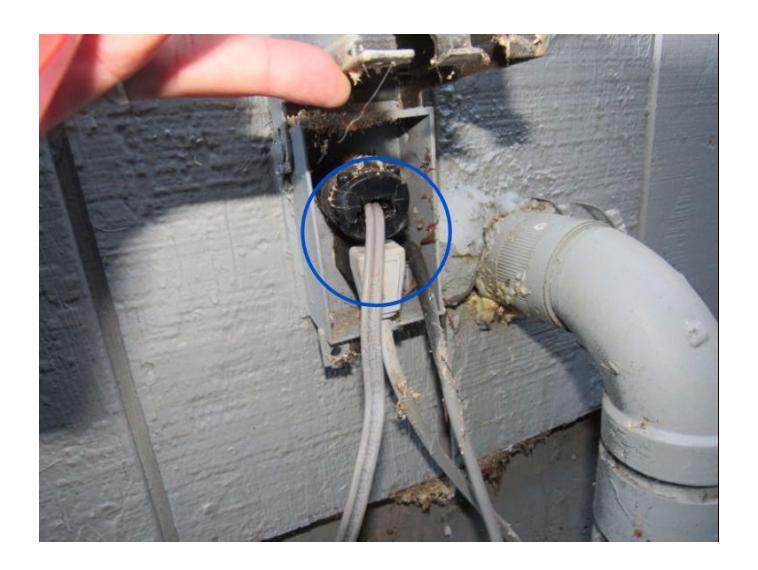
**(E-6) Repair:** Non-metallic sheathed cable should not be installed with a plug into a receptacle - see wiring to the south sump pump. This wiring is designed to be hard wired with terminations inside listed junction boxes. The wiring should be repaired to eliminate this configuration.

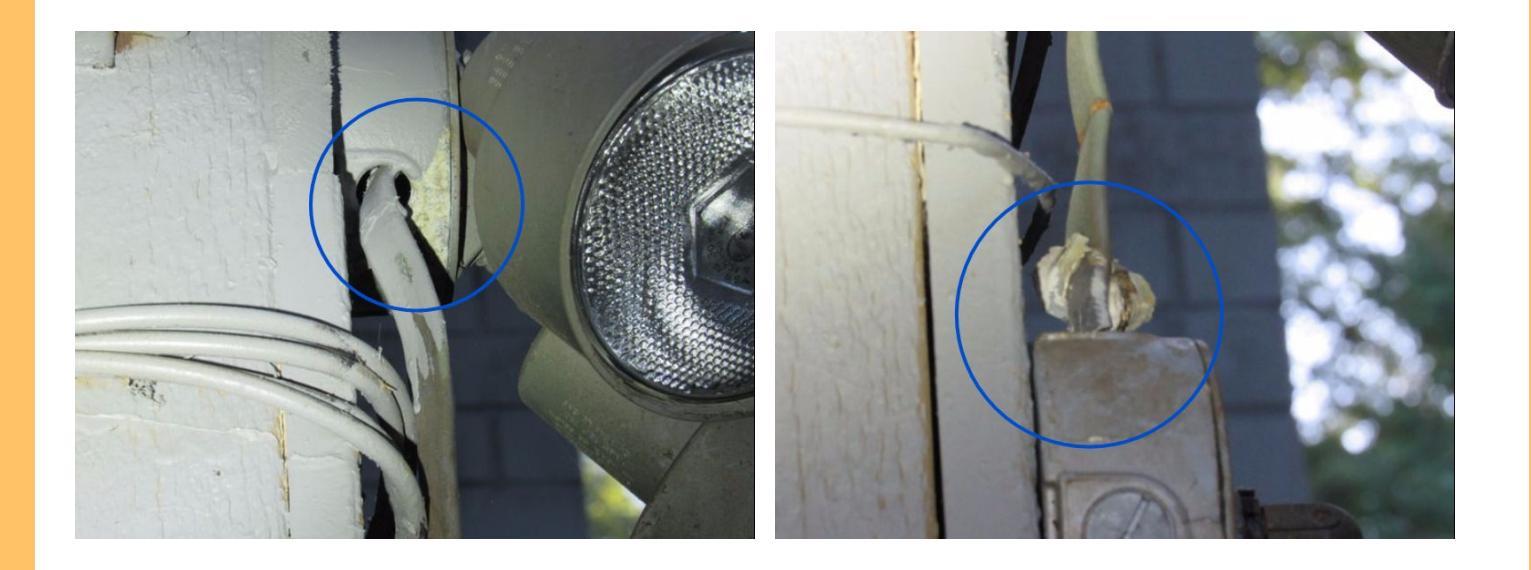
**(E-8) Repair:** The exterior lighting on the SW corner of the building does not look weather proof - see corrosion on junction box. Have this further evaluated and repaired as recommended by a licensed electrical contractor.

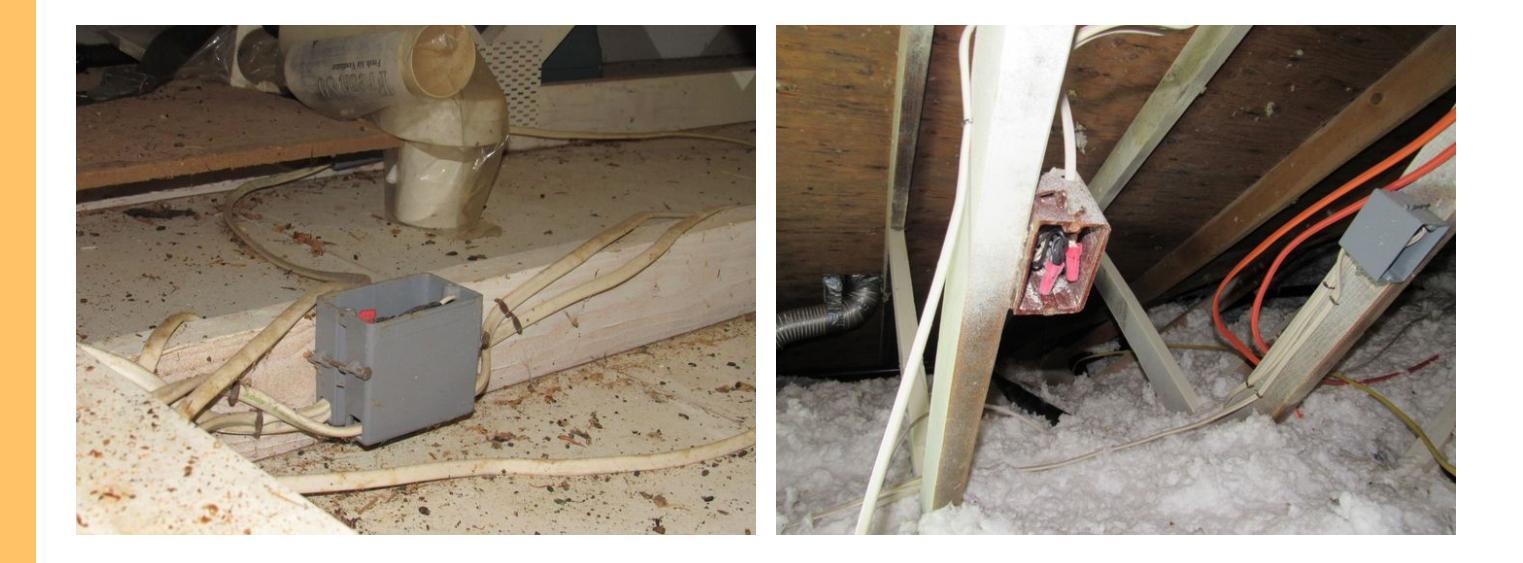
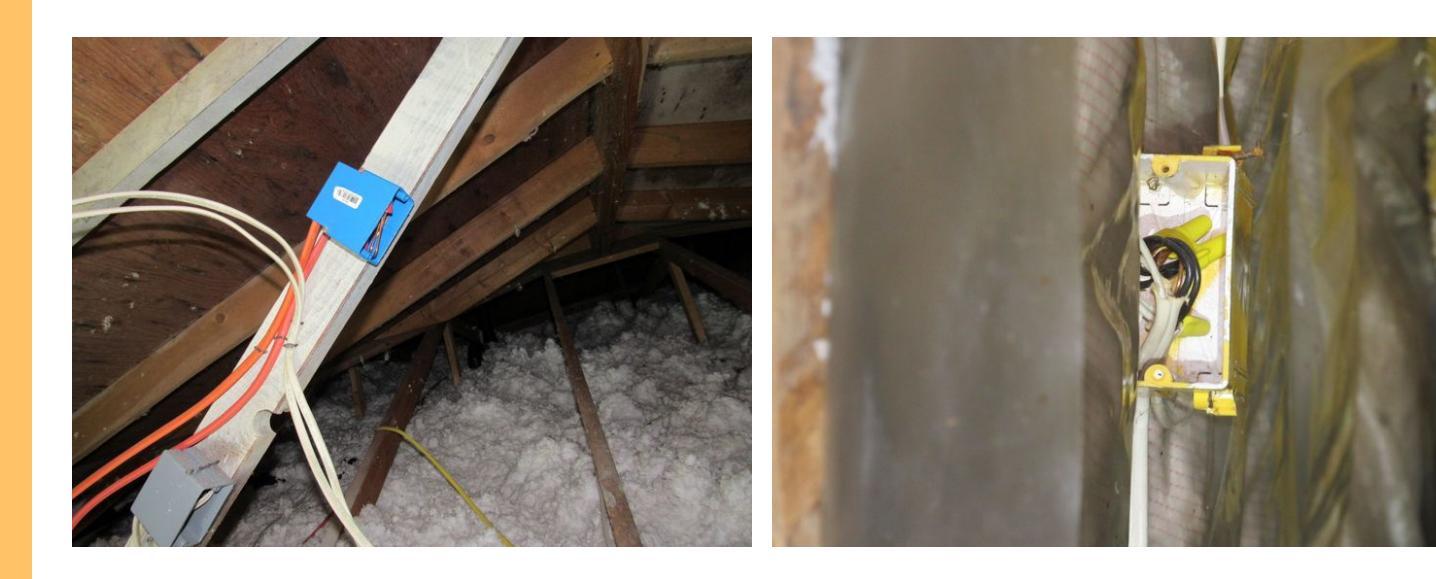
**(E-9) Repair:** The open electrical junction boxes need to be covered for improved safety - see both access points in the attic and in the crawl area in the basement.

This shows the open junction box in the basement.

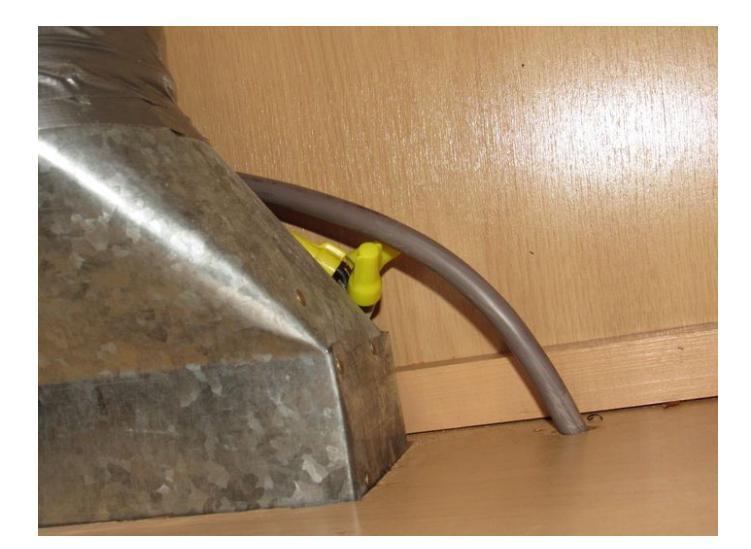
**(E-10) Repair:** The open electrical splice needs to be contained inside of a listed junction box - see behind fan in basement kitchen.

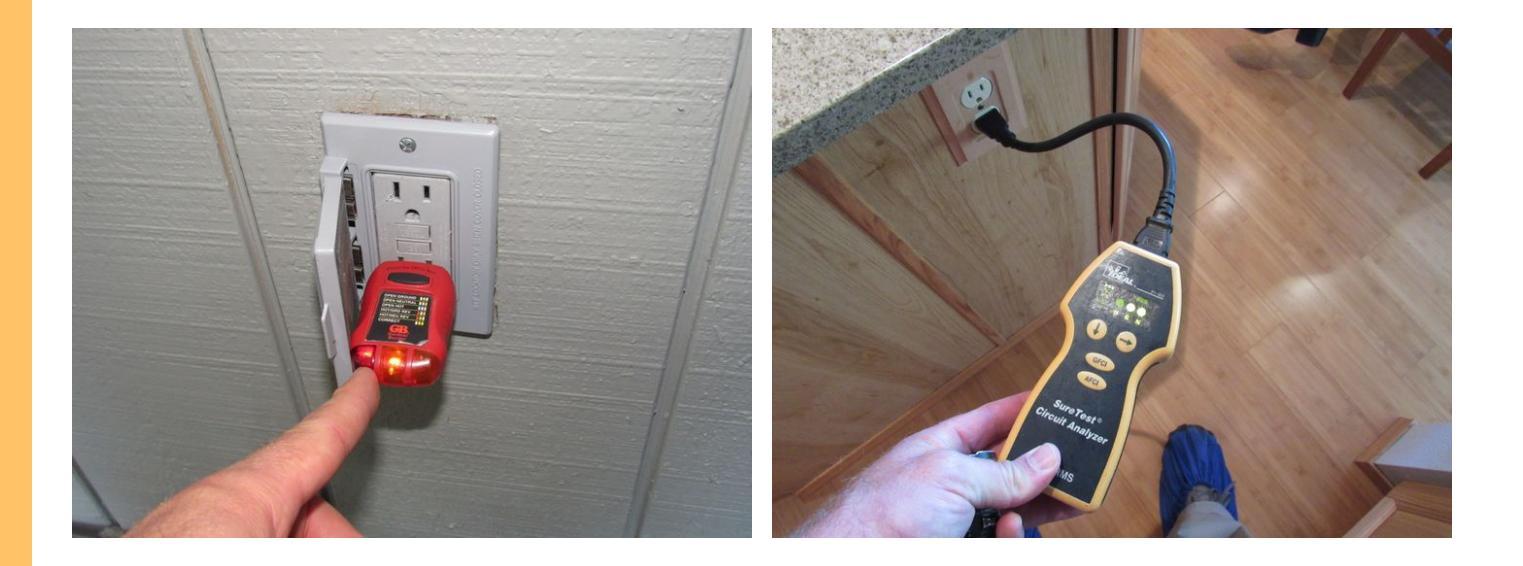
**(E-12) Repair:** Reverse polarity was noted at the electrical receptacle at the exterior main floor deck and also at the kitchen bar. This is when the hot and the neutral have been wired backwards. This is a safety issue that should be corrected by a licensed electrician.

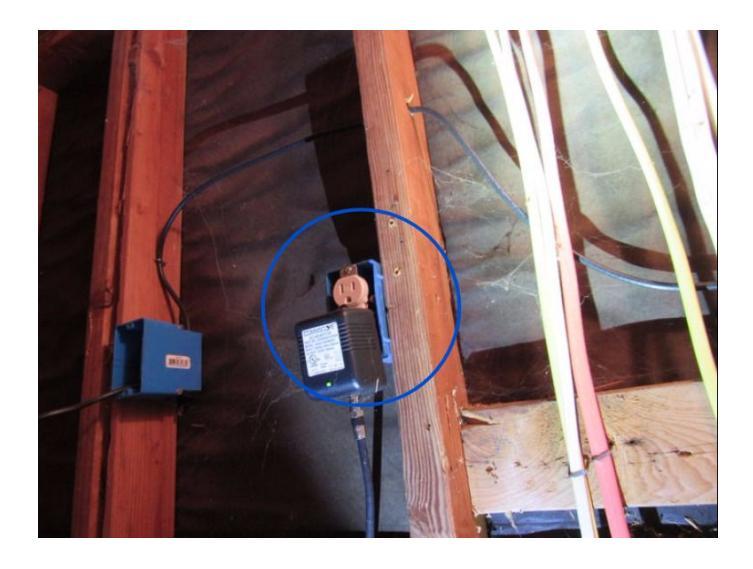
**(E-13) Repair:** The missing cover plates should be installed to cover all access to wiring at switches and receptacles - see storage closet by electric panels. Please note that extension rings may be needed as the reveal between the outlets and switches and the wall finishes is not even.

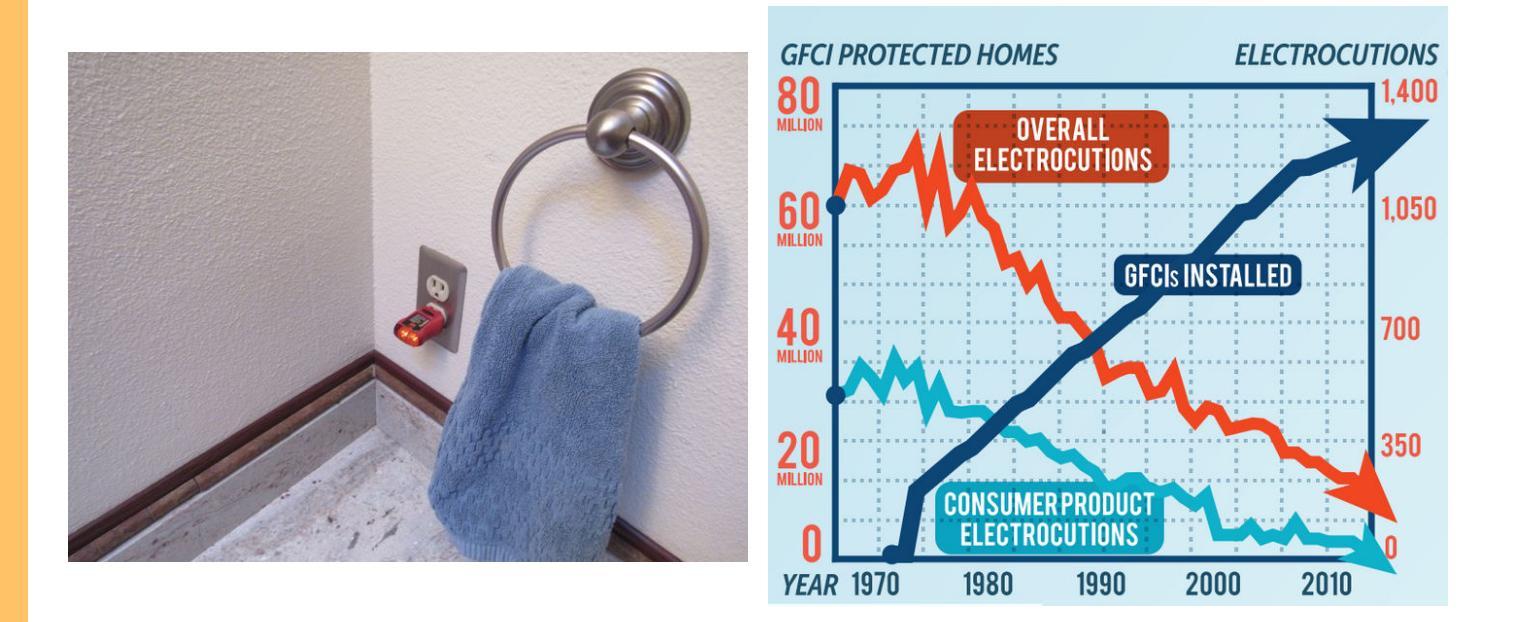
**F** (E-14) Repair: The use of GFCI (Ground Fault Circuit Interruption) protection is inconsistent with modern minimum standards for safety - see receptacle in the family bath. GFCI protection is recommended for the electrical receptacles in the following locations: the two dedicated kitchen appliance circuits, all receptacles within 6 feet of a sink, bathrooms, exterior, garage, unfinished basements, laundry and all wet and damp locations. GFCI's protect against electrocution by limiting the duration of an electrical shock. These are an important modern safety feature that have proven to save lives. Hire a licensed electrician to further evaluate and update GFCI protection for improved safety.

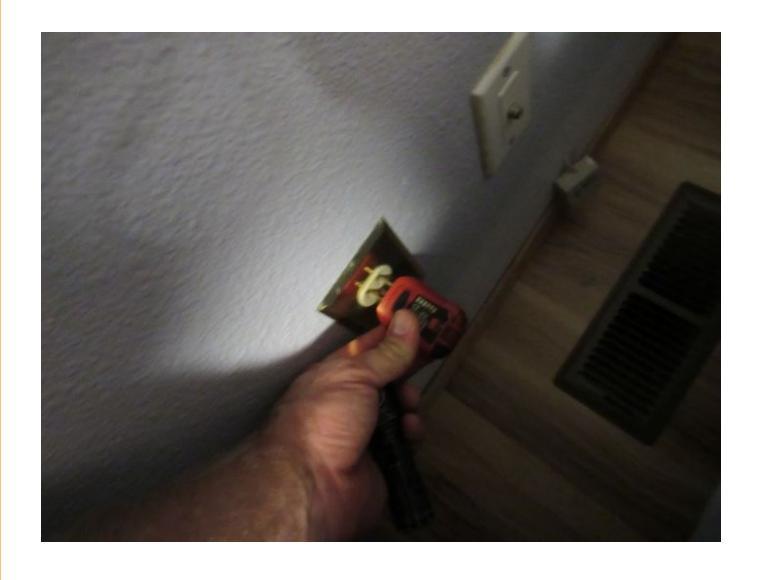
**(E-15) Repair:** My receptacle tester is not fitting into the receptacle correctly indicating the receptacle may have something stuck inside - NE bedroom. This may require replacement. have this further evaluated and repaired by a licensed electrician.

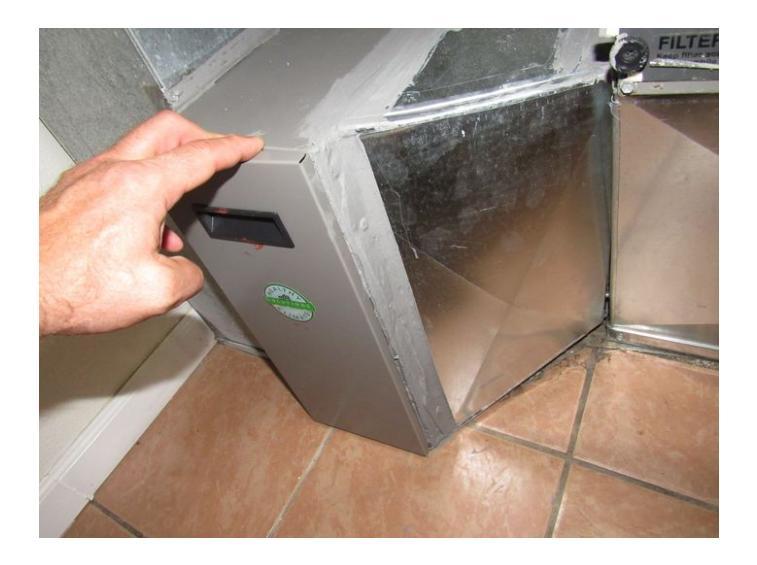
**(HCF-1) Repair:** The furnace filter cover is sealed shut. This should be repaired to access and change the filter - the filter should be changed quarterly.

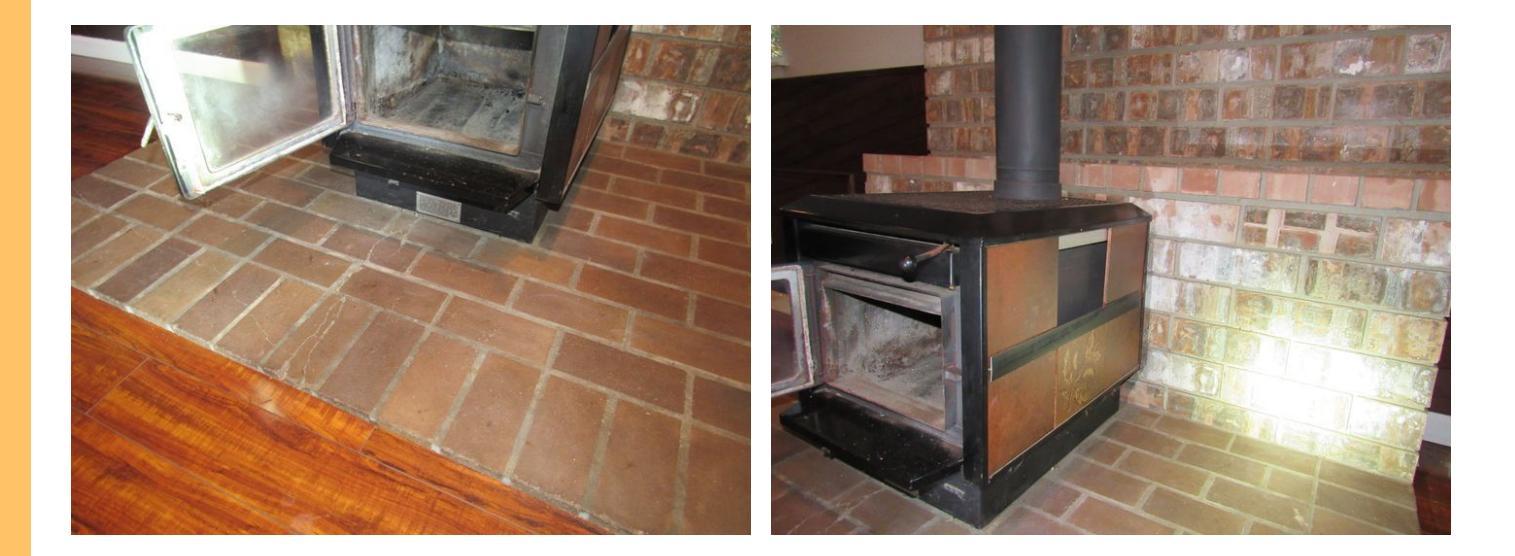
Corrosion inside the wood stove firebox

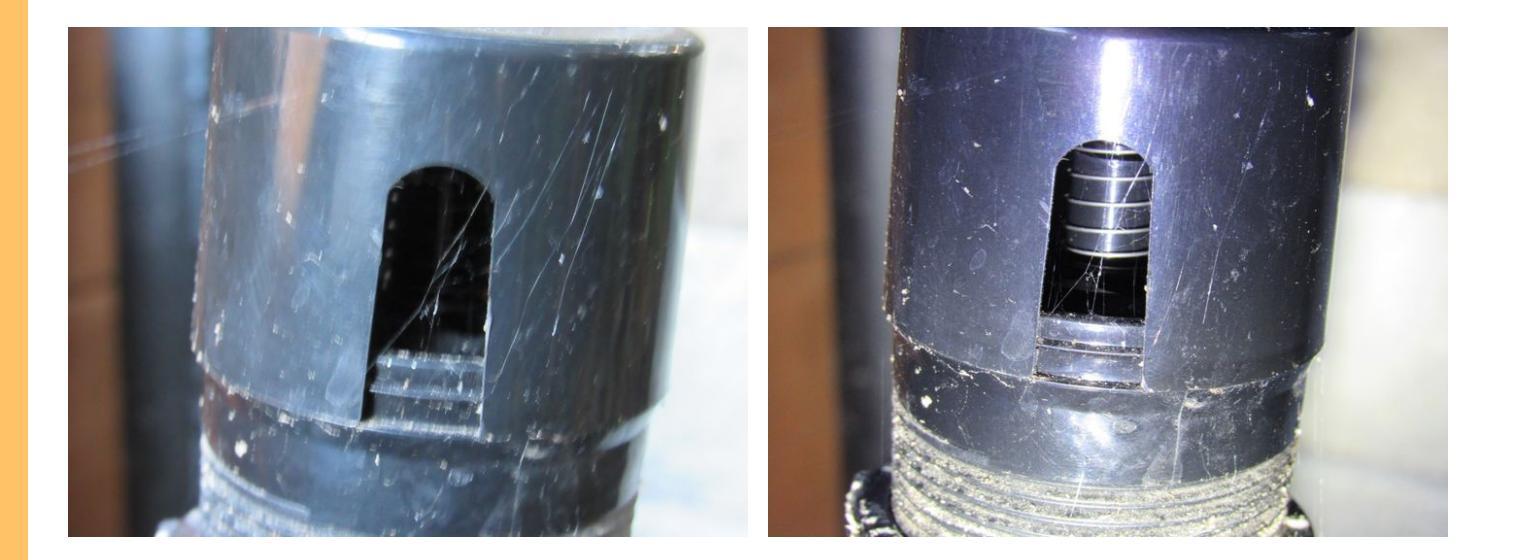
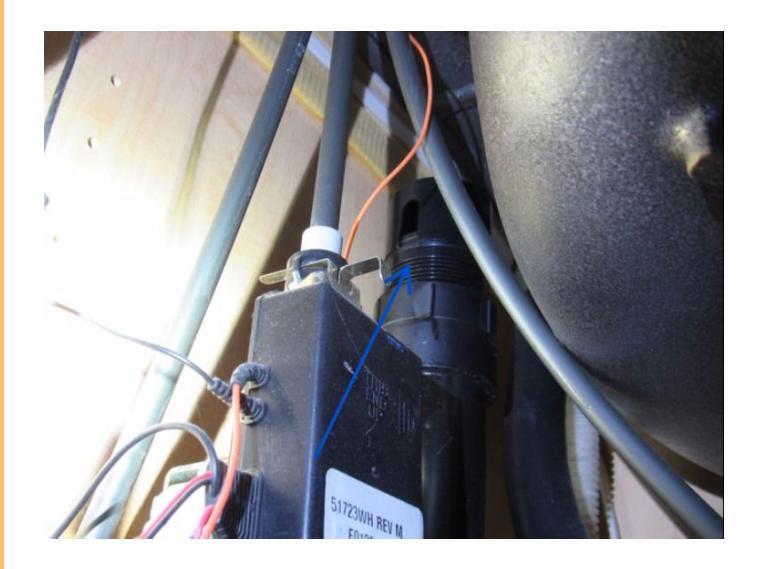
**(P-3) Repair:** The air admittance valve does not appear to be the correct type of vent - this is actually an auto-vent - see out by septic system as well as below the kitchen sink. This is a spring-loaded mechanical vent that is not recommended in residential construction. Have this further evaluated by a qualified plumber and repaired as recommended with a proper air admittance valve.

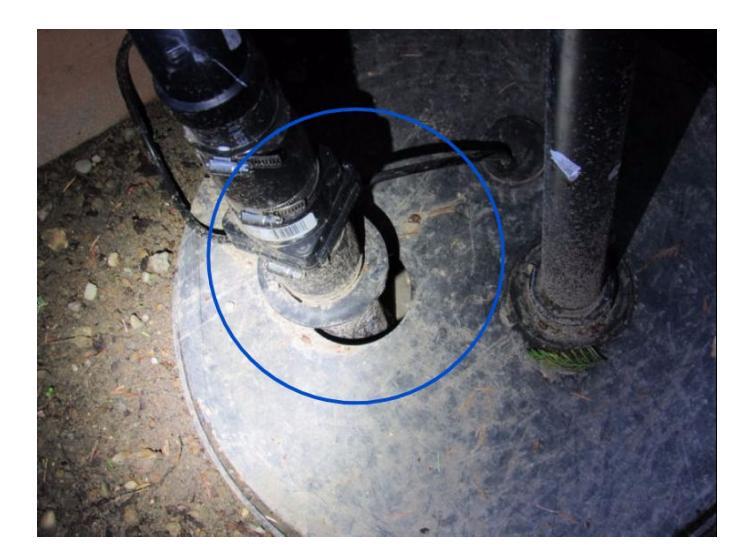
**(P-4) Repair:** The covers to the septic system do not appear to be adequately sealed. Have these pump access covers further evaluated and repaired as recommended by a qualified contractor.

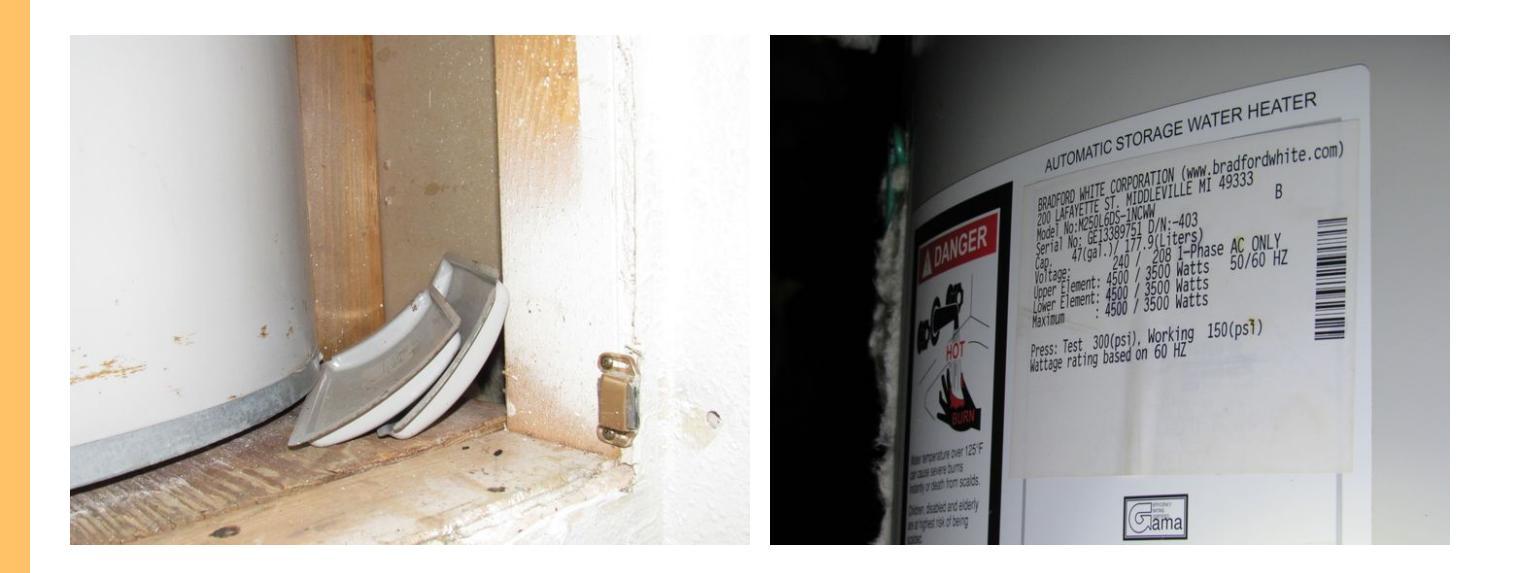
The thermostat covers were off at the time of inspection - this is a safety hazard

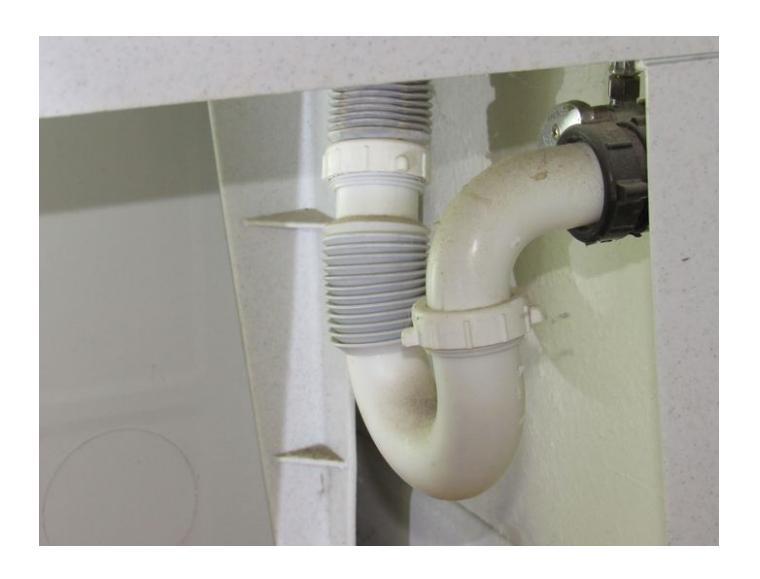
**(P-7) Repair:** Corrugated waste pipe was used to drain this laundry sink. This in an unlisted plumbing product. Use smooth wall pipe only. Hire a licensed plumber to further evaluate and repair as needed.

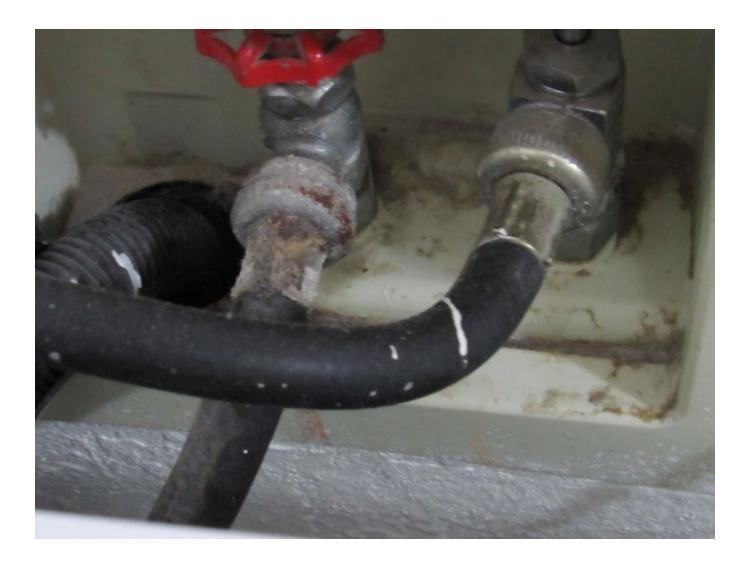
**(P-9) Repair:** The current hoses that supply water to the clothes washer have some moderate corrosion - see basement. I recommend updating as soon as possible to insure reliable performance. For improved protection against accidental leaks at the clothes washing machine consider improving water supply connection hoses to a flood safe design.

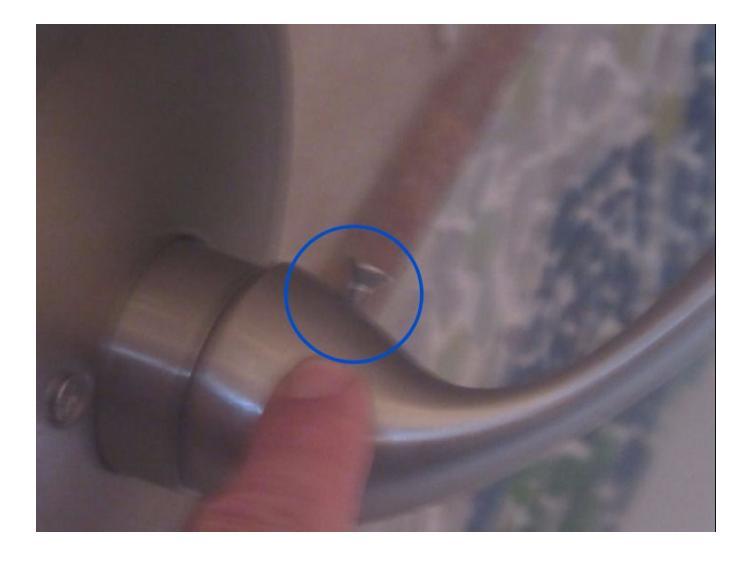
**(FB-1) Repair:** The wrong set screw has been used for the mixing valve in the family bath. Repair as needed.

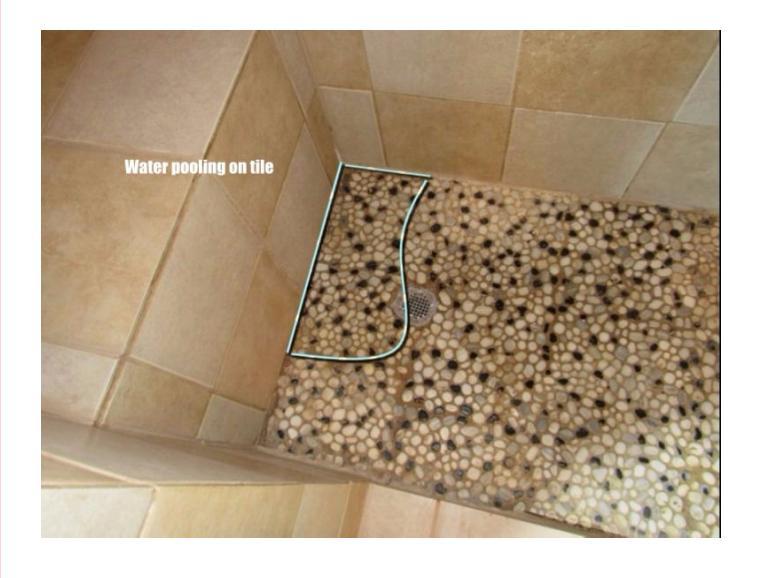
(MB-1) Major Concern: The master bath shower pan is not sloped to drain and is allowing some standing water. This may not be cost effective to repair but it is not done correctly and could lead to some standing water and premature failure. All plumbing fixtures should be sloped to drain. Hire a qualified plumber to evaluate and repair as possible.

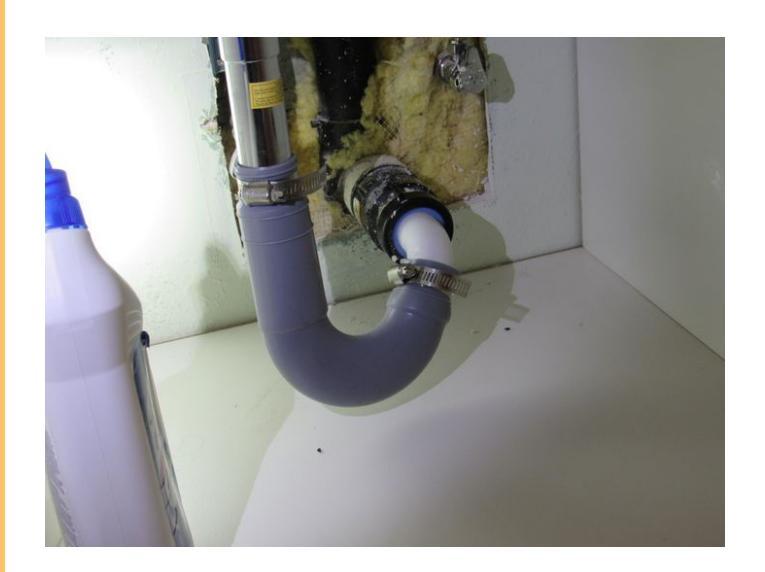
**(BB-1) Repair:** The trap for the bathroom sink is not done using a listed plumbing product. Have this drain piping further evaluated and repaired by a licensed plumber.

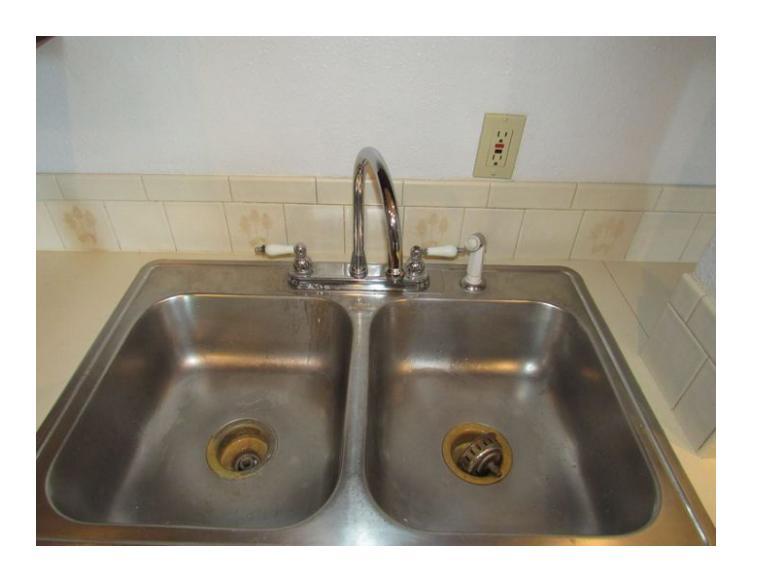
**(KL-1) Repair:** The kitchen sink faucet is installed with the hot and the cold installed backwards. Repair for proper operation.

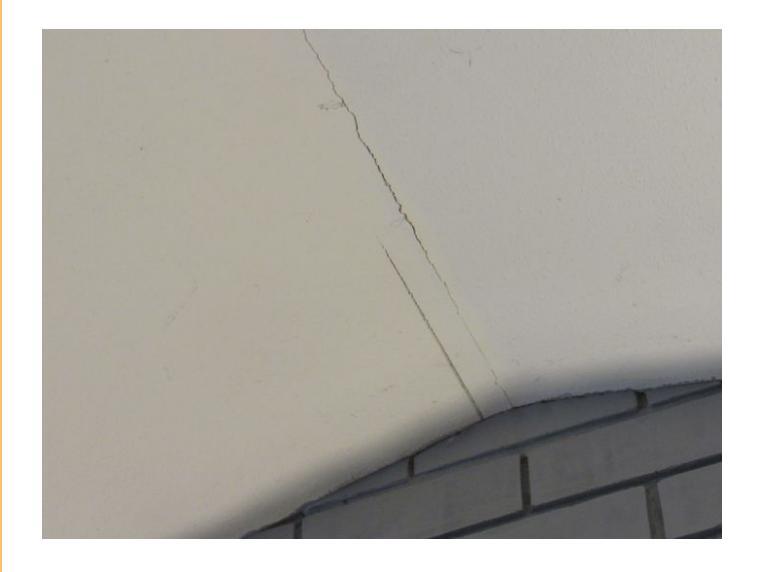
**(I-1) Repair:** The drywall / sheetrock finishes require some tune-up repair: See localized cracking at the living room ceiling by the propane wood stove. No red flags were found to indicate structural movement. Repair sheetrock blemishes as desired.

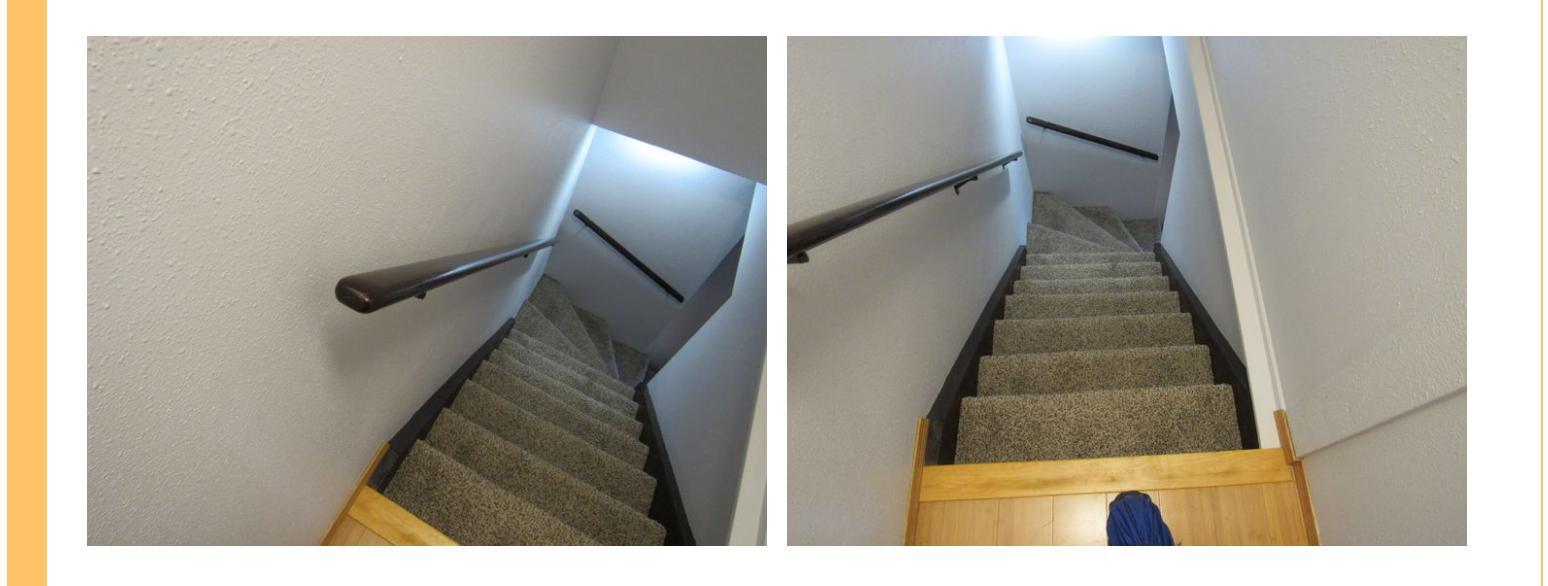
**(I-2) Repair:** The stairs to the basement are non-conforming stairs - see how steep they are. This will not be cost effective to fully correct. Use caution when navigating these steep stairs. Improvements could be made to the handrail system to improve the safety of the stairs - have the ends of the handrail return into the wall.

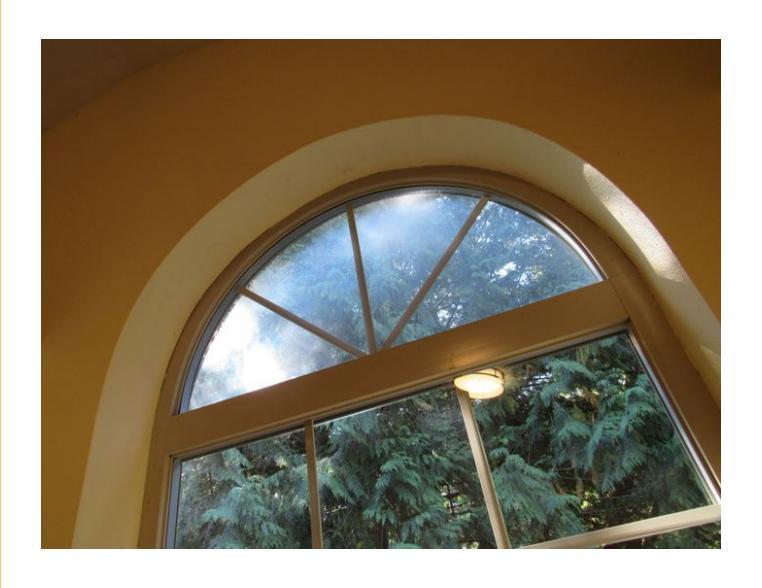
**(I-3) Repair:** A lost seal was noted in the glazing - south side half-round window. This has resulted in fogging between the panes of glass that cannot be cleaned without glazing repair or replacement. Hire a glazing specialist to further evaluate and repair or replace all glazing with lost seals.

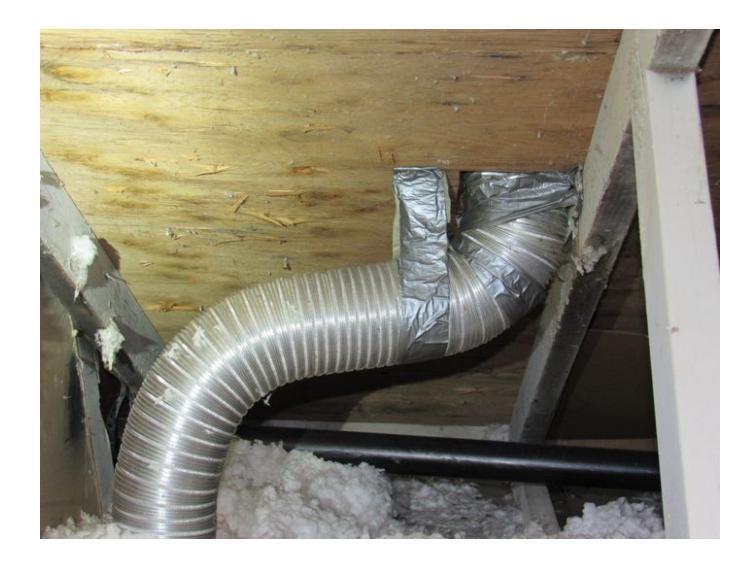
Bath Fan Ducting Non-standard Kitchen Fan Ducting Ductwork not visible, Ductless fan **(I-5) Repair:** The ductwork for the bathroom fans is uninsulated in the attic space. This can cause condensation during cold weather and is less energy efficient. Replace these ducts with insulated ducts or insulate to R-8 or better.

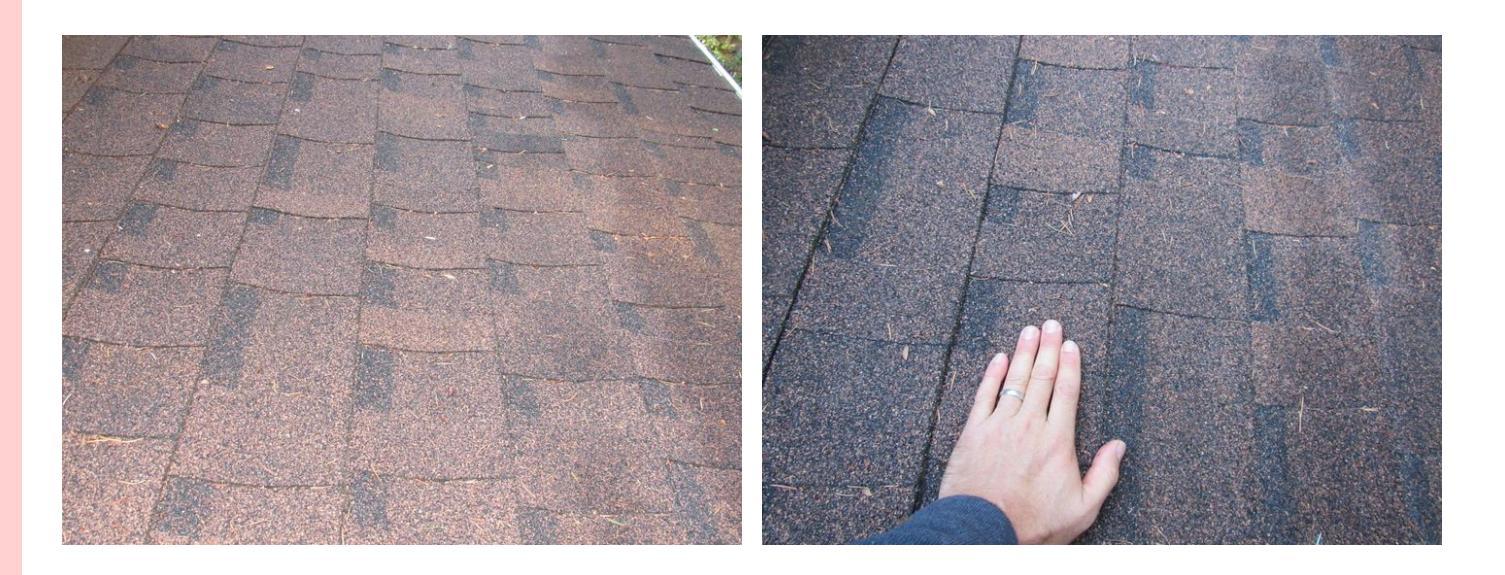
Shingles cupping - could hold water

Water can easily run behind this valley.
