**Orca Inspection Services LLC**

# Inspection report for the property at 76423 Football Road USA

This report is prepared exclusively for **Russell Wilson** On: **2018-10-01**

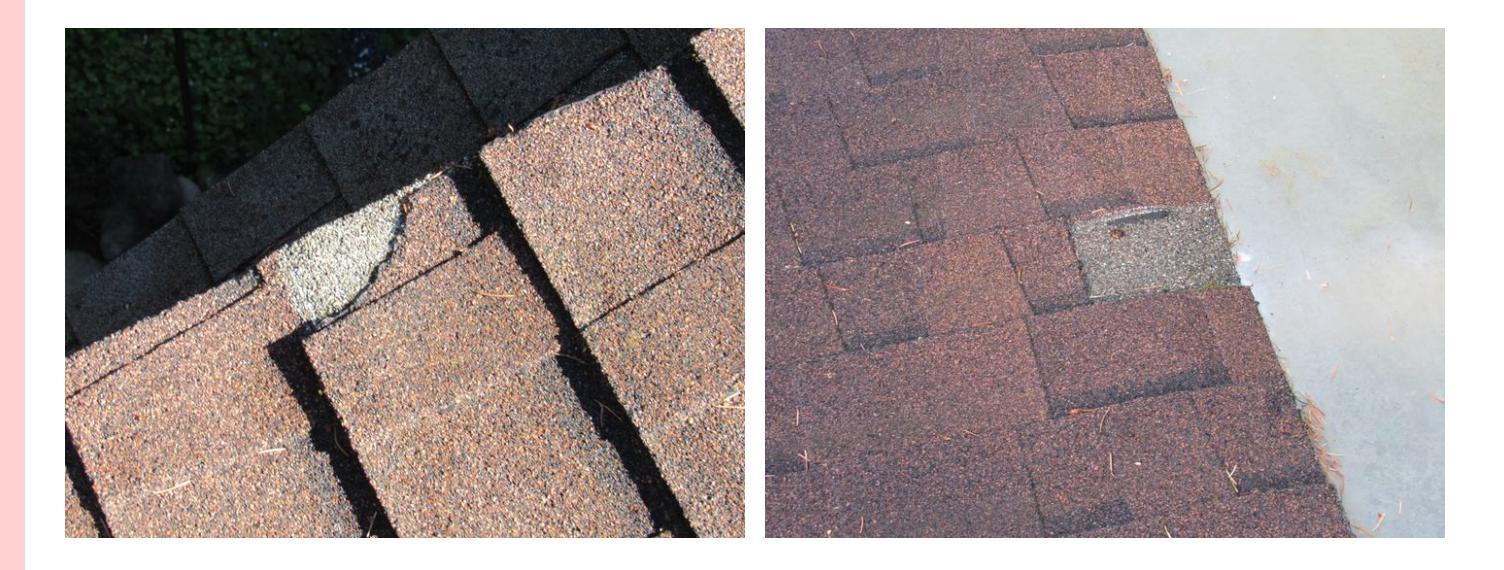
A few localized damaged shingles

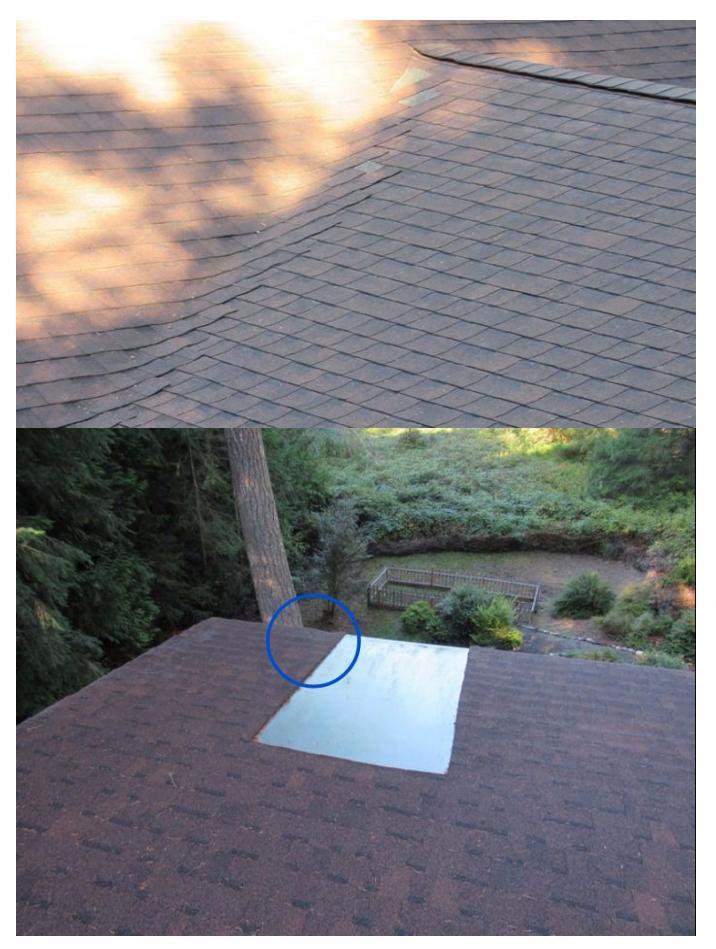
Active leaks and water damage around the porch skylight

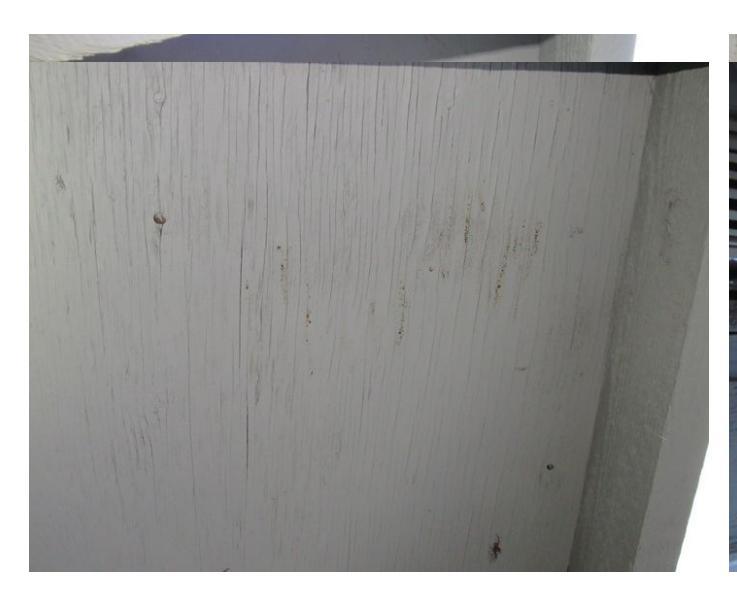
Water damage at eaves by SW skylight

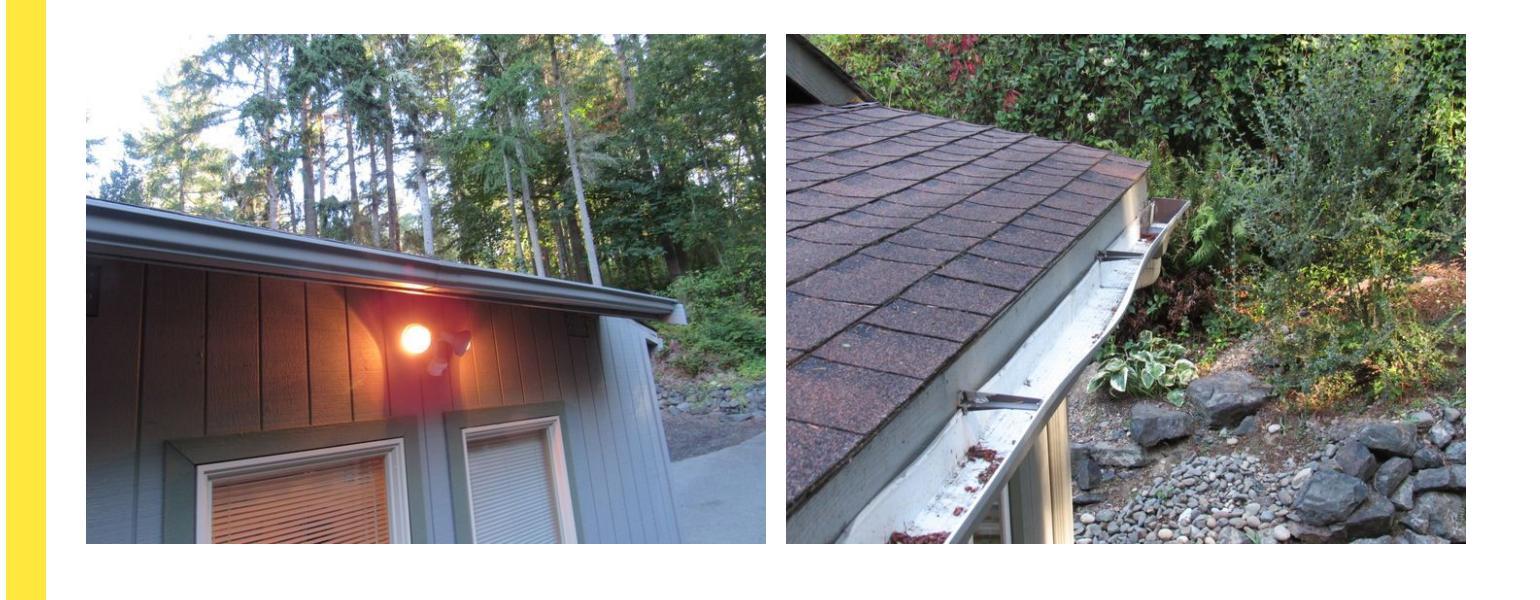
**W** (RA-2) Improve: Plastic gutters were used for this building. As a general rule I find plastic gutter systems are unreliable and require constant maintenance to insure proper slope and to prevent leakage. Updating the plastic gutters is recommended for improved reliability and lower maintenance.

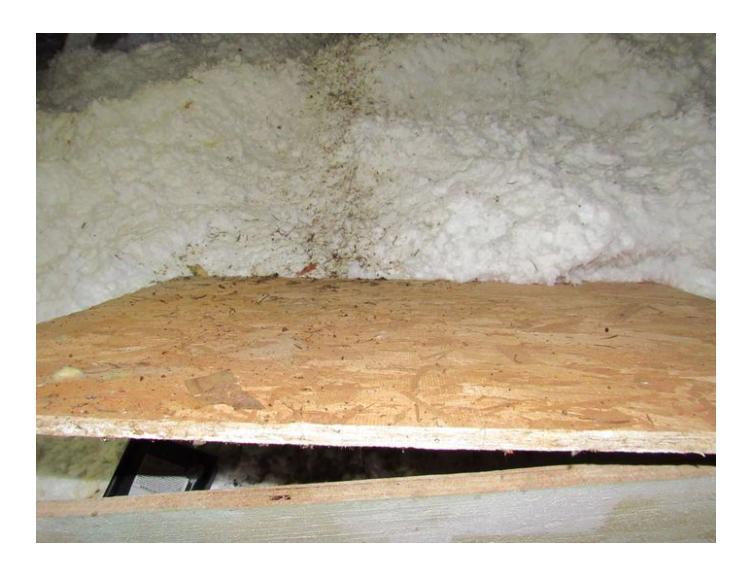
**(RA-4) Repair:** The attic access hatch requires insulation and weather stripping to prevent heat loss and heat migration into the attic.

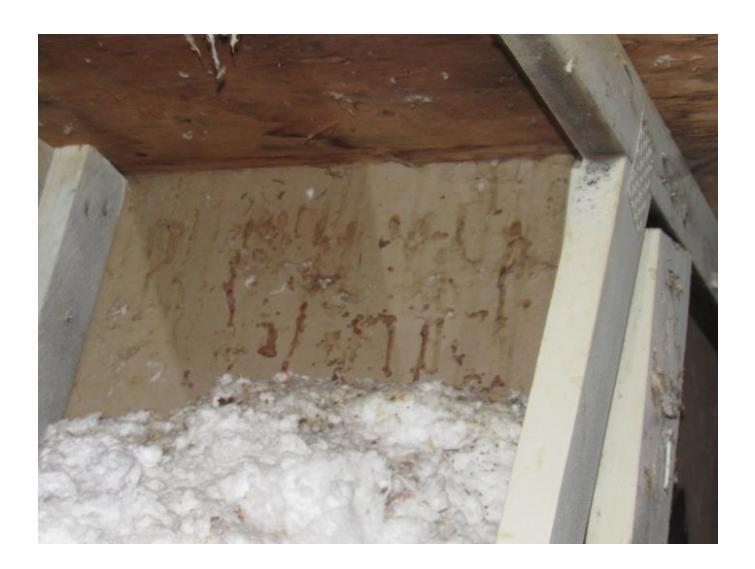
**(RA-7) Repair:** The attic insulation is rodent-damaged and incomplete. Remove all contaminated insulation and complete repairs to fans, wiring, ventilation.... Once repairs are complete re-insulate to modern standard or to best possible levels. Be sure to seal up all air leakage points during repairs and prior to insulating to modern standard be sure all rodent issues have been resolved and all projects like wiring and bath fans have been completed.

Water stains noted on the skylight chamber access point is inside the house. Could be from roof leakage or condensation.

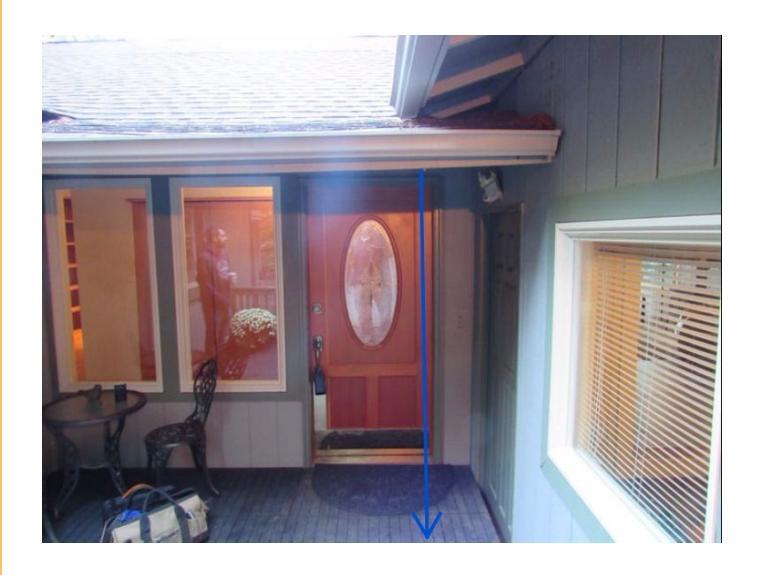
**(EG-3) Repair:** The exterior entry door is a primary egress door. This should have a minimum height of 78 inches. This is currently obstructed by a low roof in the front. This could be difficult to correct without re-framing the entry roof.

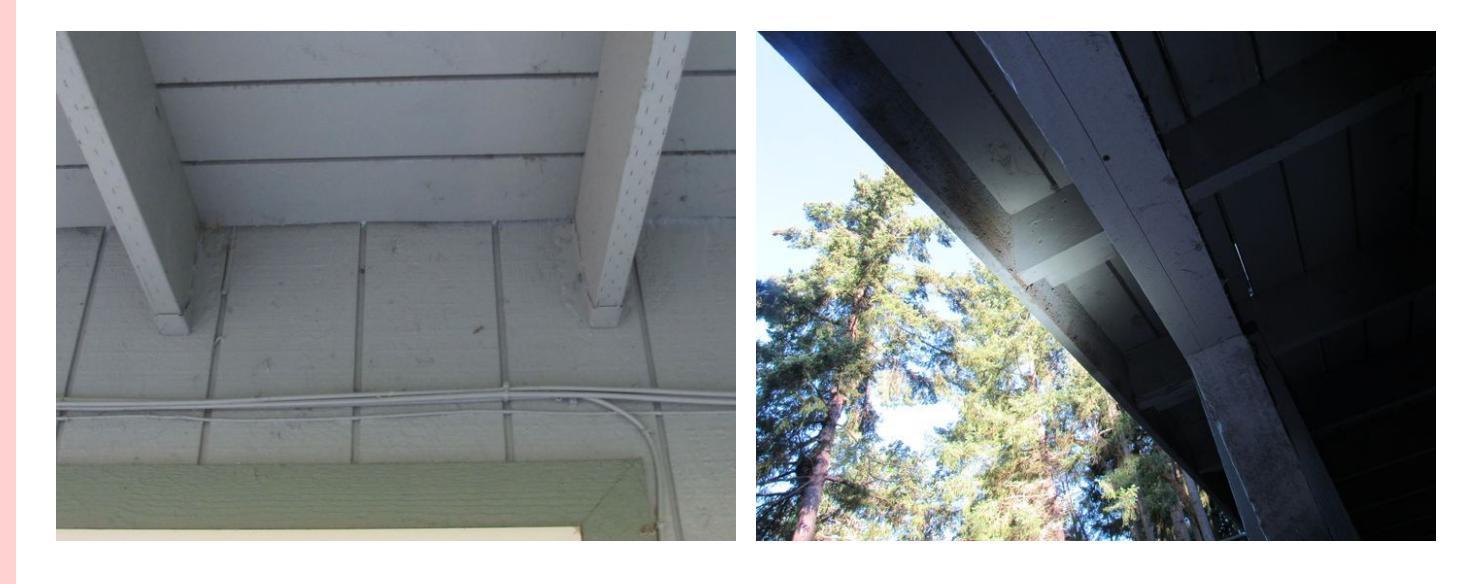
No ledger board - joist hangers nailed directly Inadequate lateral support at the beam and to the siding - this creates an unreliable connection between the deck and then house.

the rim joist - see how the rim is just 1x material

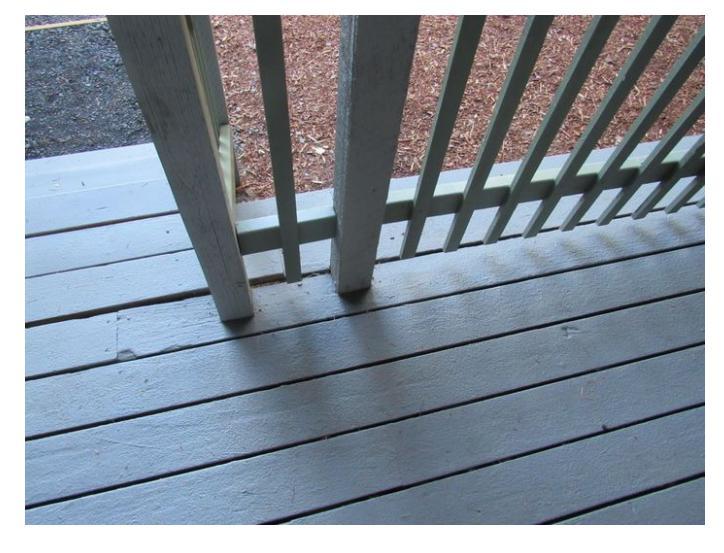
Wood decay at the base of some deck posts.

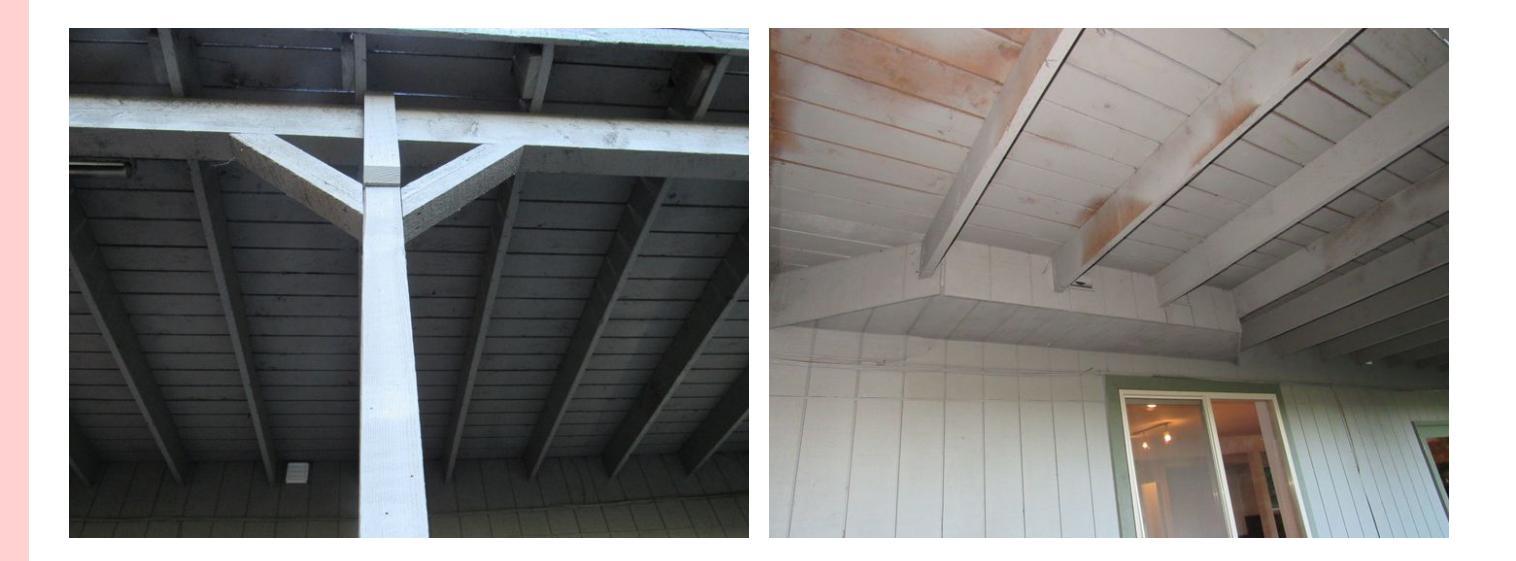
Inadequate 4x4 posts, especially for such a heavy deck - supporting two decks and a roof

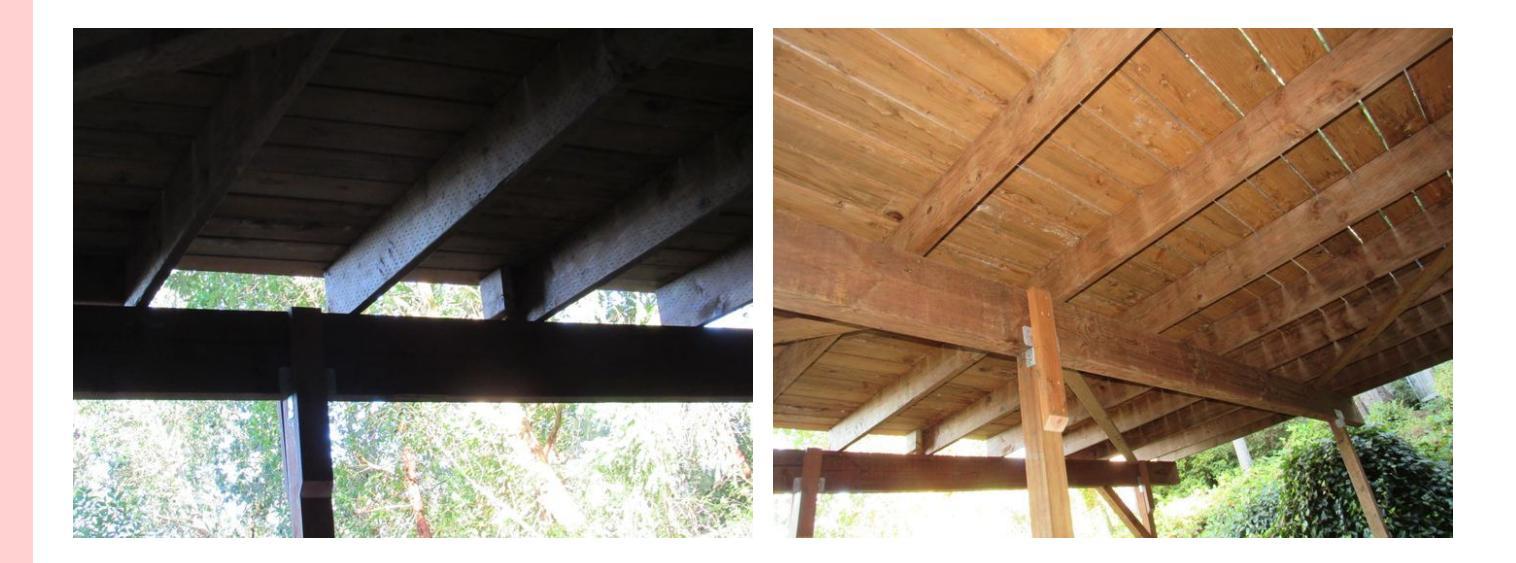
Inadequate lateral support at the new deck

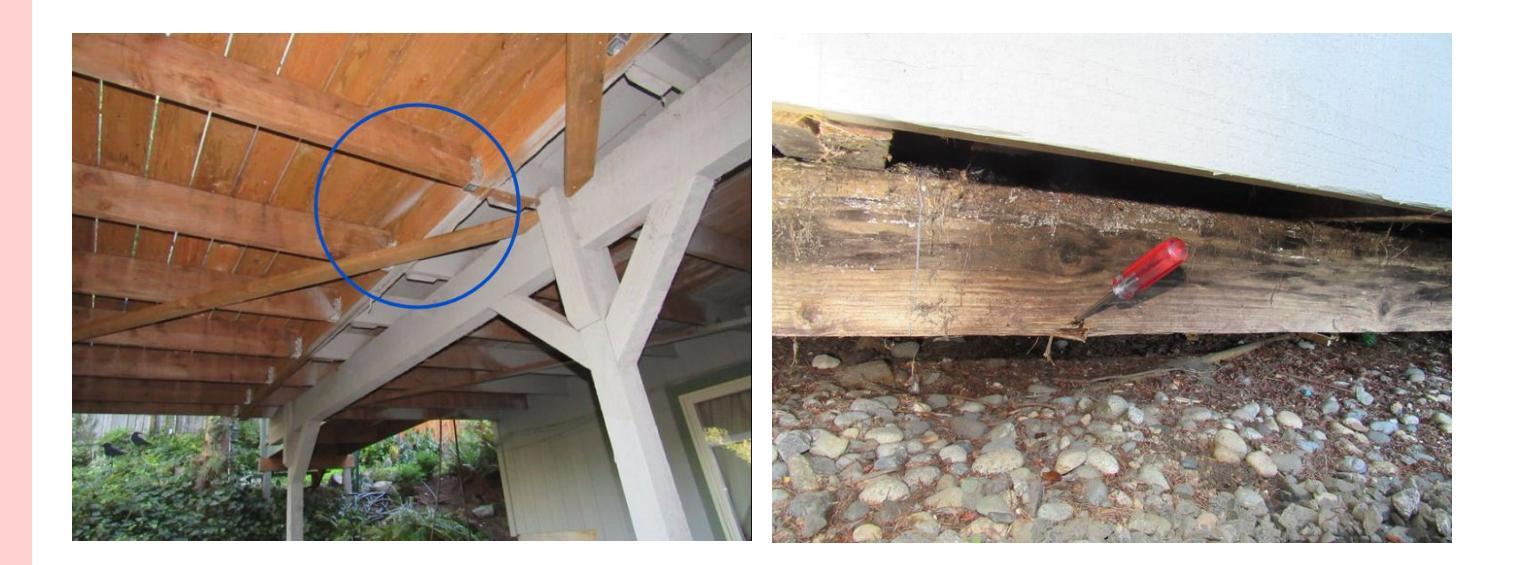
Unreliable attachment of the new deck - this is a weak and non-standard connection.

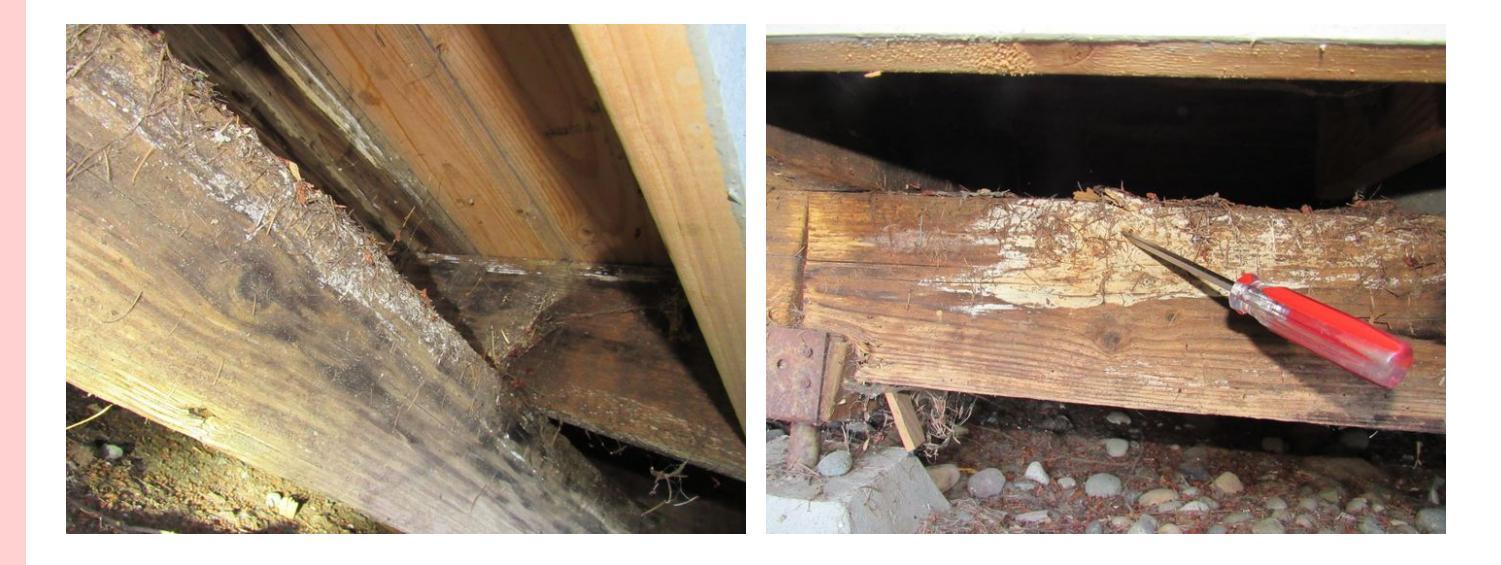
Wood decay and anobiid beetle damage in the wood beam below the lower deck

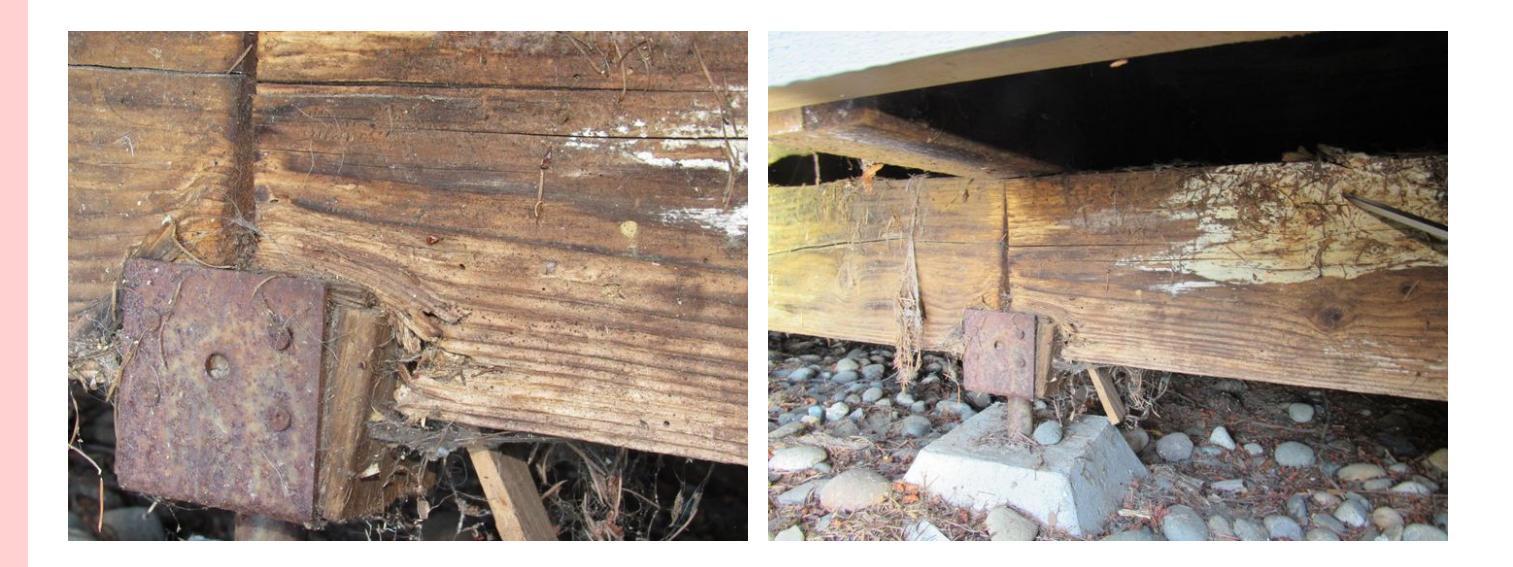
Rotting non-treated beam below lower deck

Under-sized footings and saddle for this large deck

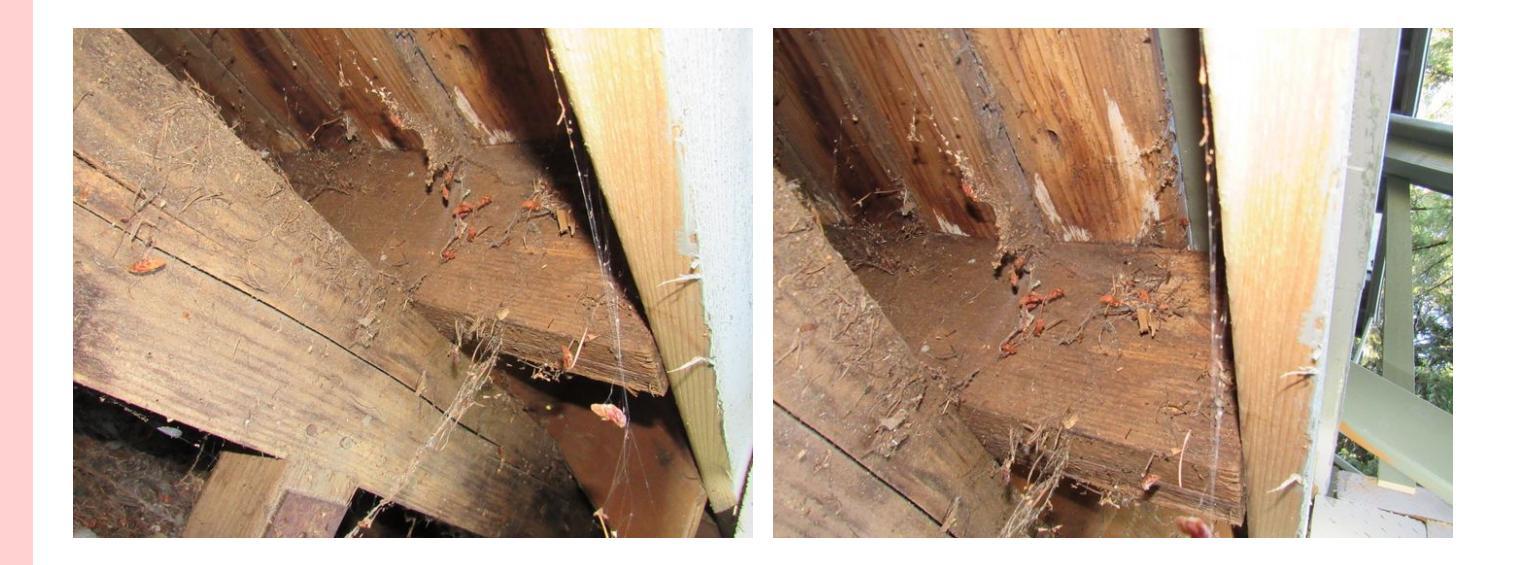
Fungal rot and anobiid damage to framing and decking at lower deck

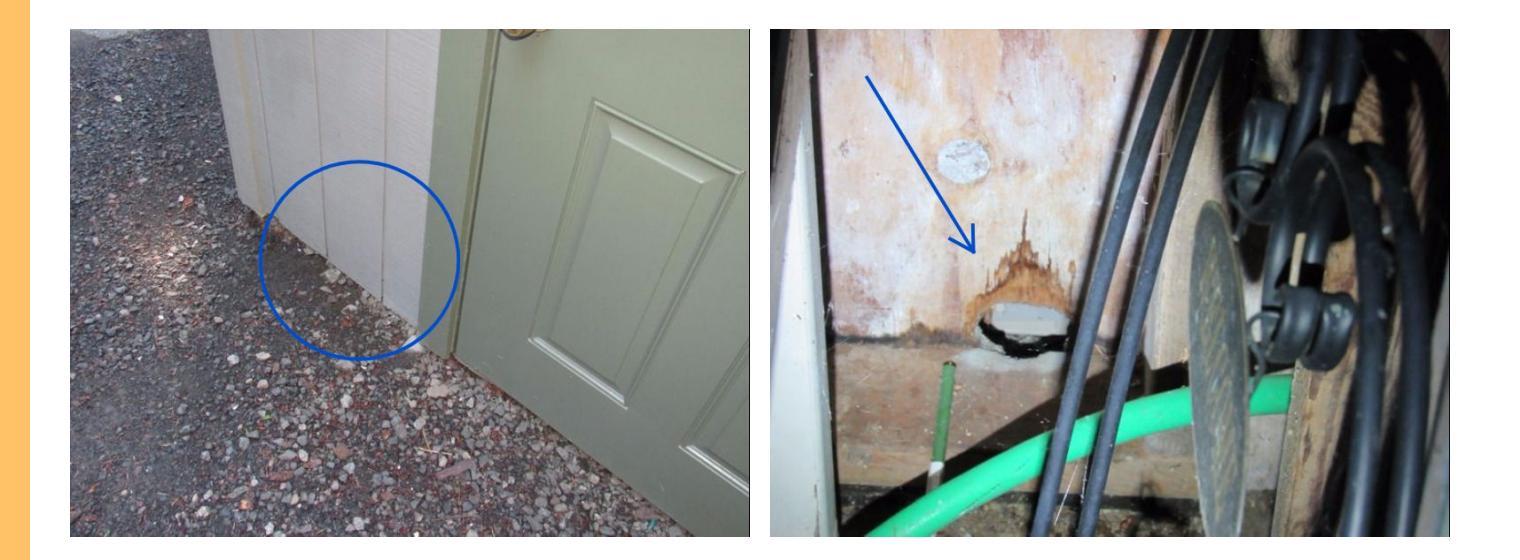
**G-2) Repair:** Eliminate wood /soil contact to reduce the chances for rot and pest damage and repair any hidden rot as needed - see N storage shed. Generally, a 6-inch clearance between soils and wood is recommended. This is often not realistic on older homes, but repairs should be made to get as much clearance as is possible and all contact with the soils should be eliminated.

Rodent entry points noted at N storage shed

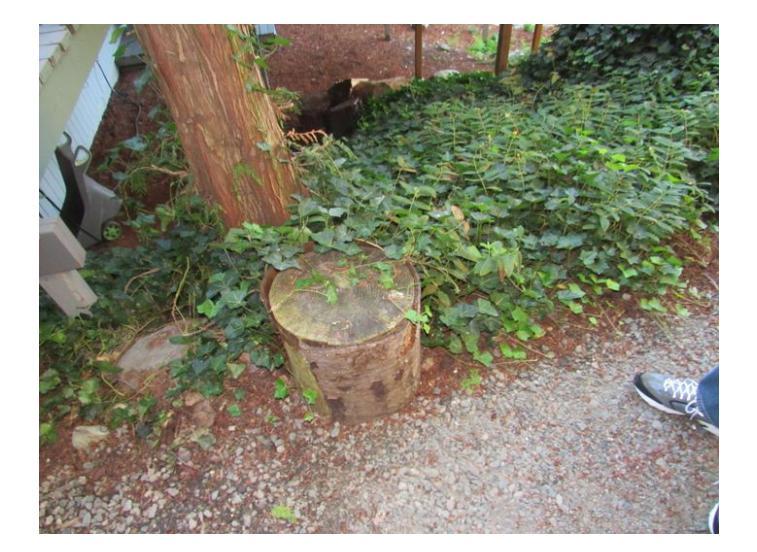
**G-5) Repair:** The rotten stumps near the house should be removed from the yard to eliminate a condition conducive to wood destroying organisms. Eliminating conducive conditions near the home can help create a natural barrier between your home and wood destroying organisms.

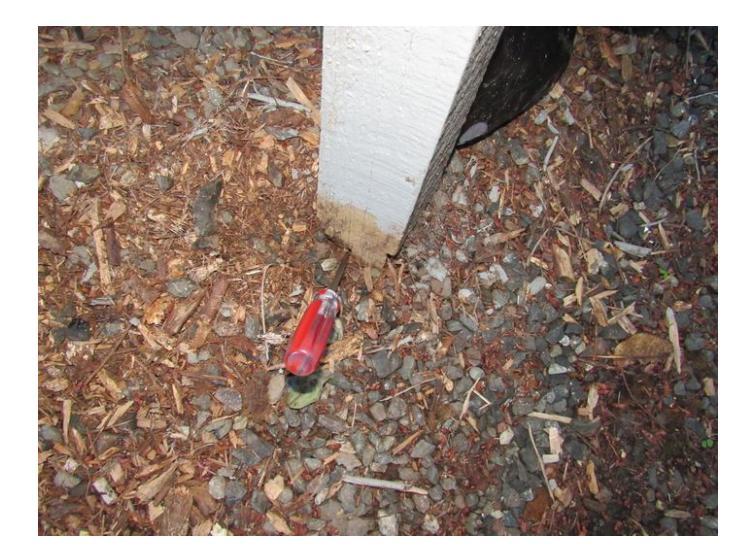
**G-7) Repair:** A rotted post was noted at the east side of the carport. Replace this rotted post with pressure treated lumber.
