# Inspection report for the RV at Cottonwood St, Minnesota

This report is prepared exclusively for **Jane Doe**  
Inspected On: **11-30-2021**

## 2018 Grand Design Momentum 399TH

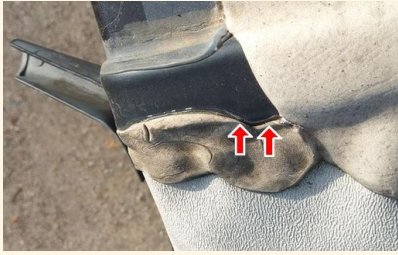
*Streetside Front Cap Sealant*

**🚩 (RE-1) Major Issue:** The inspector observed a number of areas along the front cap joint where the sealant is deteriorating, cracking & separating. It is recommended that the front cap sealant be repaired by a qualified RV technician to prevent future water intrusion.

**RE-1 Roof Exterior - Roof:** The inspector observed a number of areas along the front cap joint where the sealant is deteriorating, cracking & separating. It is recommended that the front cap sealant be repaired by a qualified RV technician to prevent future water intrusion.

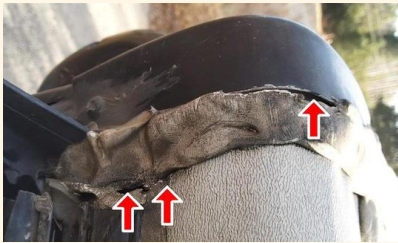
*Curbside Rear Roof Sealant Gap*

**🚩 (RE-2) Major Issue:** The rear cap roof joint, on both the curbside and streetside corners, have cracked sealant. It is recommended that these areas be repaired by a qualified RV technician to prevent future water intrusion.

**RE-2 Roof Exterior - Roof:** The rear cap roof joint, on both the curbside and streetside corners, have cracked sealant. It is recommended that these areas be repaired by a qualified RV technician to prevent future water intrusion.

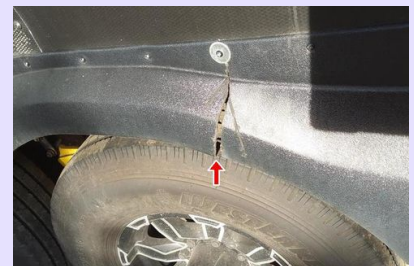
*Streetside Tire Fairing*

The inspector observed a crack in the streetside wheel fairing. It is recommended that this be serviced by a qualified RV technician.

**ES-2 Exterior Sidewalls - Streetside Sidewall:** The inspector observed a crack in the streetside wheel fairing. It is recommended that this be serviced by a qualified RV technician.

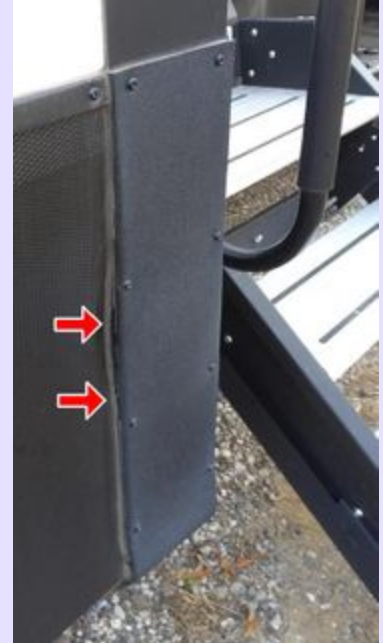
*Front of Curbside Slideout T-Molding*

Inspector observed gaps in sealant of the lower front T-Molding on the curbside front slideout. It is recommended that this be serviced by a qualified RV technician.

**S-1 Slideouts - Curbside Center Slideout:** Inspector observed gaps in sealant of the lower front T-Molding on the curbside front slideout. It is recommended that this

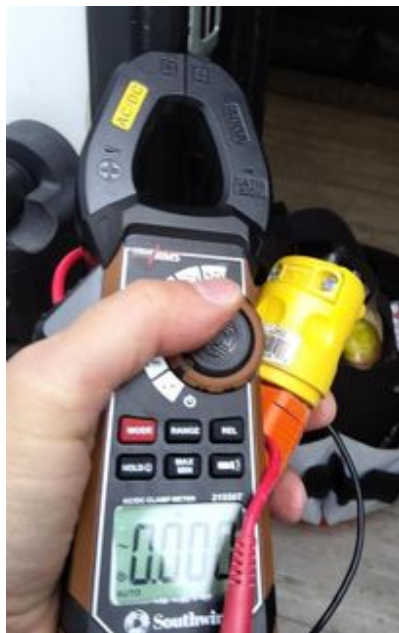
No unsafe voltage over five volts was recorded.

*No Excessive Voltage at  
Entrance Door*

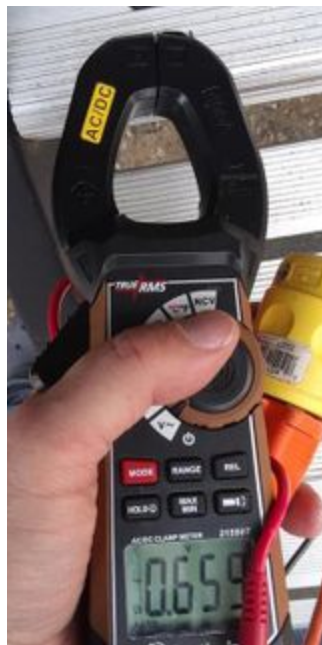
*No Excessive Voltage at Steps*

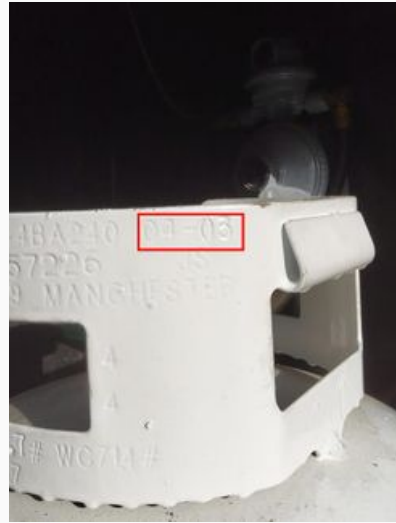
*Streetside LP Tank*

**⚠ (PTLC-2) Life Safety Issue:** The inspector observed that the streetside LP tank has a 2003 date code. Propane cylinders must be requalified or replaced every 5 or 10 years depending on the cylinder type, condition, and previous requalification method. (Ref. 49 CFR § 180.205(d) and 180.209(e).) Recommend that this be replaced with a newer tank.

**PTLC-2 Propane Tank, Lines and Connections - DOT Tanks:** The inspector observed that the streetside LP tank has a 2003 date code. Propane cylinders must be requalified or replaced every 5 or 10 years depending on the cylinder type, condition, and previous requalification method. (Ref. 49 CFR § 180.205(d) and 180.209(e).) Recommend that this be replaced with a newer tank.

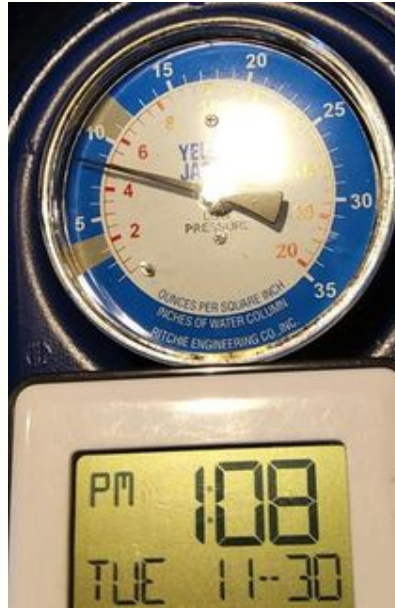
LP Leak Test - Start

**LP Leak / Drop Test -:** Pass

**LP Leak / Drop Test - Did Pressure Drop During Leak Test:** No

🚩 **(PTLC-4) Notice / Comment:** The propane system passed the leak test.

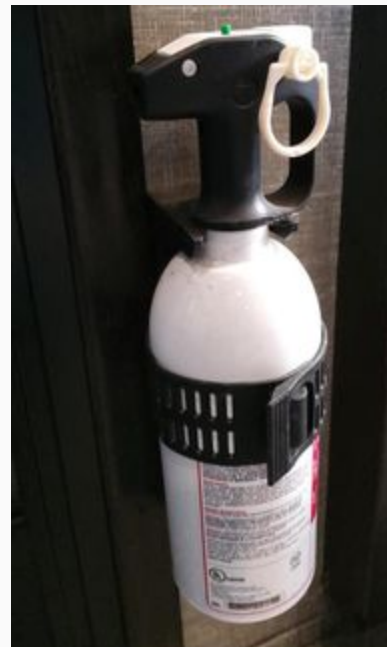
Fire Extinguisher - Garage

**Fire Extinguisher Condition:** ☒ Poor

**⚠️ (PTLC-9) Life Safety Issue:** The inspector recommends installing a larger Fire Extinguisher, 10 B:C is recommended.

5 B:C

**PTLC-9 Propane Tank, Lines and Connections - Fire Extinguisher:** The inspector recommends installing a larger Fire Extinguisher, 10 B:C is recommended.

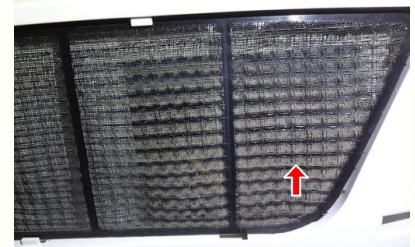
*Garage AC Filter*

The inspector observed that the air conditioner filters were dirty. It is recommended that they be cleaned to improve the efficiency of the units.

**AAC-3 Appliances: Air Conditioners - Air Conditioners - Rear/Garage:** The inspector observed that the air conditioner filters were dirty. It is recommended that they be cleaned to improve the efficiency of the units.
