Inspection report for the property at

Slightly Complex Ave Neat Custom Home, USA

This report is prepared exclusively for **Custom House** On: **2018-02-25**

ICN#: 10296AR0011

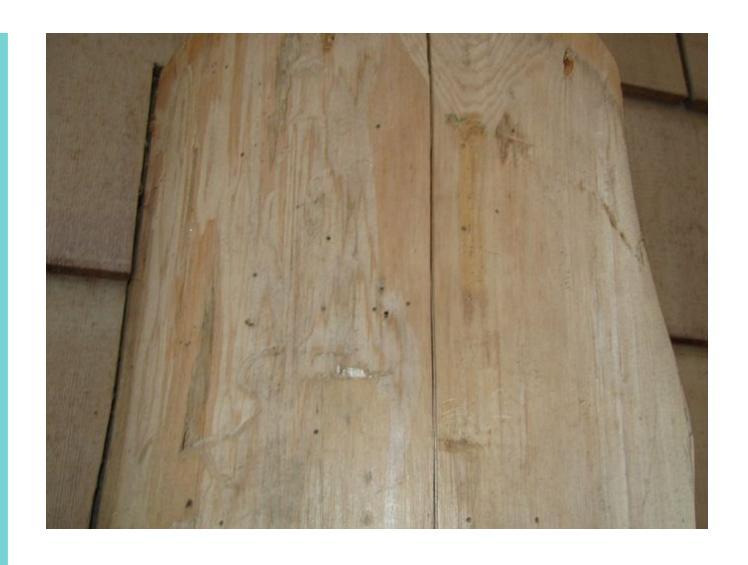
✔ ♥ (PWDO-3) Due Diligence (WDO): Localized moisture ant frass was noted during inspection today - see above door to the newer crawl space. Moisture ants are a wood destroying organism that are indicative of a moisture problem. They will often form nests and tunnels and can damage structural wood. Repairs need to be made to eliminate wet wood and repair all hidden damage to the building. Once the source of moisture is removed and all wood is repaired the ants should go away. During inspection today I found no live ants suggesting this may be an older water problem. But I am concerned this is related to the other red flags in that east wall by the covered porch. Additional evaluation is needed.

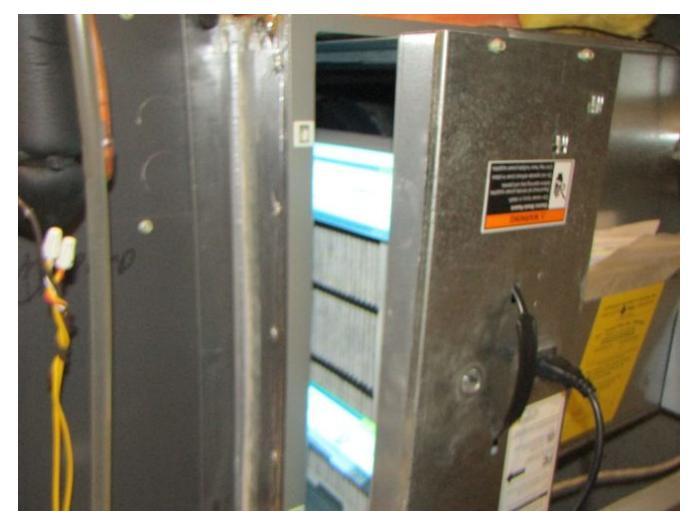
Electrostatic air filter noted

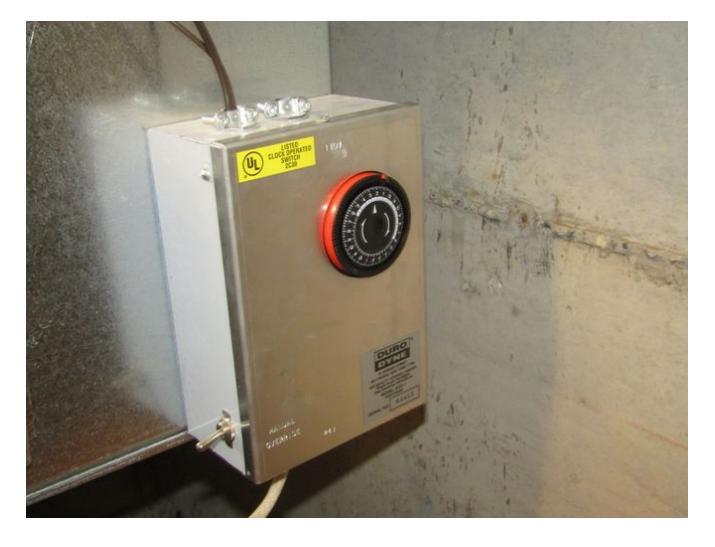
(HCF-2) Note: The Duro Dyne mechanical ventilation timer was set at the time of inspection - this appeared to be operating when tested. The goal of this fan is to provide fresh air for the house and to control relative humidity. During winter months try and keep relative humidity below 55%.

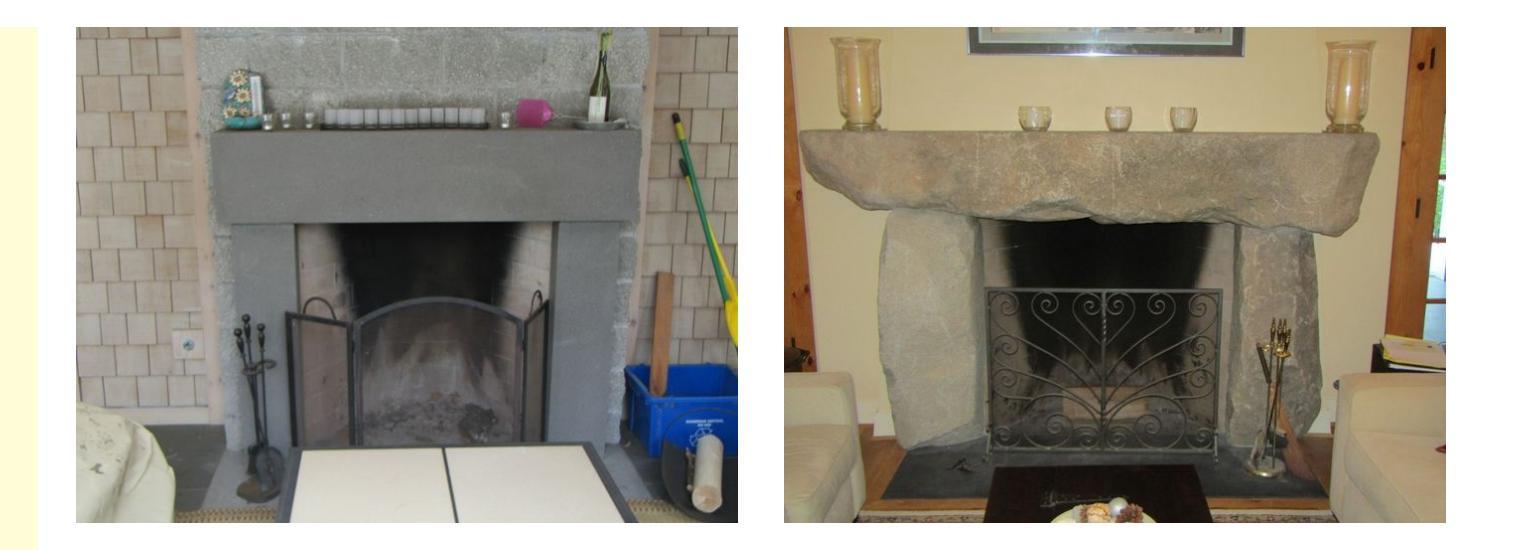
(HCF-7) Note: This house has a **<u>Rumford fireplace design</u>**. These are characterized by shallow and tall fireboxes that project heat into the room - see both inside and out.

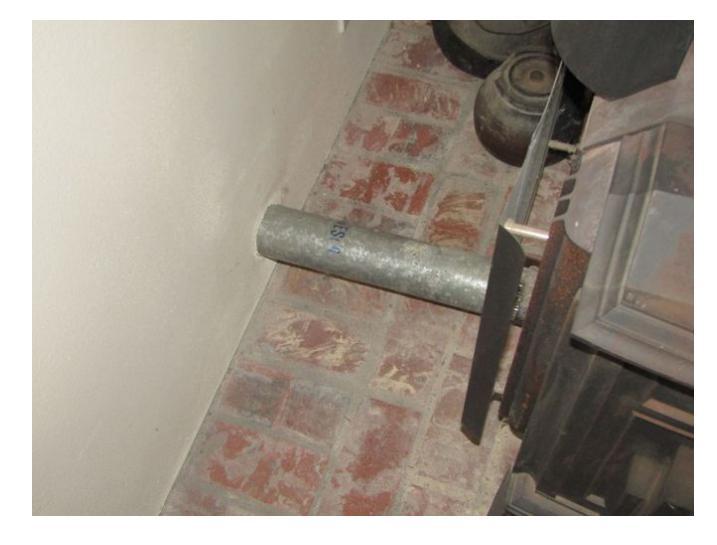
(HCF-8) Note: Exterior combustion air has been provided for the wood stove to improve the energy efficiency and safety of the wood stove. This helps the wood stove run more efficiently because it uses outside air for combustion.

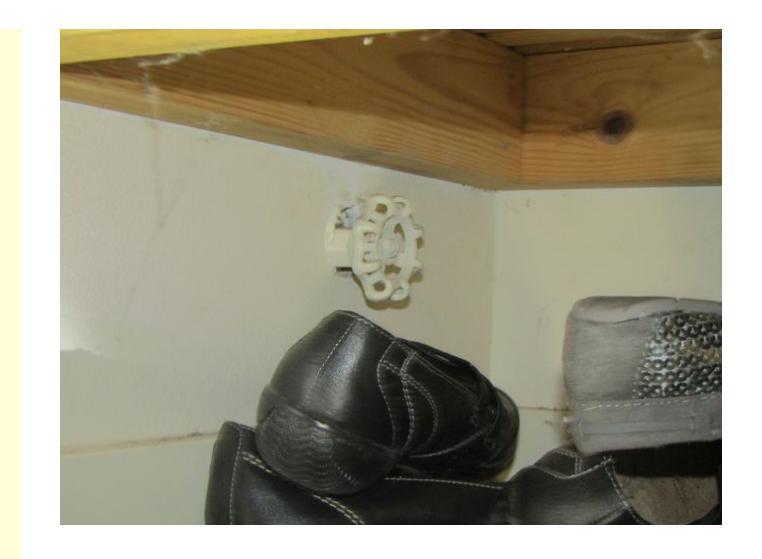
% (P-1) Note: This shows the main water shut off below the mudroom bench.

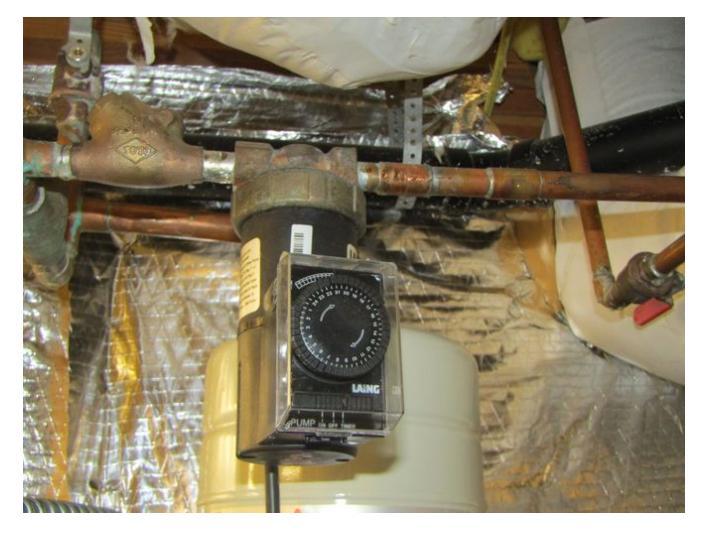
★ (P-2) Note: I noted that the water heating system has a circulation pump. This appeared to be operating at the time of inspection. For improved efficiency these are often put on timers so the pump can be timed to go off at night and in the middle of the day. I noted a timer for the pump - I recommend setting as desired so the pump is operating during your likely hot water demand times.

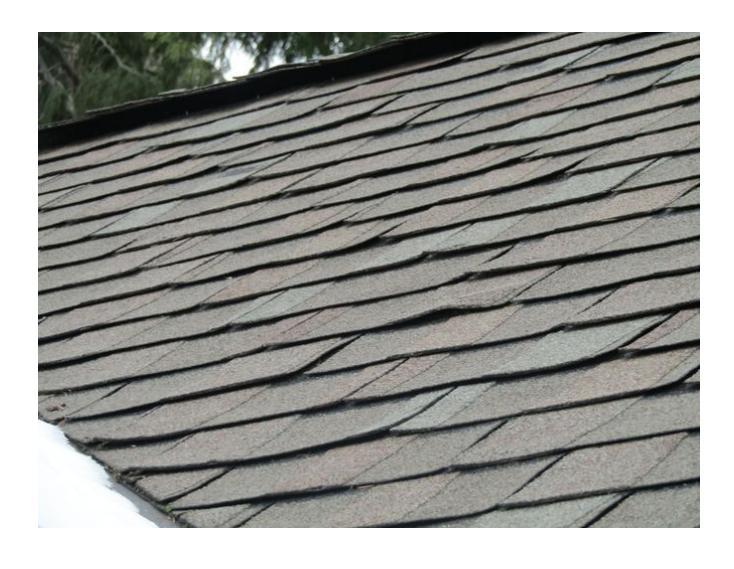
(RA-1) Major Concern: The garage roof covering is close to the end of its reliable service life. The average life of these roofs is 18-22 years and that is how old this roof looks. Hire a licensed roofing contractor to further evaluate and replace this roof soon to insure reliable roofing performance. During roof replacement, I always recommend doing a complete tear off, evaluating the roof decking for damaged or soft boards, evaluating roof venting and indoor fan terminations and replacing all flashings. I could not find leaks at the time of inspection, indicating that the roof has performed well to date.

Shingles are curing at the edges indicting the shingles are old and starting to dry out.

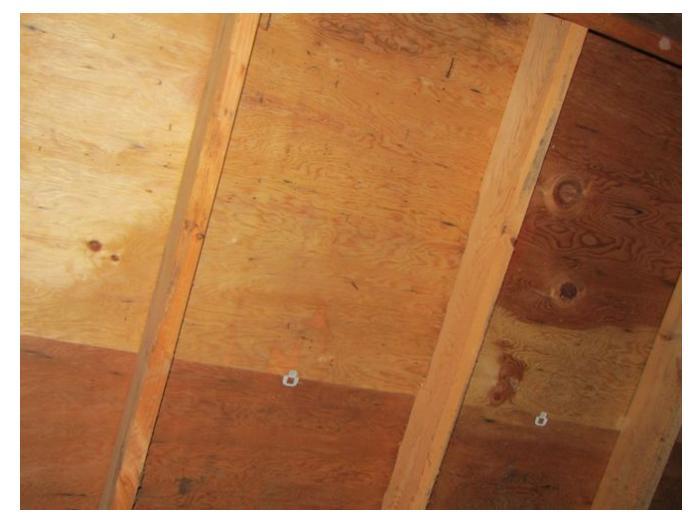
Here you can see the ridge and the gable vent

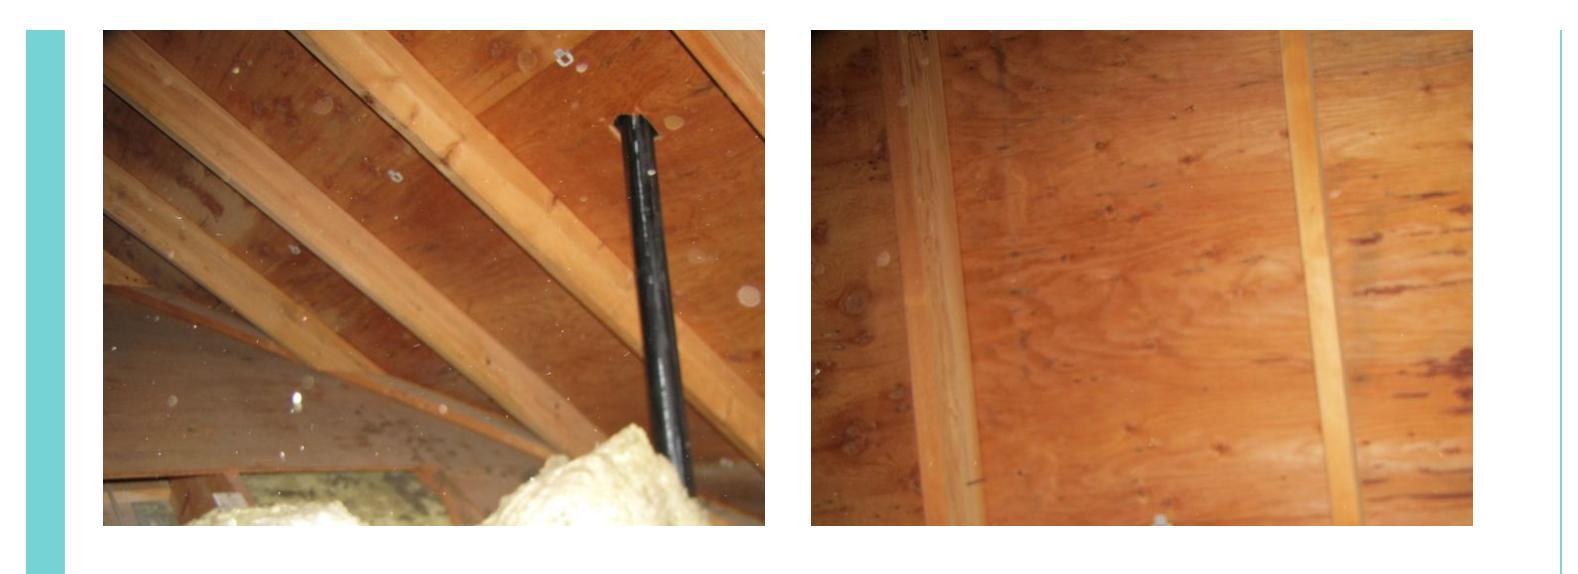
The wood in the attic that is accessible has a nice bright color.

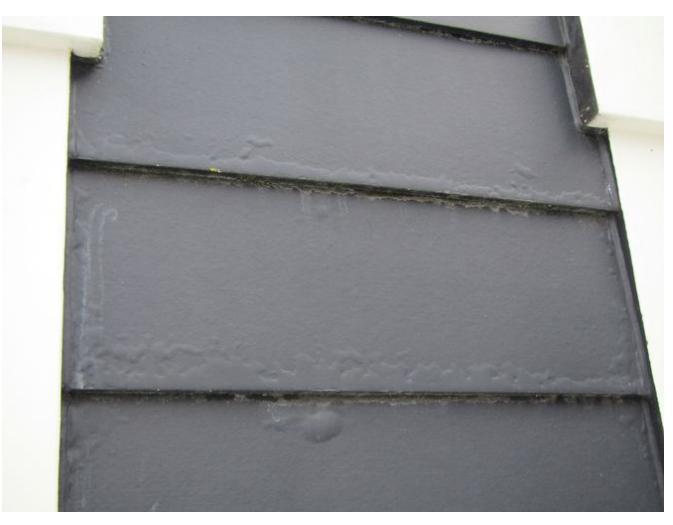
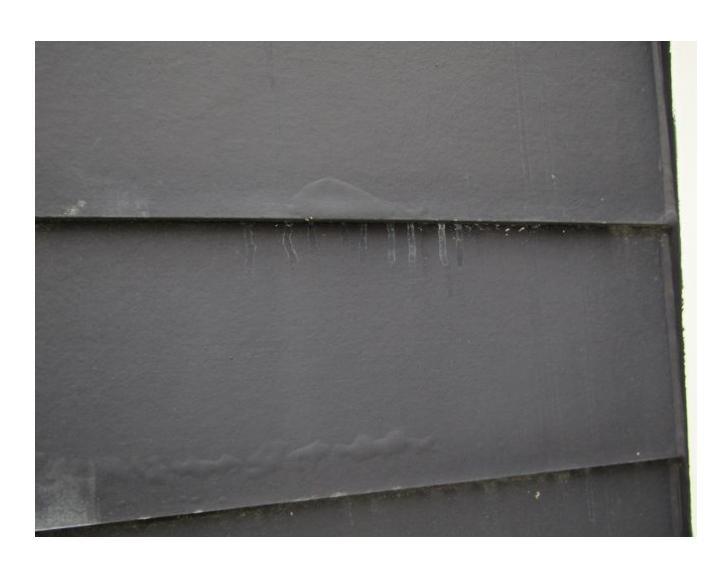
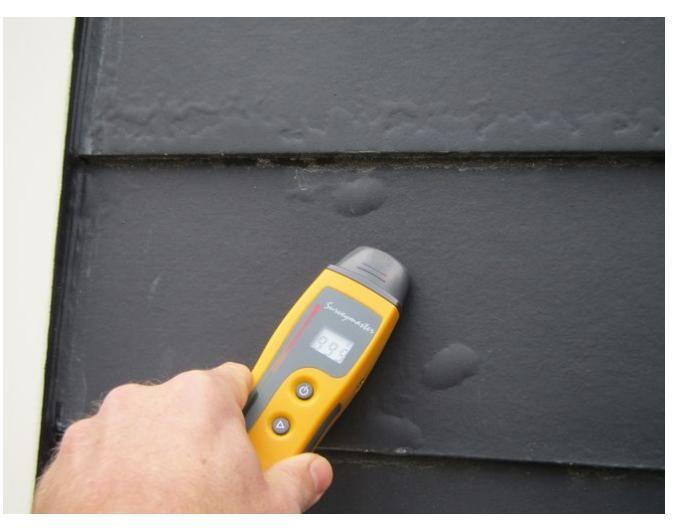
(EG-1) Major Concern (WDO): Visual inspection of the fiber cement siding installation showed the need for repairs as well as some installation details that are not consistent with modern manufacturers installation requirements. This is typical for this age of construction, however, red flags at the exterior of the east porch indicate possible concealed water damage. Additional inspection is needed by a qualified contractor to further investigate the siding and determine the scope and extent of the needed repair. Examples of observations noted during inspection include:

- Blistering paint on fiber cement siding indicates likely saturated siding.
- High moisture meter readings where paint was bubbling
- Water stains indicate possible water behind siding
- Fungus growing at inside corner
- Siding run right to the horizontal flashing and sealed. This is not recommended but difficult to fix at this point.
- Missing back flashings at butt joints this can be retrofit on exposed sides of the building with metal flashing tabs or maintained with caulking.
- Signs of concealed water damage at inside corner below deck
- These stains are typical and should be distinguished from the red flags at the east side. These stains can be cleaned and siding re-painted if needed.

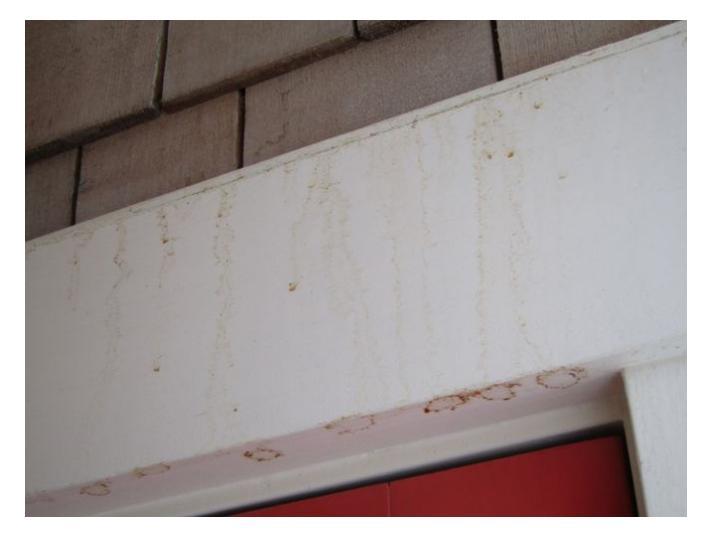
(EG-2) Repair: The tannin stains at the west / back door appear to be from pressure washing. No elevated moisture meter readings were found at the tie of inspection. Clean stains, repaint if

needed and monitor.

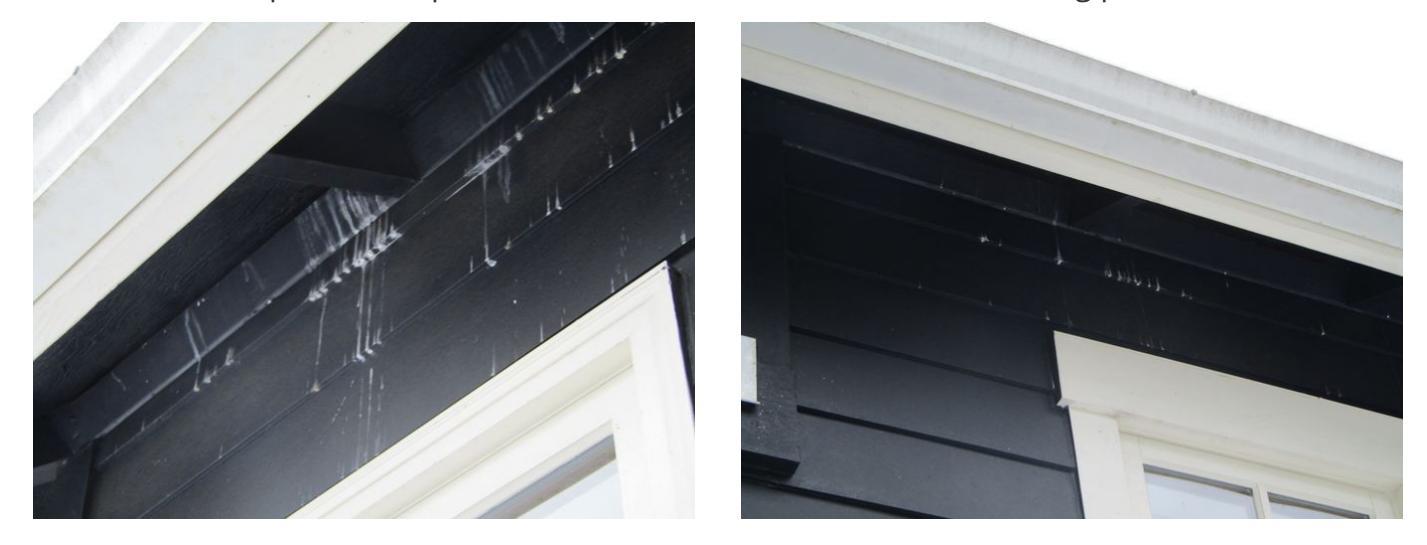
(EG-3) Repair: Birds appear to have been roosting at the exterior - see bird feces on the side of the building in places. I did not see any nests in the attic though some of the eave areas were not visible to inspection. Implement exclusion work and / or anti-roosting provisions as needed.

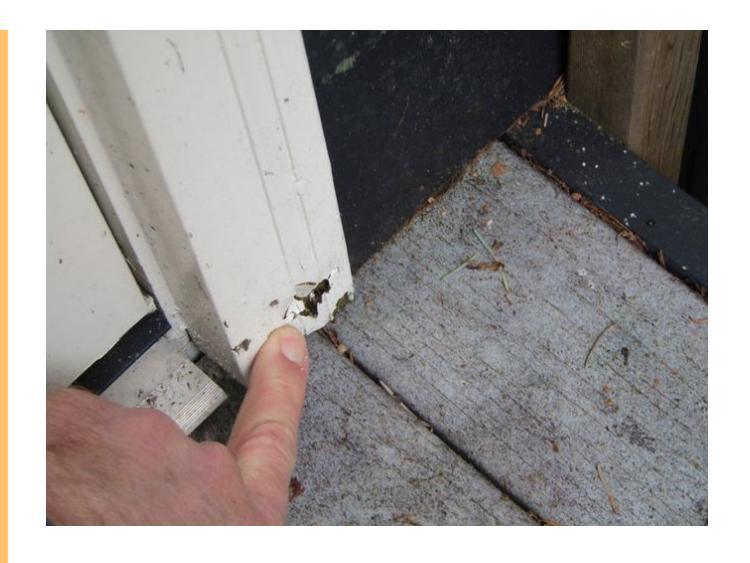
G U (EG-6) Repair (WDO): The wooden door trim is rotting near the deck - north garage mandoor. Repair / replace damaged wood as needed.

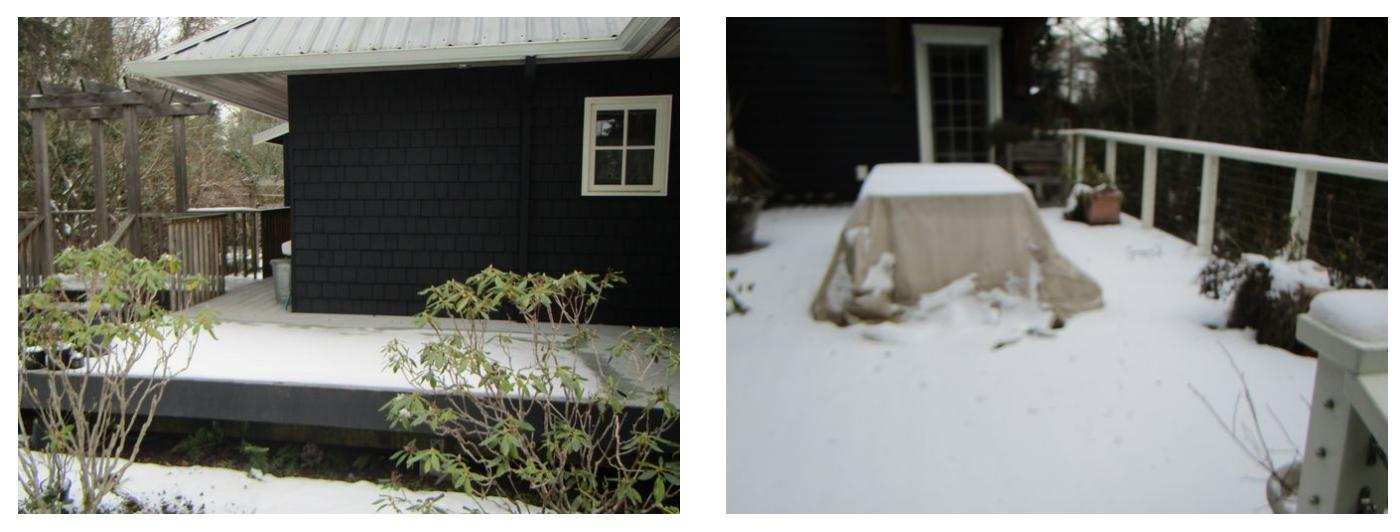
(EG-7) Note: Snow cover limited inspection of the decks - the decking condition was not visible.

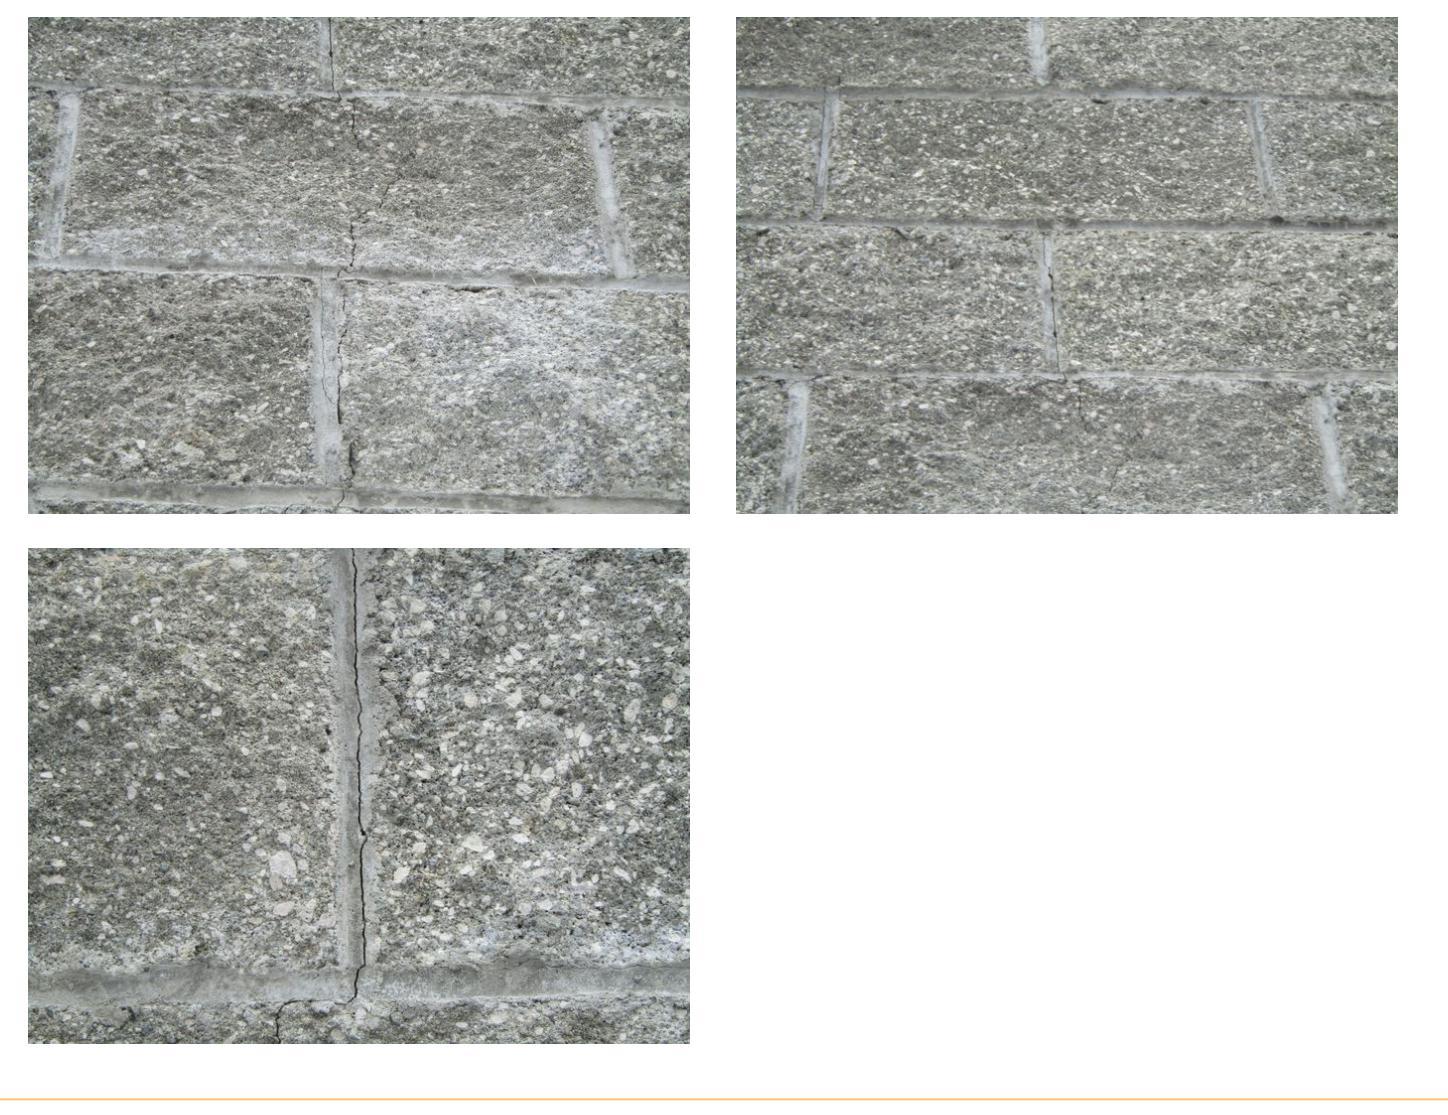
(EG-11) Repair: Hairline cracks were noted in the east face of the masonry brick chimney. These were small and minor at the time of inspection. Monitor - no repair appears needed at this time. I did note some minor mortar failure as well. Have this further investigated by a qualified mason during the next chimney sweep and repair as recommended.

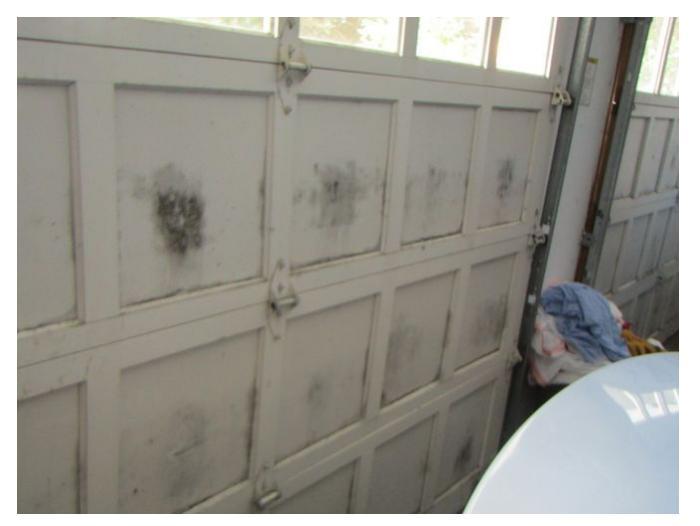
Geta (EG-13) Repair (WDO): Mold-like substances were noted on the back side of the garage door. For improved indoor air quality in the garage I recommend priming and sealing these stains with an appropriate sealer and finish paint. Please note this can be a red flag indicating excessive moisture in the garage slab or just related to parking wet cars in the garage. This is difficult to verify during a one-time inspection. Additional repair options include installing a fan to better ventilate the garage and / or sealing the concrete with a sealer to help reduce moisture evaporation into the garage.

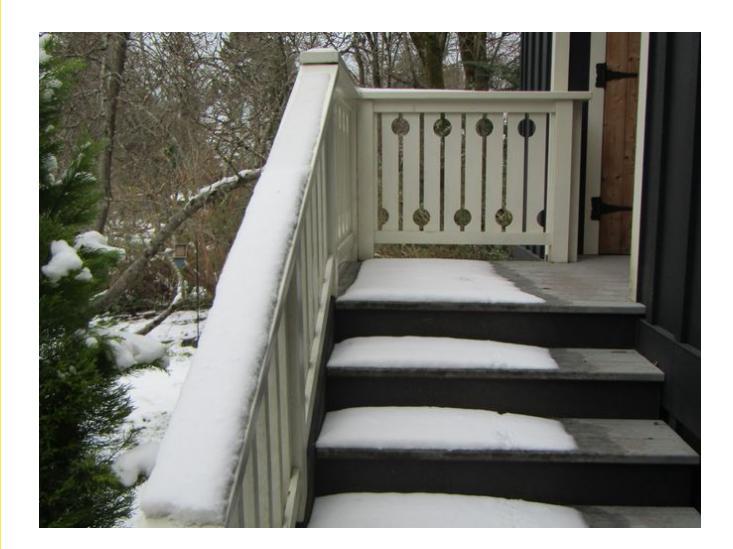
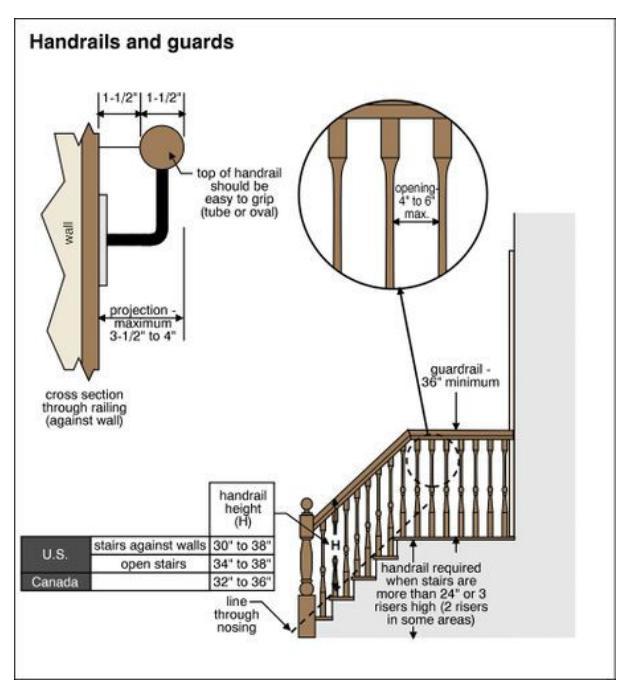
(G-3) Improve: The exterior back stairs are missing a graspable handrail for safety. This should be a round railing 1 and 1/4 inches - 2 inches in diameter. If the railing is not round it must have a finger groove that is 3/4 of an inch down from the tallest point of the rail. The graspable handrail should also be 1.5 inches from the wall. 2x material is not considered a graspable handrail. Have a qualified contractor build suitable railings to reduce the potential for falls.
