Inspection report for the property at
6754 Sample Lane USA

This report is prepared exclusively for **Bono**
On: **2018-10-01**

Orca Inspection Services LLC

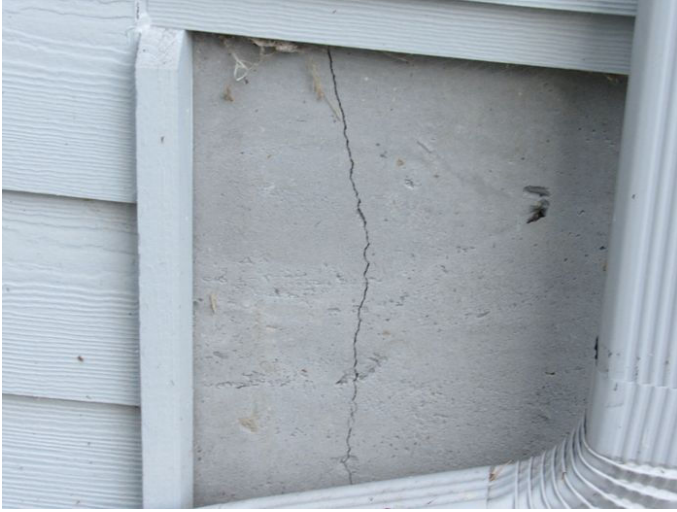
📌 **(SB-1) Note:** Typical small cracks were noted in the foundation - see east side. No repair appears needed at this time. Minor settlement and shrinkage cracks are common in poured

concrete and do not require repair as long as they do not continue to grow. The best way to prevent on-going settlement is by controlling roof runoff and site drainage to promote dry soils around the foundation; wet soils do not bear weight well. This will also help to prevent basement or crawl space moisture problems.

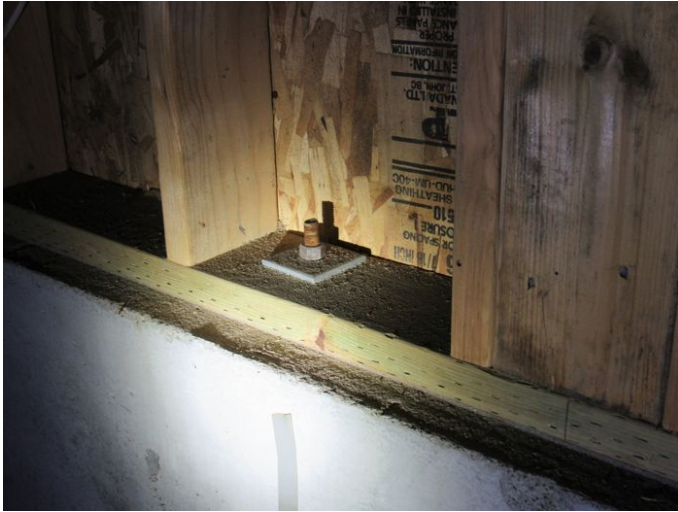
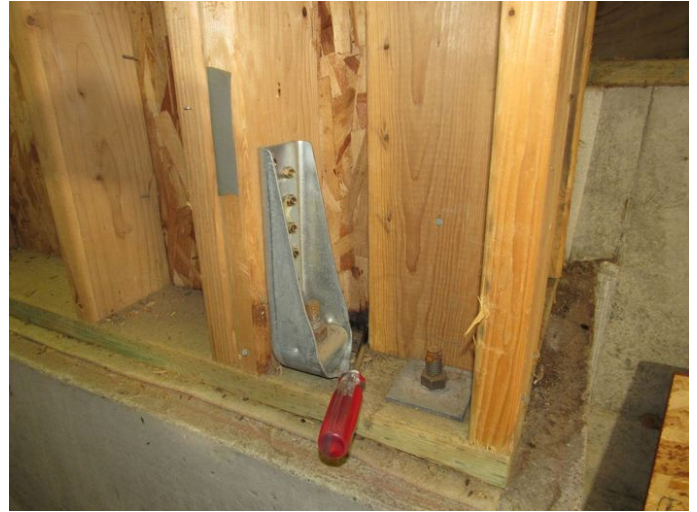
📌 **(SB-2) Note:** Nice positive connections noted on posts and beams in crawl space. This will help the building resist failure in a seismic event.

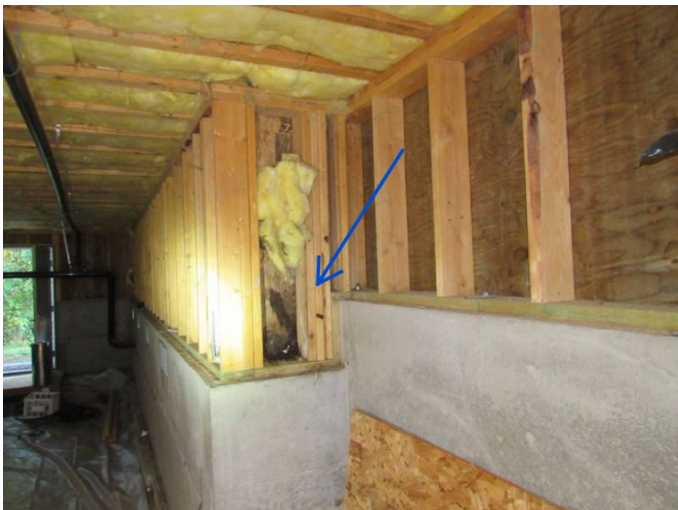
⚠️ 🐜 **(PWDO-2) Pests and Wood Destroying Organisms:** Moisture ant damaged wood was noted in a localized area of the building - see below the entry porch in the pony wall - west side of crawl space. Moisture ants are a wood destroying organism that indicate there is a problem with wet wood. They will often form nests and tunnels and can damage structural wood. Once repairs are made to eliminate the moisture sources, the ants typically go away, so treatment is rarely needed. In this case, *live ants were found* suggesting that the water problems require repair. Damaged sheathing was noted. This is a tricky spot where concrete is installed over the sheathing at the entry porch. I recommend additional inspection by a qualified contractor - repair as recommended.

This shows the location of the moisture ant damage - west side of crawl space

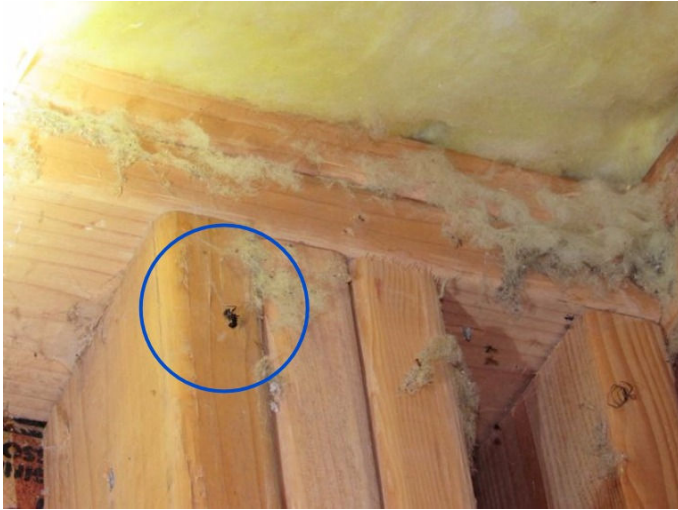
👁️ 🐜 (PWDO-3) **Monitor:** Dead [carpenter ants](#) were noted during inspection today - see same location behind porch as the active moisture ant issues. No live ants were found during inspection, but a treatment may be needed. There is always a risk of hidden structural damage or a hidden moisture problem when there have clearly been carpenter ants in the home. Inquire with the seller for a history of repairs and treatment and monitor for large black ants. If ants are found, have the property evaluated and treated by a licensed pest control operator.

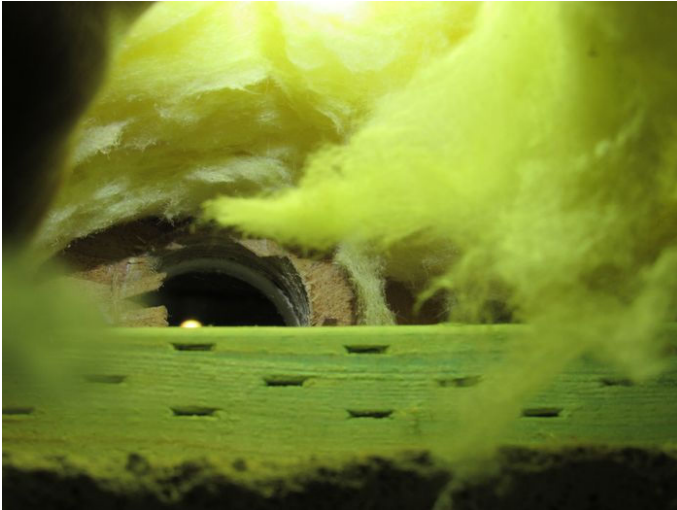
🔑 (CS-1) Repair: Seal up the hole between the garage and the crawl space to complete the fire separation.

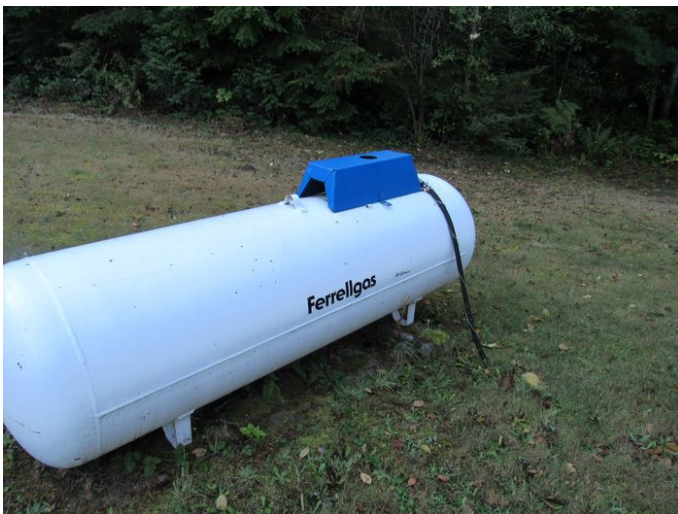
**(FSD-1) Due Diligence:** The propane tank might be a leased tank. A sticker for Ferrell Gas @ 800-441-3444 indicates they may be the owners of the tank. Consult with this company for lease information and filling terms and prices.

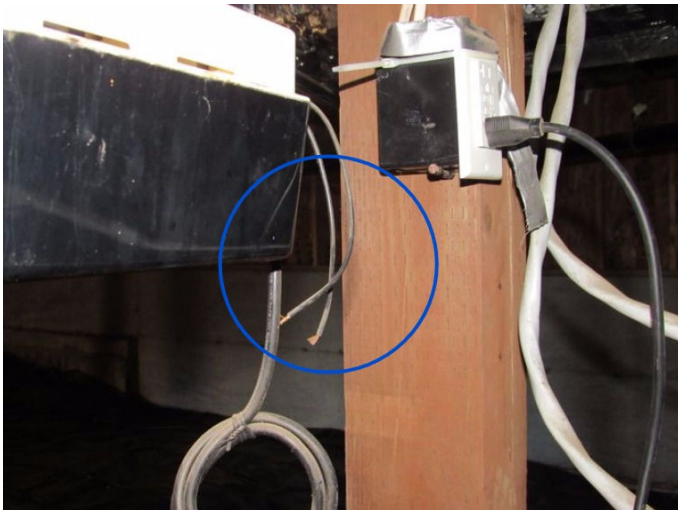
🔧 **(HCF-1) Repair:** The third and fourth wires for the condensate pump have not been connected - these are designed so that the furnace will lock out if the pump is not working correctly - a feature designed to reduce the chances of water damage from condensate. Have this further evaluated and repaired by a heating contractor. This is not too urgent as the condensate pump is in the crawl space.

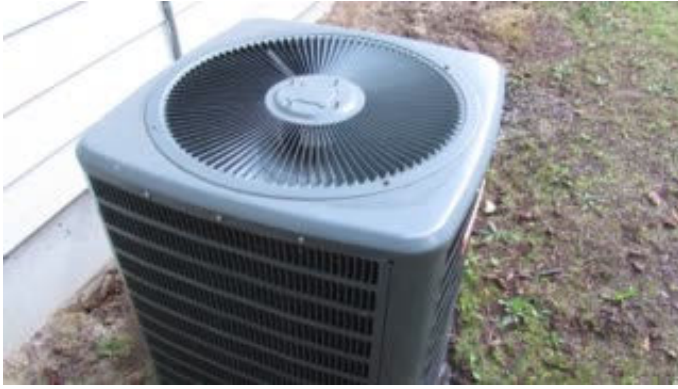
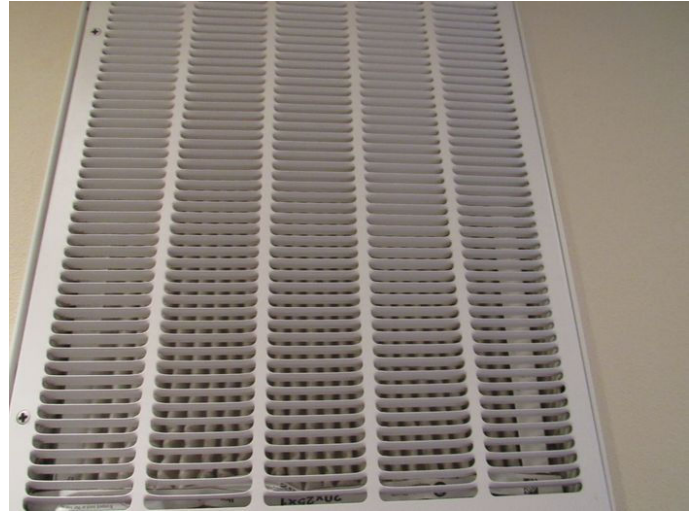
🔧 **(HCF-3) Repair:** Annual servicing is recommended for all heating and cooling equipment to ensure reliable performance. This house has an air-sourced heat pump system. The system was tested in heating mode during inspection and was operational. No recent service records were noted on the air handler. I recommend keeping this heat pump on an annual service schedule. The filter was clean at the time of inspection - located at the cold air return.

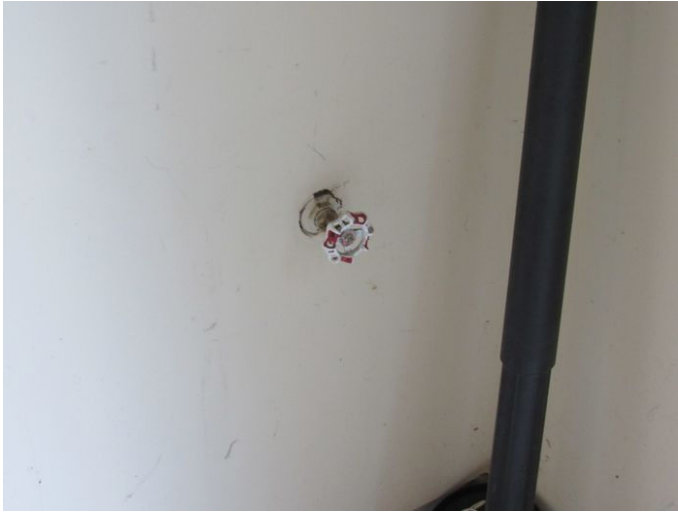
📌 **(P-1) Note:** This shows the main water shut off in the garage.

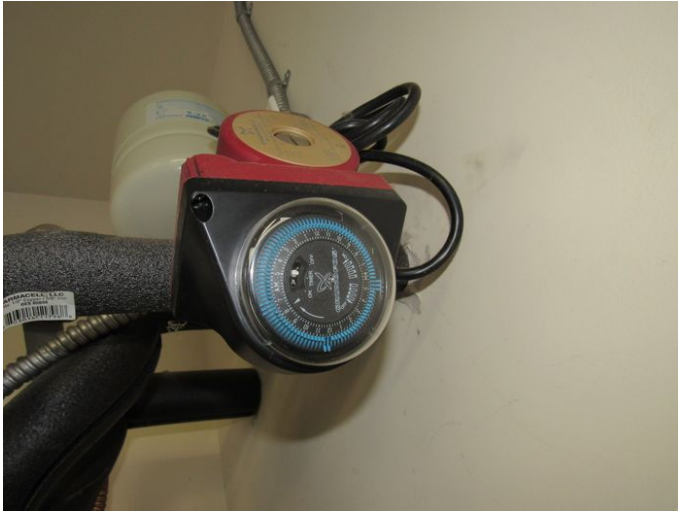
📌 **(P-2) Note:** I noted that the water heating system has a circulation pump. This appeared to be operating at the time of inspection. For improved efficiency these are often put on timers so the pump can be timed to go off at night and in the middle of the day. I noted a timer for the pump - I recommend setting as desired so the pump is operating during your likely hot water demand times.

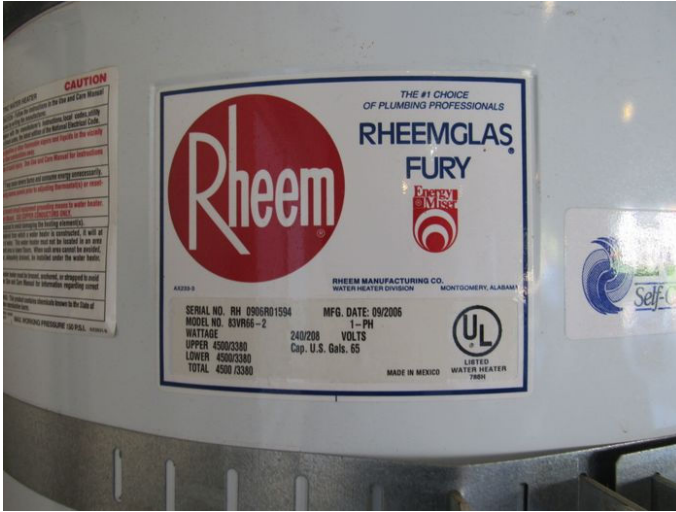
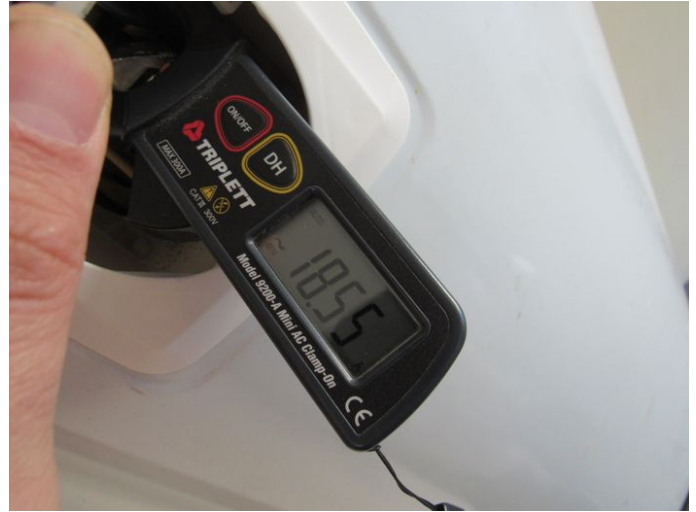
**(P-5) Repair:** There is no evidence that the water heating equipment has been serviced since it was installed. Inquire with the existing homeowner as to its last servicing. Please note that most home owners never service their water heater. This is partly why they only last on average of 8-12 years. To maximize the useful life of a water heater, the appliance should be serviced per the manufactures recommendations. The elements or burners should be

The upper element was working. I could not test the lower element - I could not get the cover off.

checked. The tank should be flushed to remove sediment in the bottom of the tank. The dip tube and sacrificial anode should be inspected and updated if necessary.

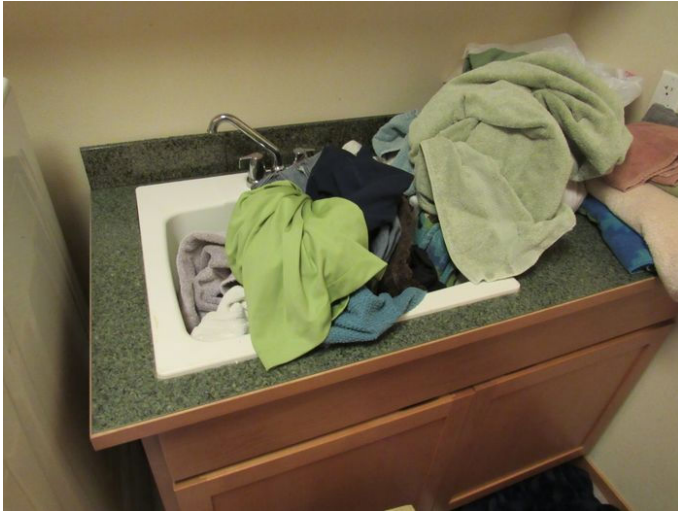
📌 **(P-7) Note:** I did not run / test the laundry sink because it was full of personal items.

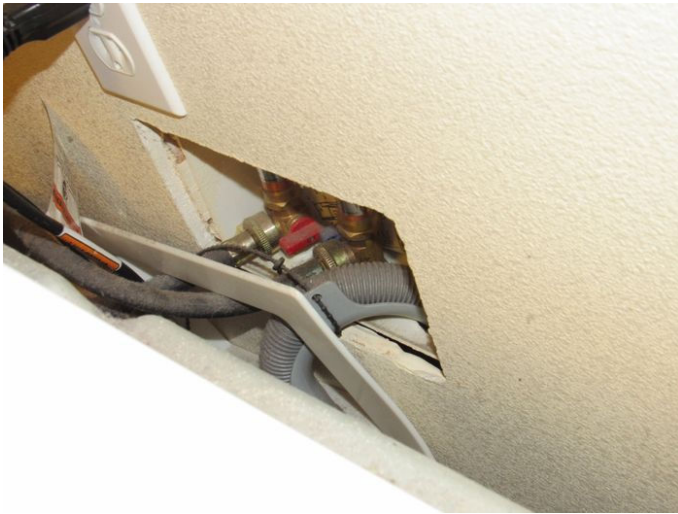
🔧 **(P-8) Improve:** A moisture alarm with water shut-off features is recommended under the washing machine to protect against accidental leaks in the supply hoses. Pans can be effective when there is a drain, but even these will not protect against a burst supply connector. A moisture alarm with automatic shut-off will. Watts is a brand I have seen installed:
<http://www.watts.com/pages/learnAbout/intelliflow.asp?catId>

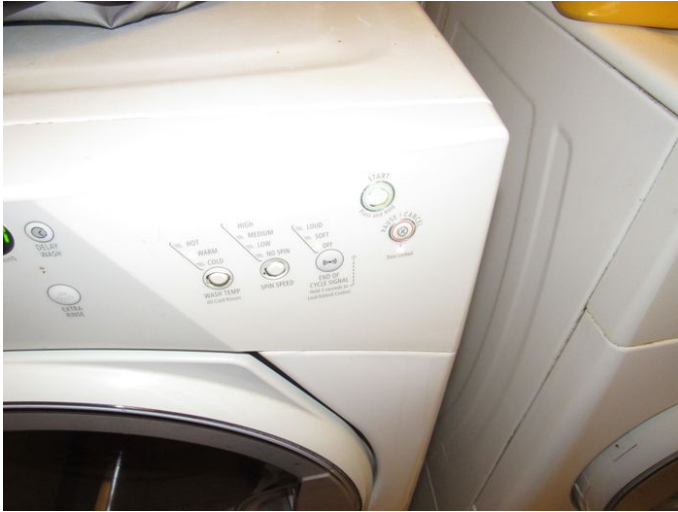
(P-9) Repair: The control panel buttons for the washer and dryer are damaged -see where the panels have worn through on primary control buttons. Repair as needed.

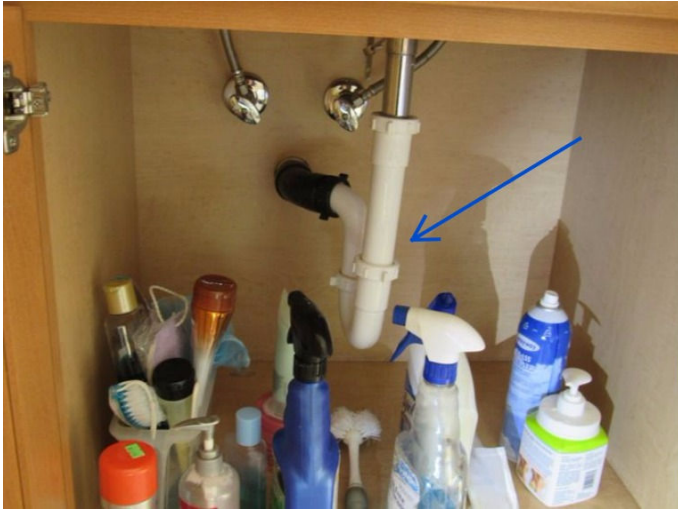
**(MB-1) Repair:** The trap seal is too deep for the right side master bath sink - this should not exceed 4 inches. Have this drain piping further evaluated and repaired by a licensed plumber.

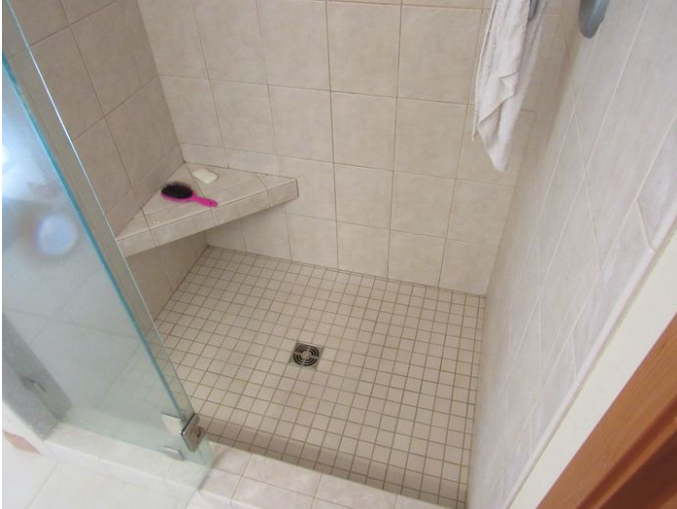
**(MB-3) Repair:** The tile and grout should be cleaned and sealed with grout sealer to prevent water damage to the tile - see especially inside shower surrounds. This should be a routine procedure with tile unless epoxy grout was used. If this is not done in epoxy grout plan on annual cleaning and sealing tile grout inside the shower surrounds to prolong the useful life of the tile.

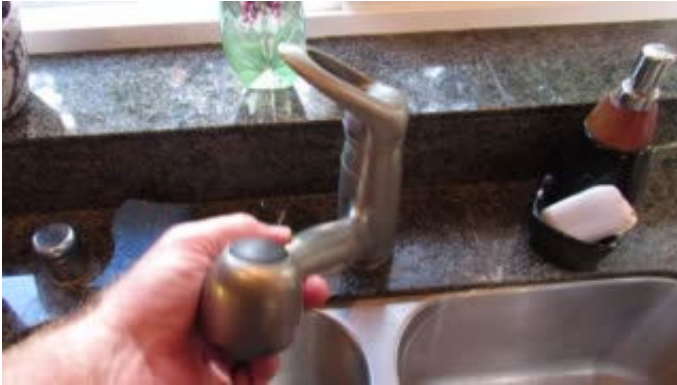
🔧 (K-1) Repair: The loose faucet for the kitchen sink should be secured to prevent leaks. Repair the loose kitchen sink faucet as needed.

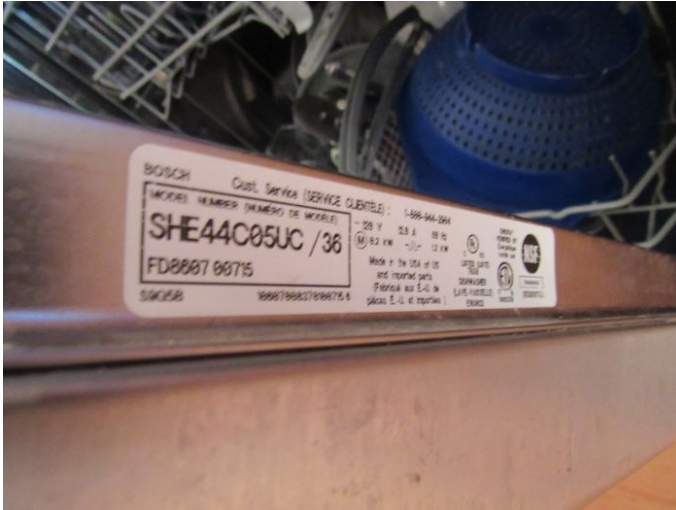
🔧 (K-2) Repair: This home has a Bosch dishwasher Model #: SHE44C Serial #: FD-8607 (Customer Service # 800-944-2904). [These dishwashers are the subject of a CPSC recall regarding potential of overheating and fires.](#) You should stop using this appliance and call BSH Home Appliances hotline @ at (800) 856-9226 for more information. Repair or replace this dishwasher as recommended.

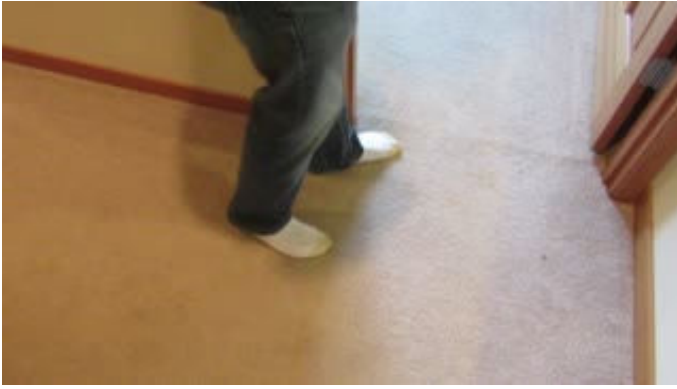
(I-1) Repair: Squeaky sub-floor was noted - see 2nd floor around the hallway. This happens when inadequate adhesive was used to secure the sub-floor to the floor frame. Screws can be used to secure loose sub-floor if the framing lay-out can be found. Finding the lay-out can be difficult if the ceiling below is finished. Often this involves removing the carpet to find the lay out and screw / secure the loose sub-floor. This is a cosmetic defect that should be repaired as desired. The best time to repair this is when replacing the current finish floor.

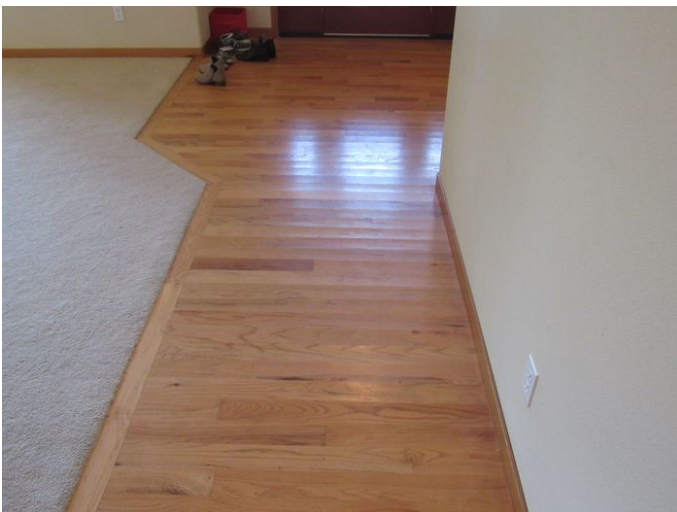
(I-2) Due Diligence: Cupping hardwood floors were noted on the main floor. This could be difficult to repair cosmetically without re-finishing all the floors. Consult with a hardwood flooring specialist to further evaluate and repair as desired. At the moment this appears to be a cosmetic defect. This can be caused by many different conditions, a common problem is not letting the floors adjust to the house long enough before installing.

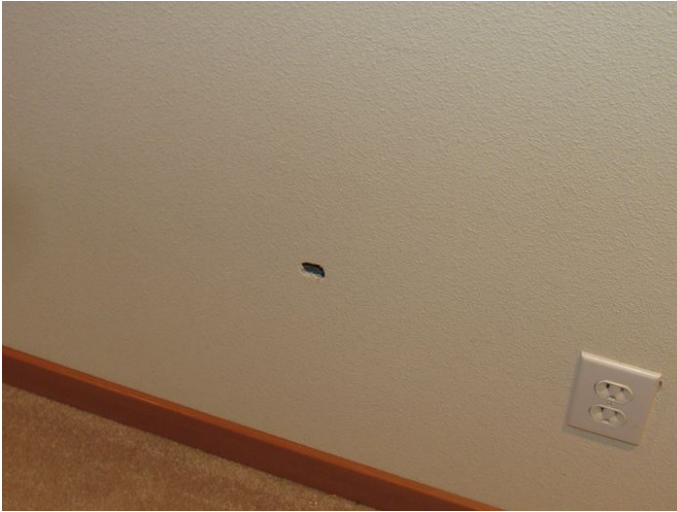
🔧 (I-3) Repair: The drywall / sheetrock finishes require some tune-up repair: See localized cracking, nail pops and minor cracks. A few 45 degree cracks at door frames inside some minor settlement. Much of the repair work looks cosmetic: see nail pops, opening tape seams and a hole in the wall - 2nd floor hallway. Repair sheetrock cracks and damage as needed.

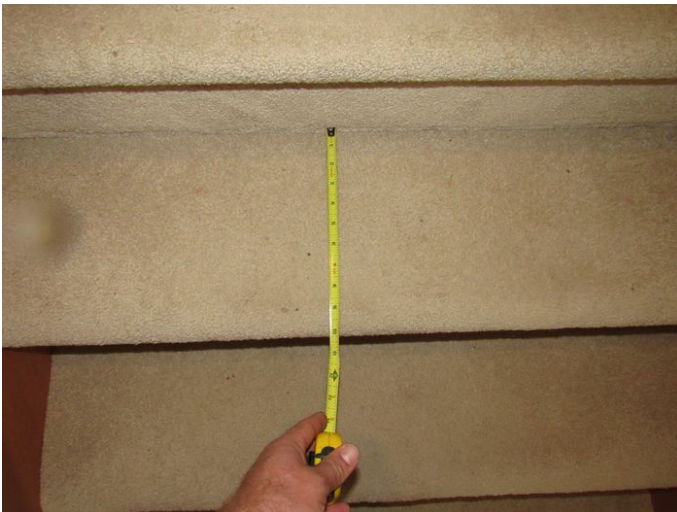
(I-4) Repair: The stairs to the 2nd floor are non-conforming stairs. This will not be cost effective to correct. Use caution when navigating these steep stairs. Odd that the stair treads are only 10-inches.

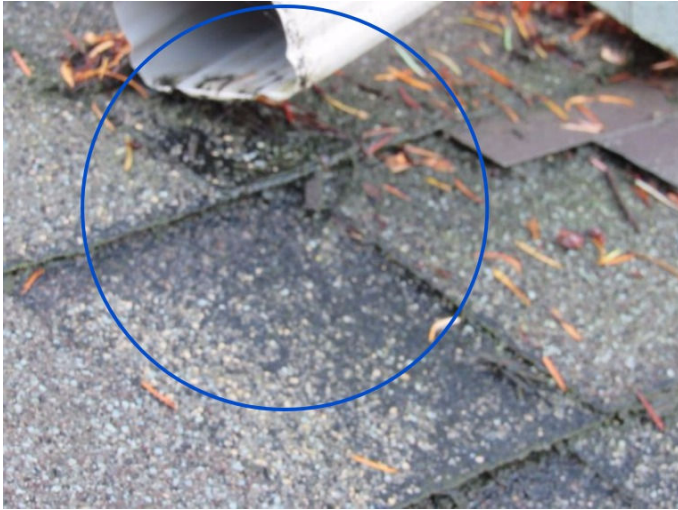
An improvement would be extending upper downspouts to drain directly into lower gutters to spare wear on the roof.

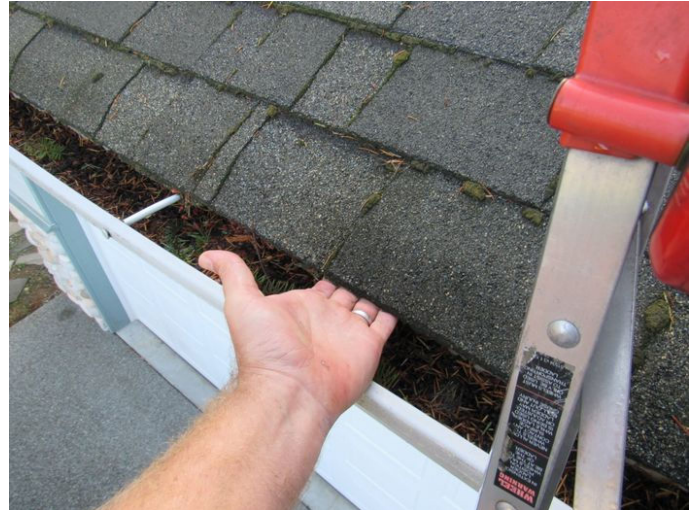
This roof installation predates the requirements for drip edge flashing - not worth repairing at this time.

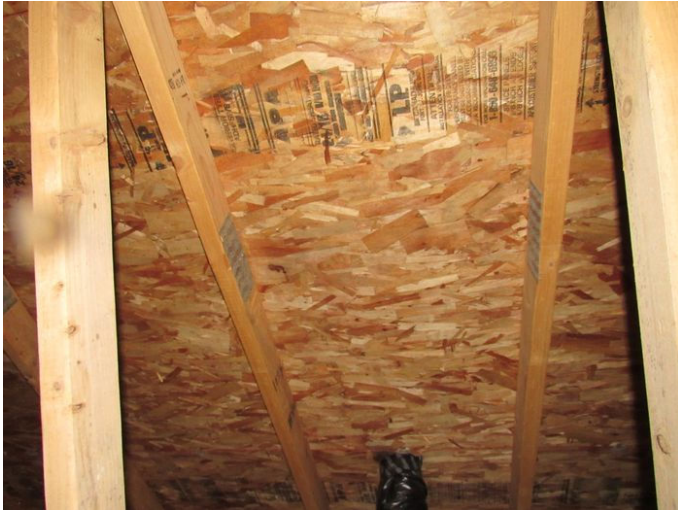
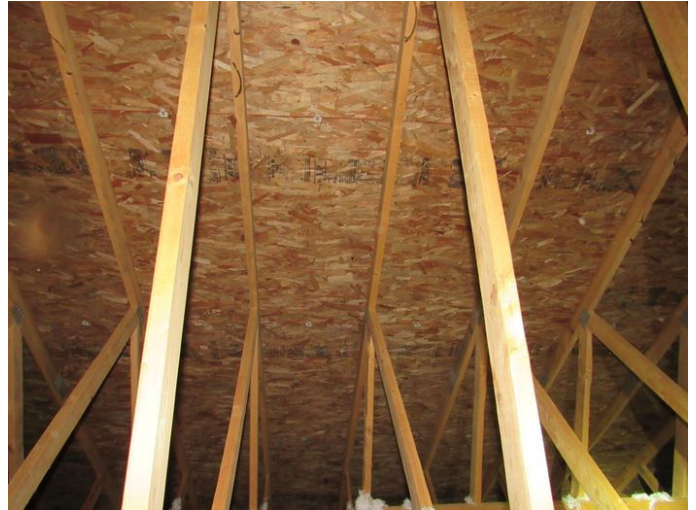
📌 **(RA-3) Note:** I inspected the attic space today and no red flags were noted regarding prior moisture build-up or relative humidity. Venting appeared unrestricted where visible. Wood has a nice bright color indicating no prior moisture problems with relative humidity or heat migration into the attic.

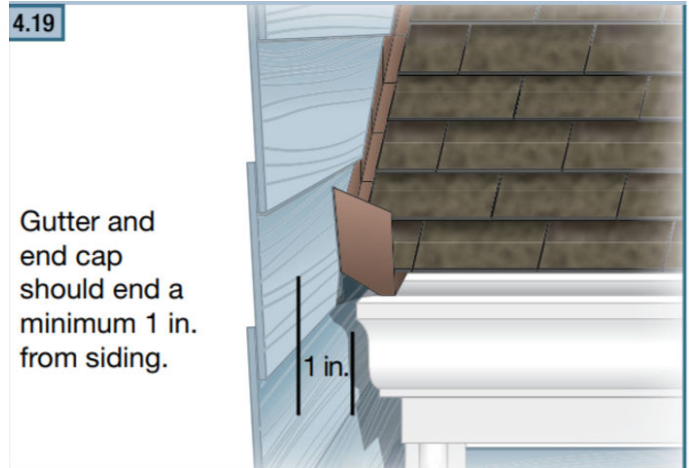
🔑 ⚠️ (EG-1) Repair: The gutters have been installed closer than 1 inch to the siding. The manufacturer of this siding recommends a 1 inch gap between the gutter and the siding. The current installation does not comply with recommended manufacturers installation requirements. Repair as needed to comply with installation requirements.

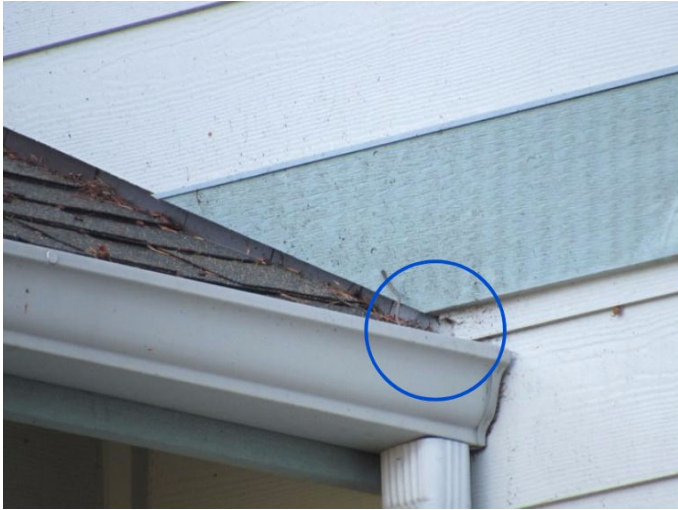
🔑 ⚠️ (EG-2) Repair: Inadequate kick-out flashings were noted between the roof and wall junctures. These are important to divert water away from the siding and onto the roof to prevent water from running behind the siding. Hire a qualified contractor familiar with siding installation to further evaluate and repair.

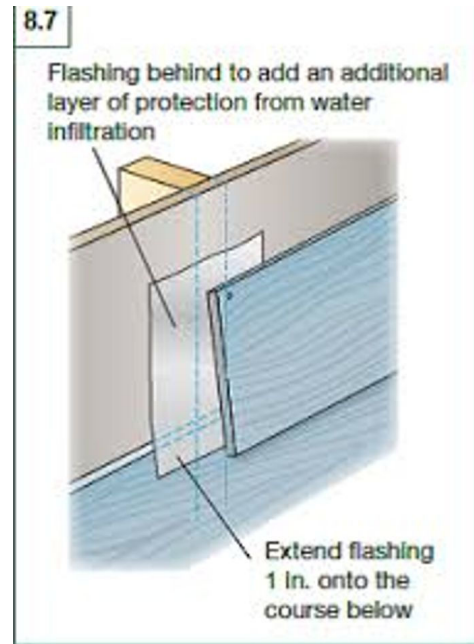
Missing back flashings at butt joints - these flashings can be retrofit on exposed sides of the building with metal flashing tabs or maintained with caulking.

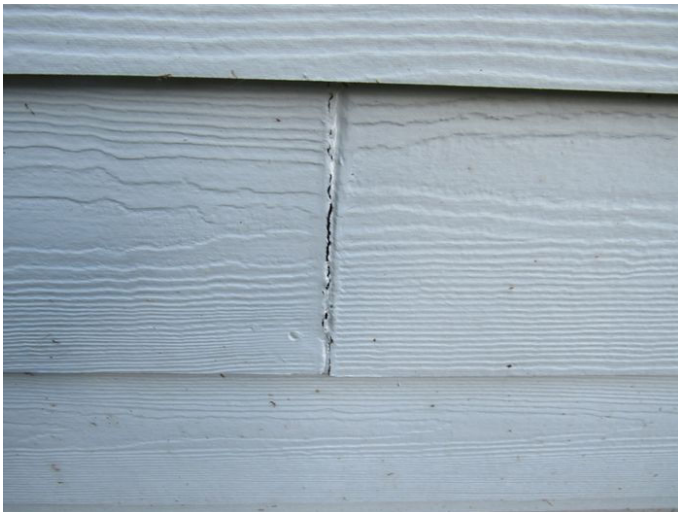
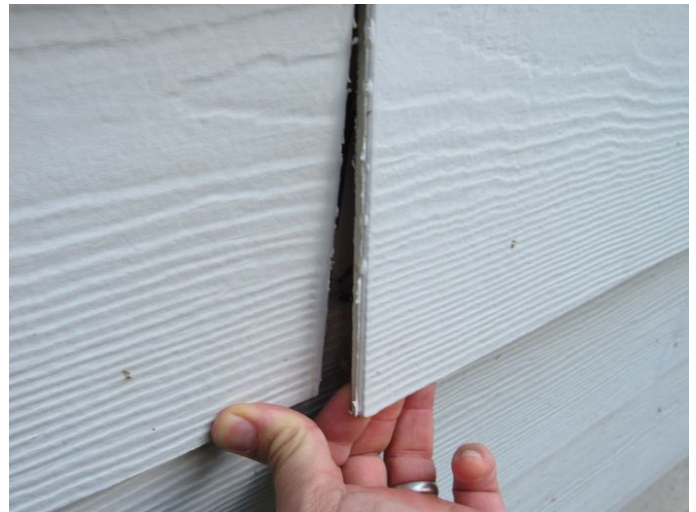
This shows a proper back-flashing detail at the butt joints

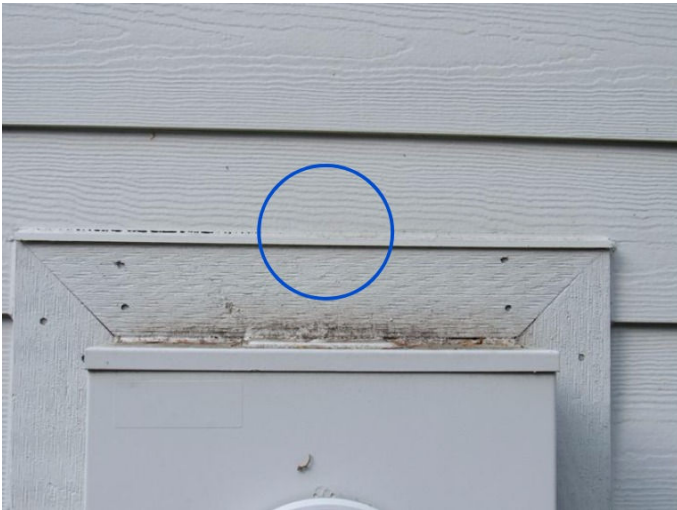
Siding run right to the horizontal flashing and sealed. This is not recommended but difficult to fix at this point.

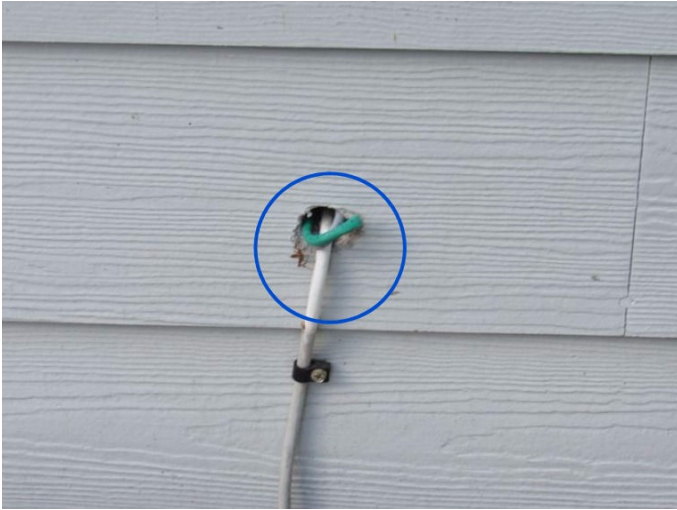
The hole in the siding at the north side should be sealed

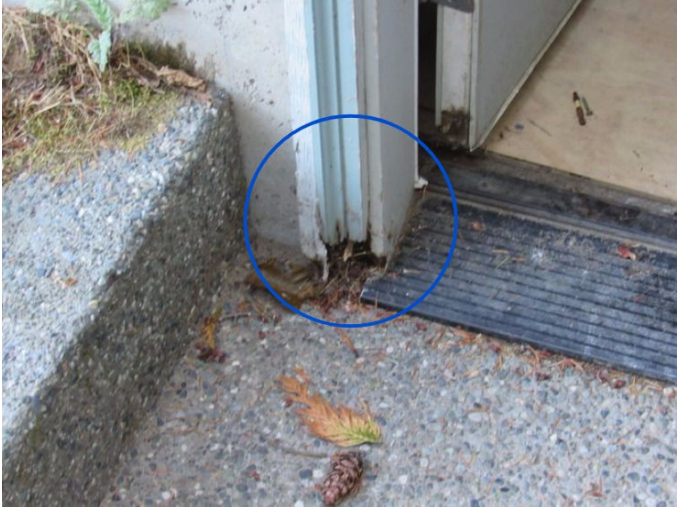
⚙️ (EG-4) Repair: The wooden door jamb material is rotting at its base near the threshold - see south crawl space access door. This condition risks hidden water damage to the floor and framing around the door. Repair / replace damaged wood as needed.

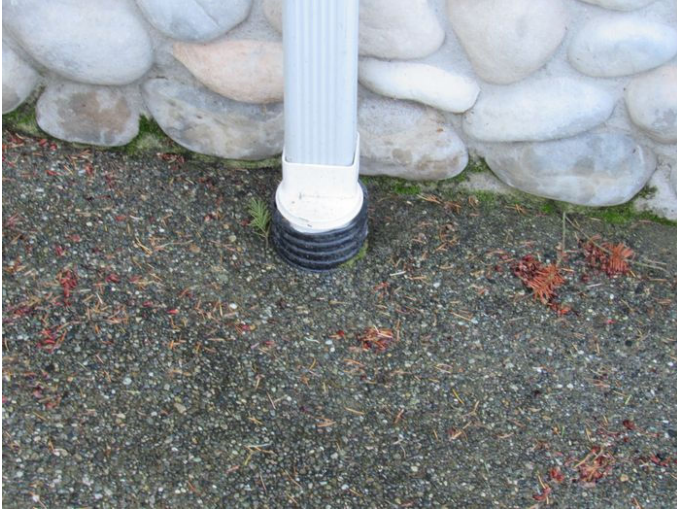
👁️ (G-1) Monitor: Corrugated storm drain pipe appears to be used for at least some of the sub-surface storm drains. This product is prone to failure as it is susceptible to crushing and clogging. Monitor these drains after heavy rains and keep your gutters clean to prolong the service life of this pipe. Clogged and overflowing pipes would indicate a need for replacement.

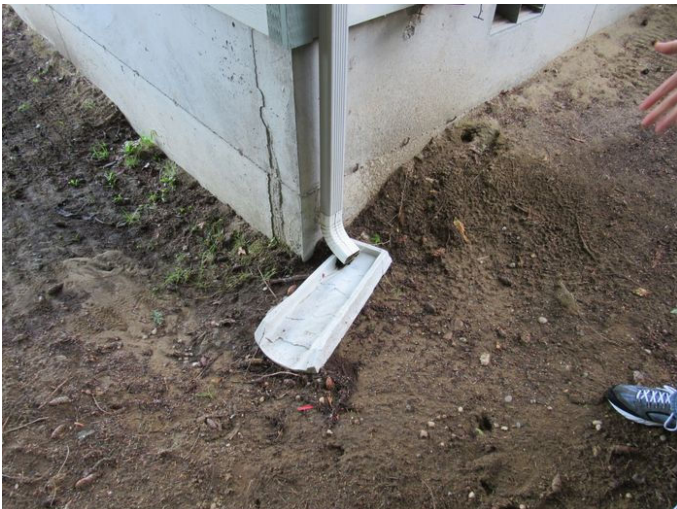
🔧 (G-2) Repair: Downspouts are discharging adjacent to the foundation - see south side of house. This can cause foundation settlement or basement / crawl space moisture problems. Make sure all downspouts discharge into a proper tight-line system that diverts water at least 5 feet away from the foundation.
