This report is prepared exclusively for **John Doe**  
Inspected On: **12-17-2021**

## 2022 Tiffin Allegro Red 37PA

**Inspected By:**

Wayne Kosters

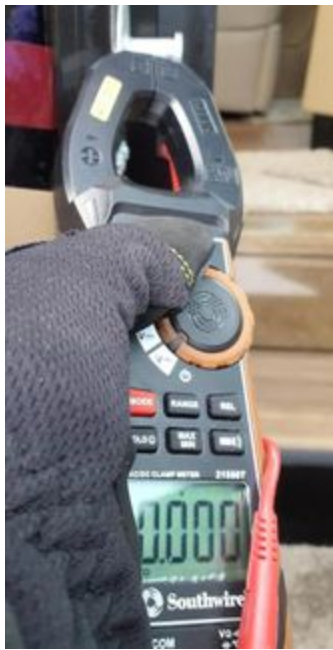
No unsafe voltage over five volts was recorded.

*No Excessive Voltage at  
Entrance Door*
