## 4-Point Inspection Form

Address Inspected: \_\_\_\_\_

Fair Winds Building Inspection Services

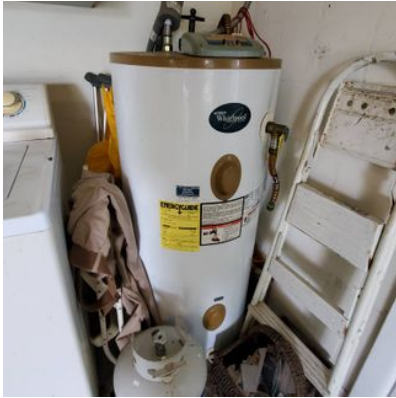
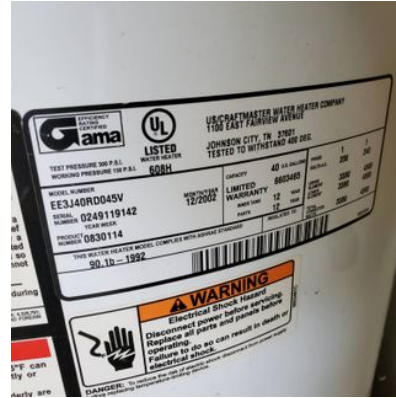
### Plumbing - Water Heater

- The inspection was limited due to the presence of household goods through the house.
- The inspection in the attic was limited due to restricted access and obstructed views. Insulation and ducts blocked the view of wood members and made it unsafe to traverse the attic floor. Very low pitched near the edges of the roof. A visual inspection was performed from point of access.
- Age of water heater: 22 yrs (manufactured in 2002)
