Inspection report for the property at  
1000 Sample Road, Seattle, WA

This report is prepared exclusively for **Sample Report**  
Inspected On: **05-23-2025**

Super Neato Inspections  
206.351.4100

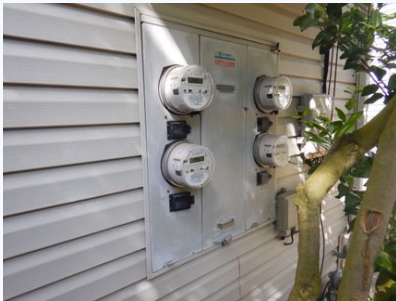
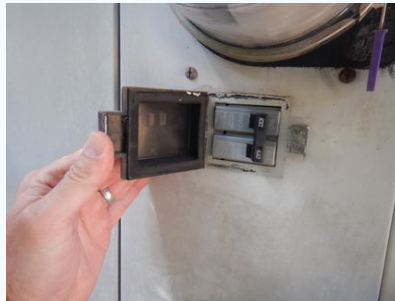
**(ES-1) Due Diligence:** Meters were not labeled. Inquire with Seattle City Light which meter is associated with the home.

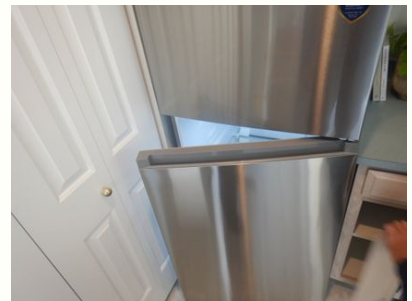
### (K-1) Note:

Refrigerator doors open in a reverse direction. This is not typical and can be awkward to remove items from the refrigerator.

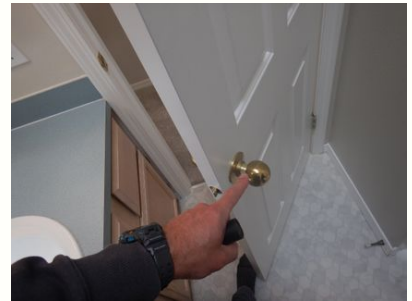
📌 **(HB-1) Note:**

Hallway bathroom does not have a privacy lock.
