**Orca Inspection Services LLC**

# Inspection report for the property at 76423 Football Road USA

This report is prepared exclusively for **Russell Wilson** On: **2018-10-01**

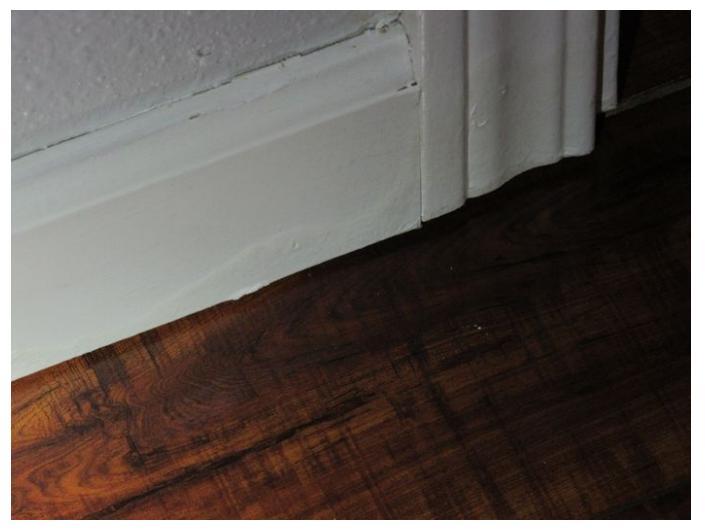
**(SB-2)** Due Diligence: A few water stains were noted in the basement . The basement was dry at the time of inspection. Inquire with the seller for any information regarding prior leaks or drainage issues. I tested these areas with a moisture meter during inspection - no elevated readings were found.

Water stain on the baseboard near the bedroom.

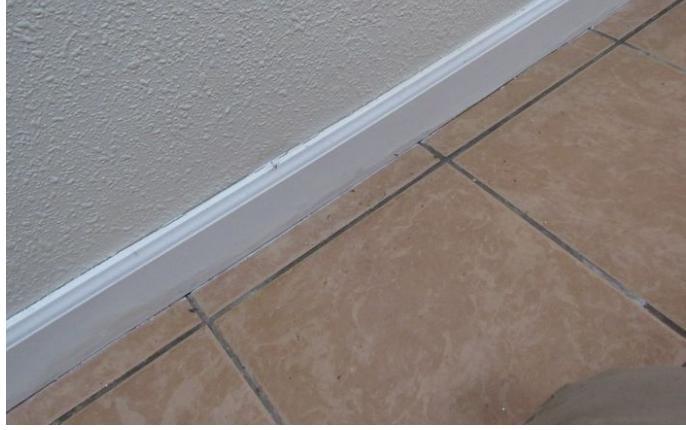
Water stains on the baseboard - laundry room

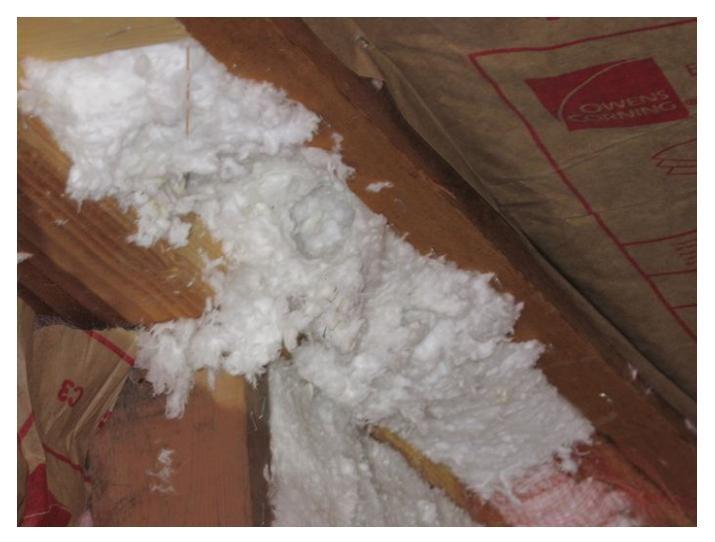
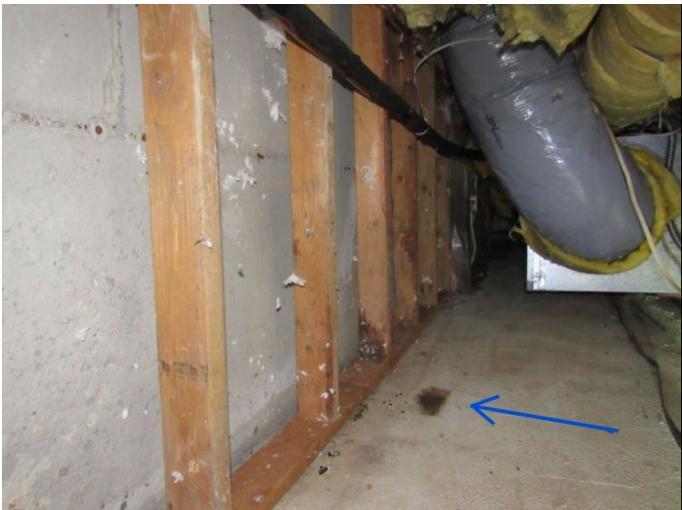
(PWDO-1) Major Concern: Extensive rodent contamination was noted in the crawl space below the house and in the attic above the house. Hire a rodent control specialist to eliminate and seal all openings and set and monitor traps. Once all rodents have been sealed out all contaminated insulation and construction materials should be remediated. On-going baiting and trapping as well as control of vegetation and elimination of food sources on the exterior of the home are often needed to prevent rodent problems / infestations. Keeping all trees pruned 6 feet off the house is recommended.

Signs of past dead rodents in the basement

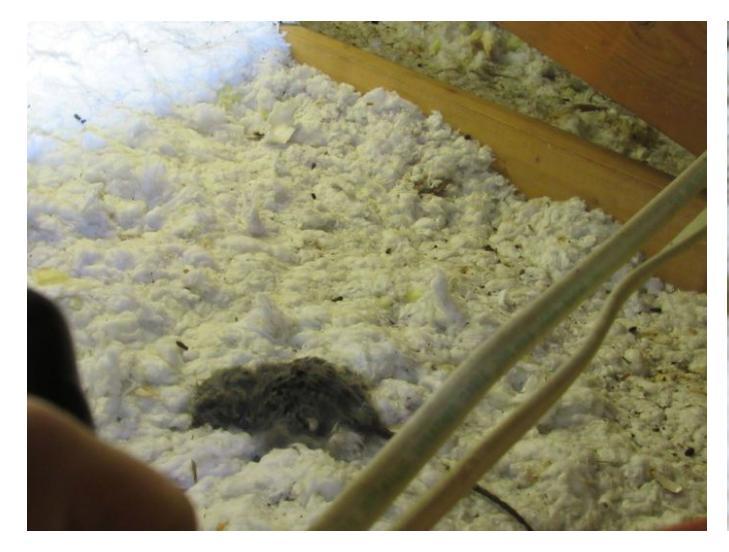
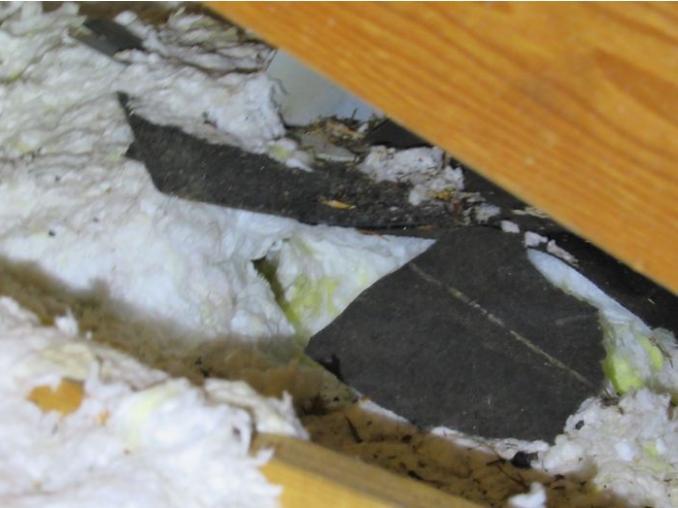
Dead rodent by access point in shop

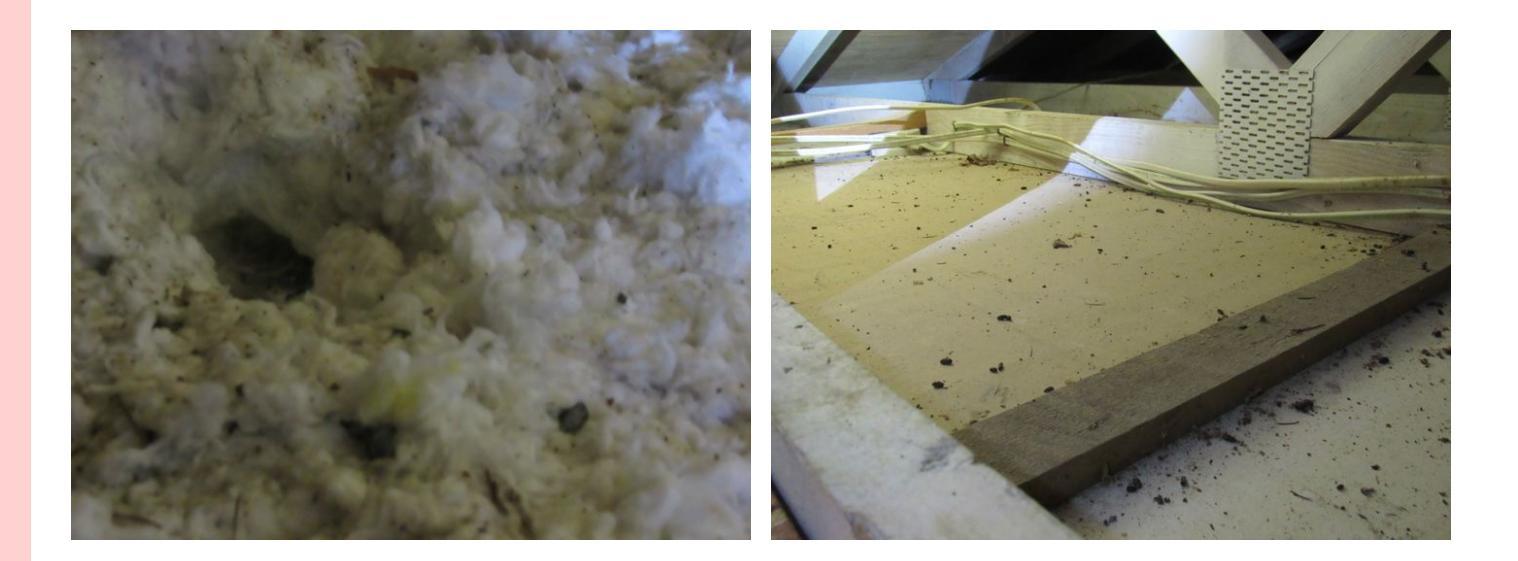
More burrowing holes

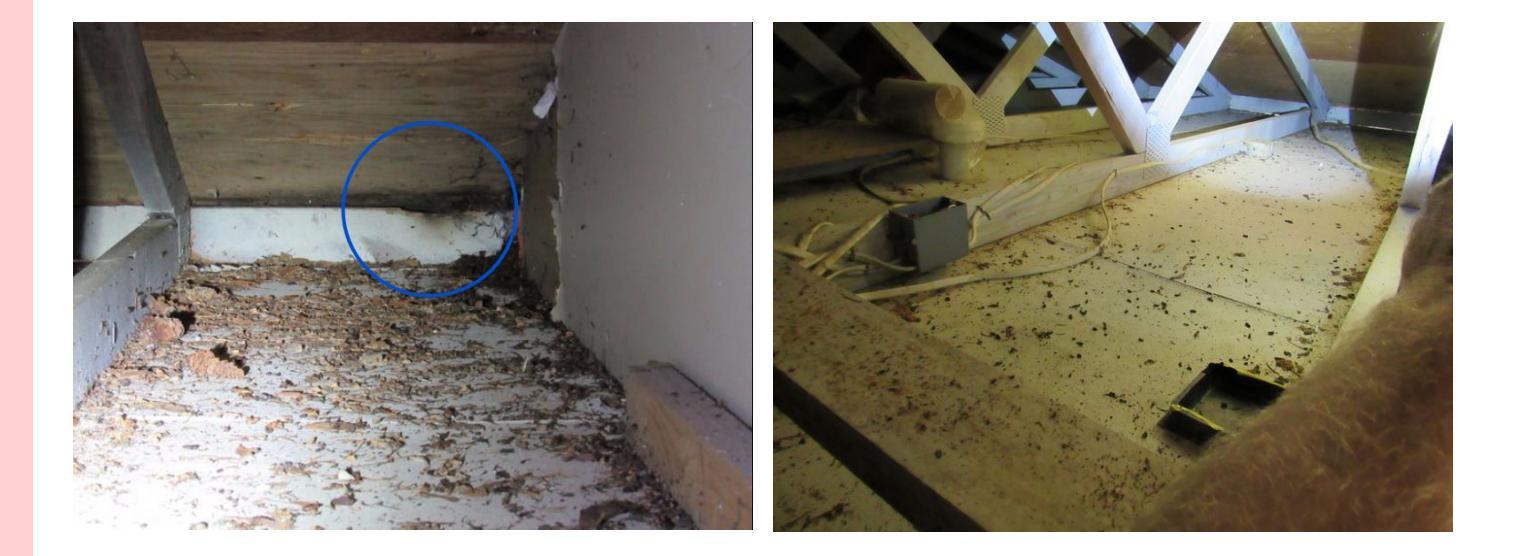
Debris from rodents and possible entry point Rodent feces above studio here at the studio

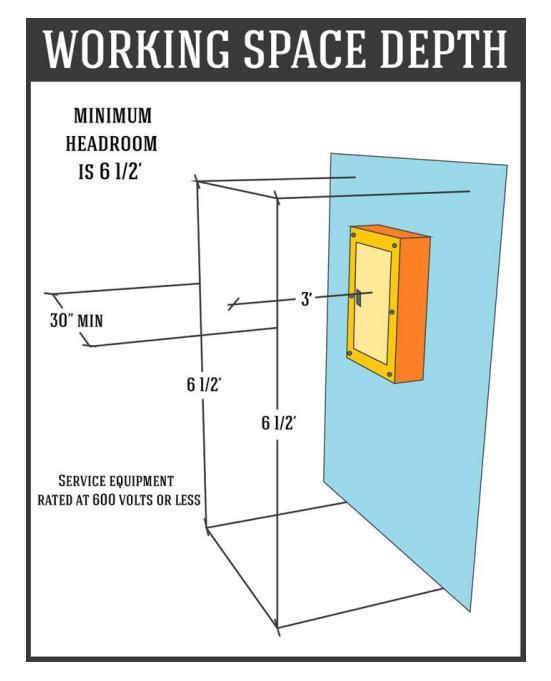
**(E-2) Repair:** An inadequate working clearance was noted for the electric load center. A 30 inch wide and 36 inch deep unobstructed working clearance is recommended for improved safety. Consult with a licensed electrician or general contractor to further evaluate this condition and relocate the panel or improve access as needed. You should be able to just remove the shelving here.

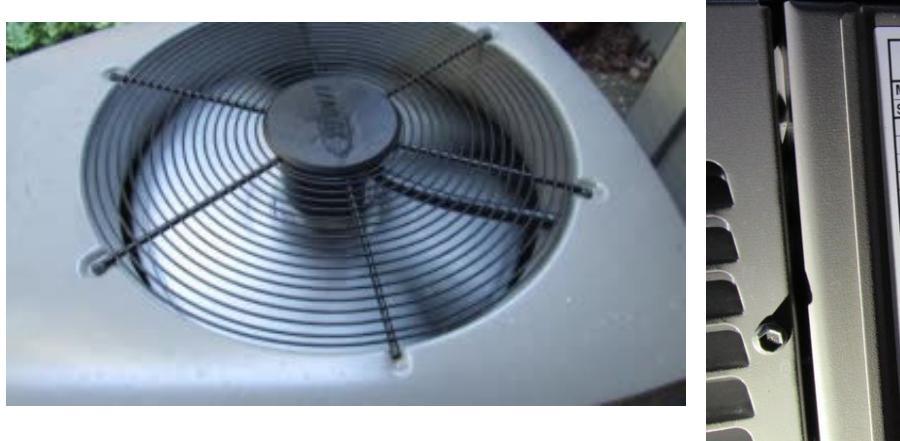
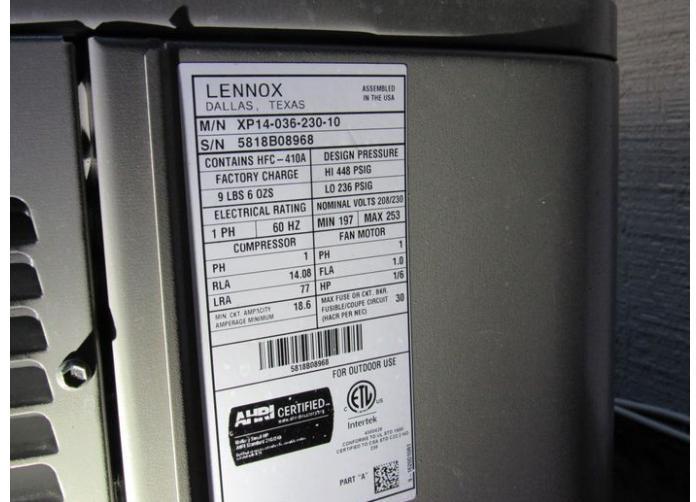
**(HCF-1) Repair:** The furnace filter cover is sealed shut. This should be repaired to access and change the filter - the filter should be changed quarterly.

**(HCF-2) Repair:** Annual servicing is recommended for all heating and cooling equipment to ensure reliable performance. This house has an air-sourced heat pump system. The system was tested in heating mode during inspection and was operational. No recent service records were noted on the air handler, but this is a very new heat pump. I recommend keeping this

heat pump on an annual service schedule. *I would go ahead and service it now as the air filter needs to be repaired.*

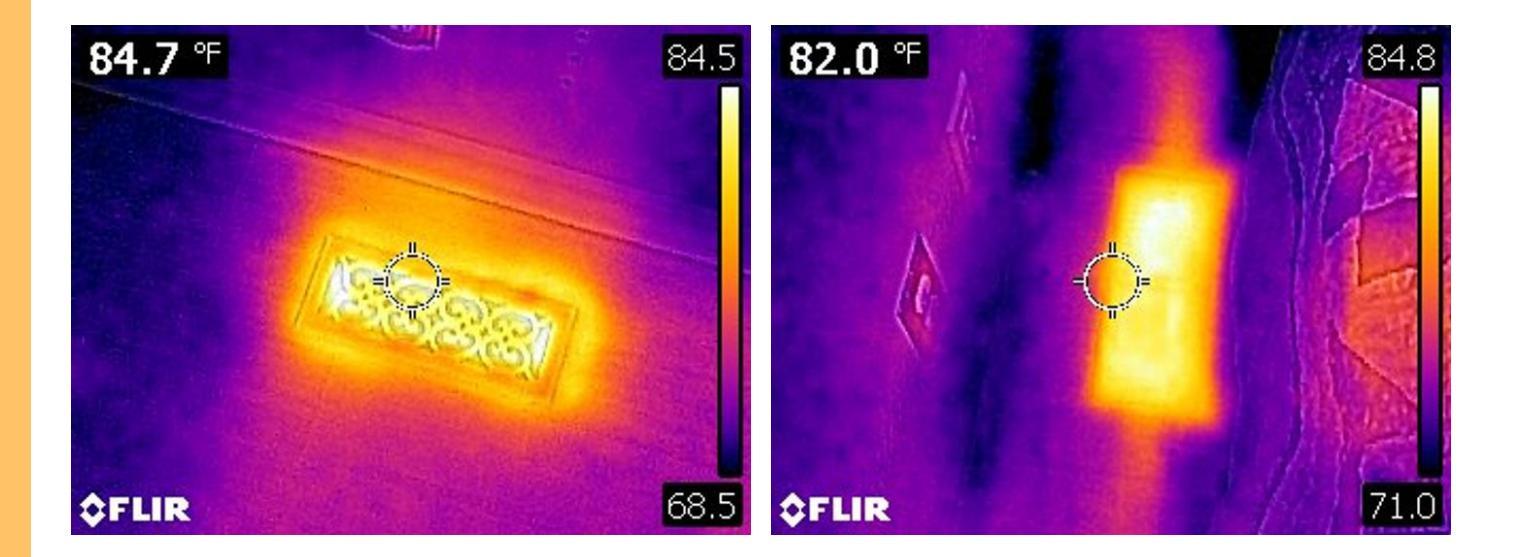
Thermal images show ducts warm during testing in heating mode.

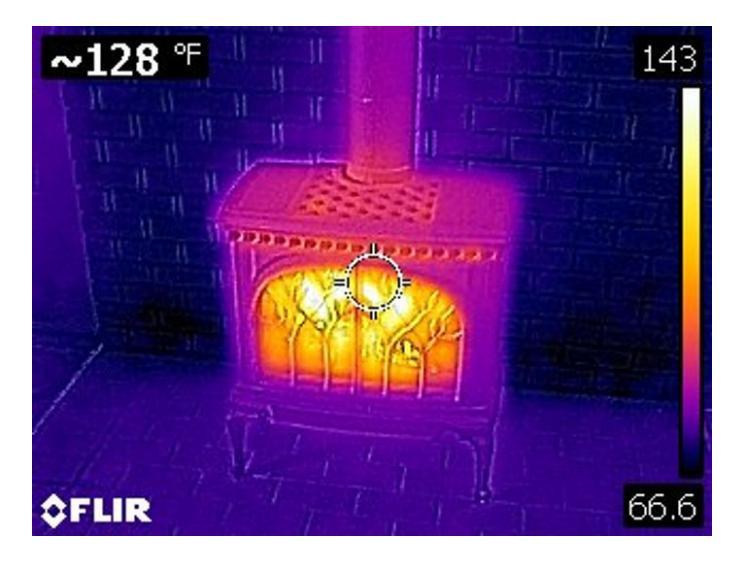
**(HCF-3) Note:** I tested the LP wood stove today. It was performing as intended.

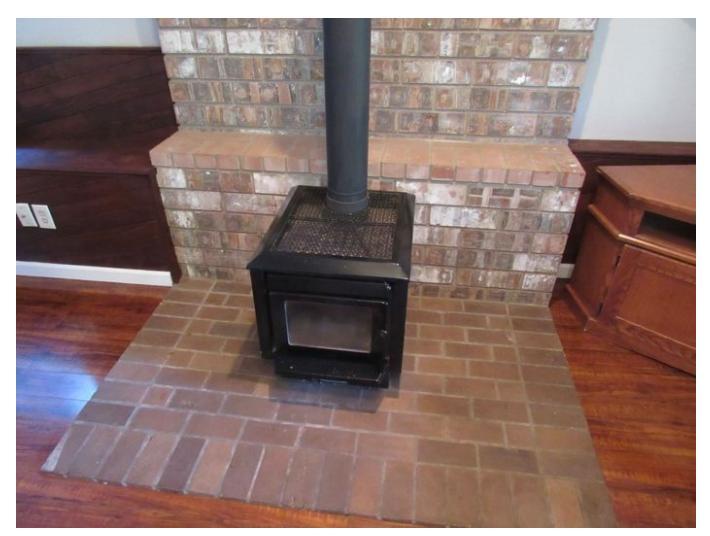
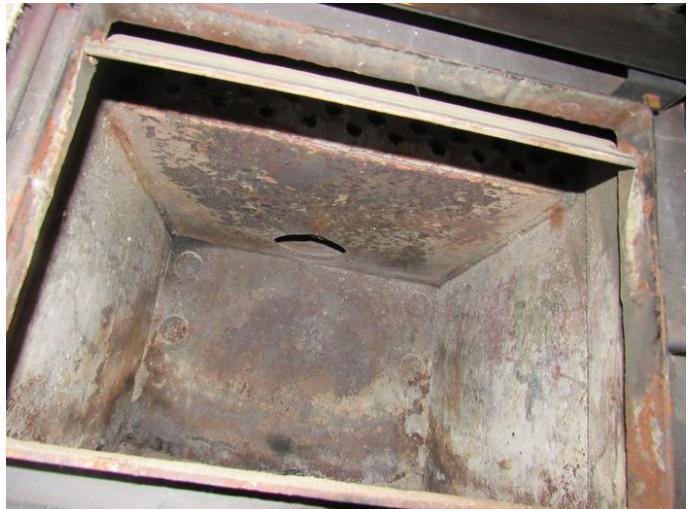
**(HCF-4) Repair:** This home has an old un-listed wood stove. Since Jan. 1, 1992, all used solid fuel burning appliances in Washington State, such as wood stoves, offered for sale must be a listed appliance. An unlisted, used wood stove may not be reinstalled in a home in Washington. As this unit was already present in the home it should be considered grandfathered, however, old wood stoves such as this are generally less safe and emit higher pollution and they can impact home owners' insurance. If you wish to keep this unit and use it, I recommend additional inspection and evaluation by a qualified chimney sweep prior to use. Implement repairs or updates as recommended to ensure safe and reliable operation. During inspection I noted:

Corrosion inside the wood stove firebox

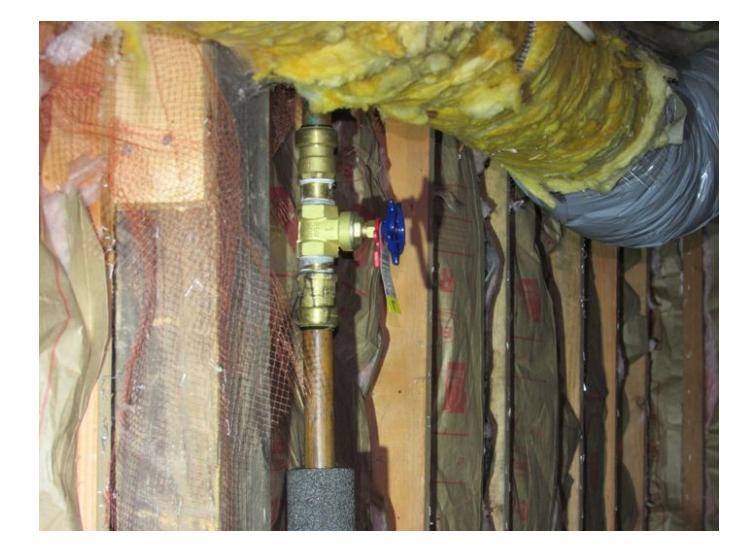
🚀 (P-1) Note: This shows the main water shut off in the crawl area.

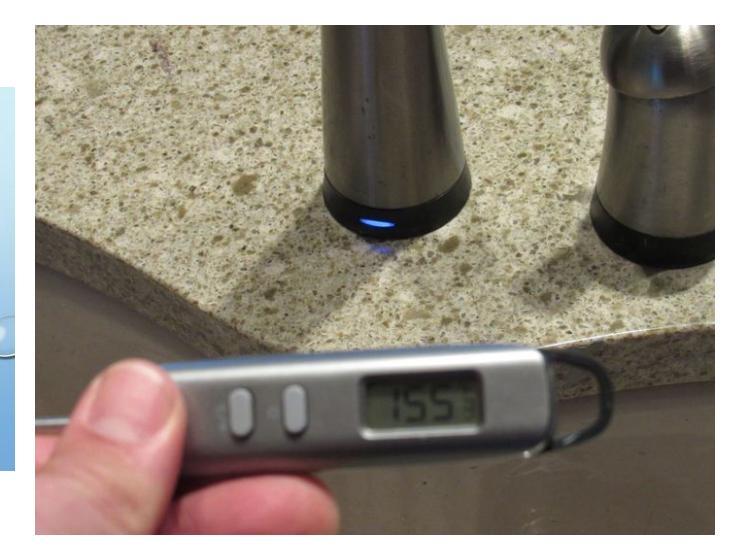
**(P-5) Repair:** *Testing of the plumbing system today, I noted the water was too hot - 155 degrees F!* This is a scald hazard. To prevent scalding, standards recommend indoor hot water temperatures do not exceed 125 degrees. There is some evidence that hot water temperatures should be greater than 130 degrees to prevent Legionaries' disease from developing in the water heater. If this is a concern, you can heat the water in the tank to 140 degrees F and have a tempering valve installed at the hot water tank. Have this further evaluated and repaired by a licensed plumber or simply turn down the temperature as desired to eliminate a scald hazard.

The thermostat covers were off at the time of inspection - this is a safety hazard

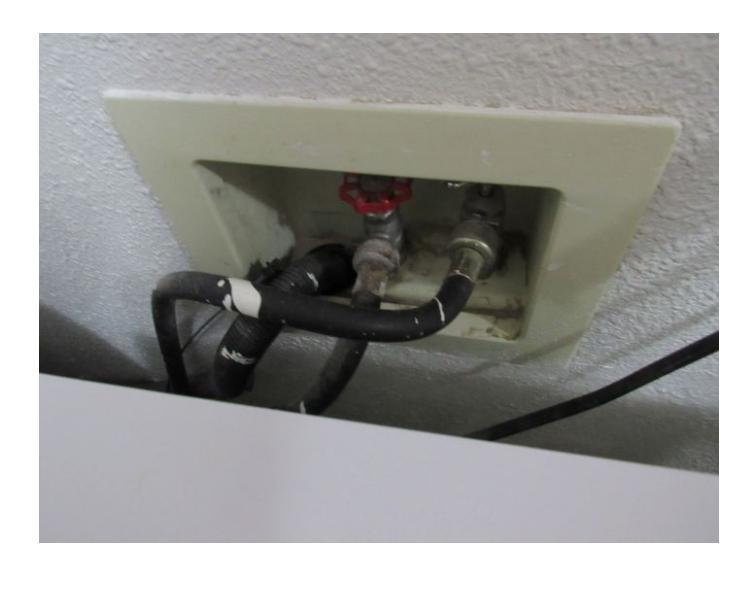
**(P-8) Improve:** A moisture alarm with water shut-off features is recommended under the washing machine to protect against accidental leaks in the supply hoses. Pans can be effective when there is a drain, but even these will not protect against a burst supply connector. A moisture alarm with automatic shut-off will. Watts is a brand I have seen installed: <u>http://www.watts.com/pages/learnAbout/intelliflow.asp?catId</u>

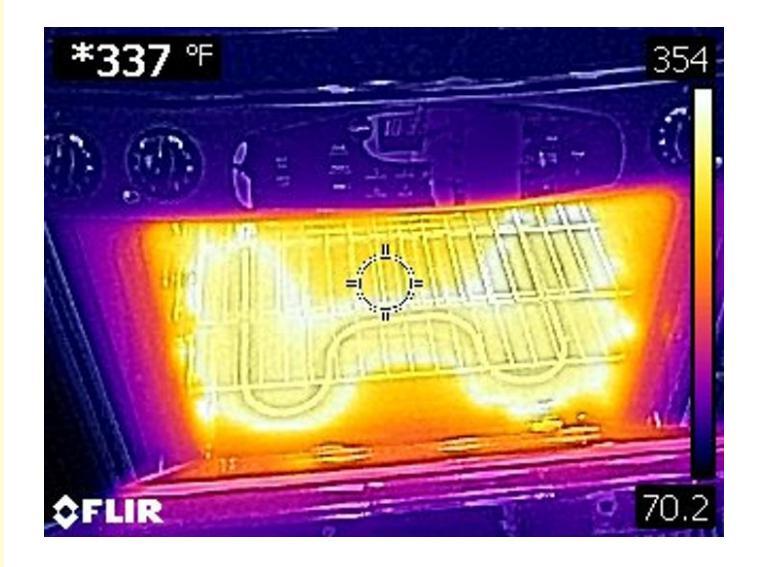
**%** (K-2) Note: The oven was tested in bake mode and was working at the time of inspection.

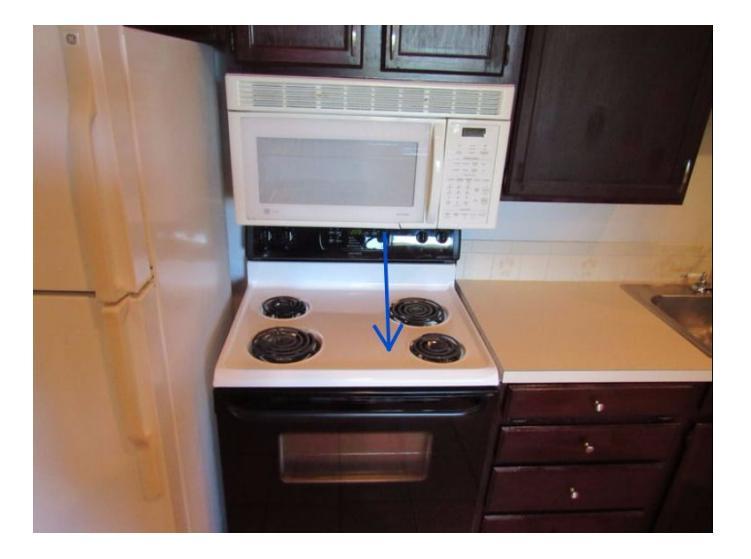
**(KL-2) Repair:** The microwave is installed close to the cooktop. Generally, a 24 inch clearance is recommended, though installation to the manufacturers minimum specifications is acceptable. Be sure this installation complies with manufacturers installation specifications or re-install for proper clearance above the cooktop as needed. Please note that most

installations do meet manufacturer's specifications but can still be inconveniently close to the cooktop.

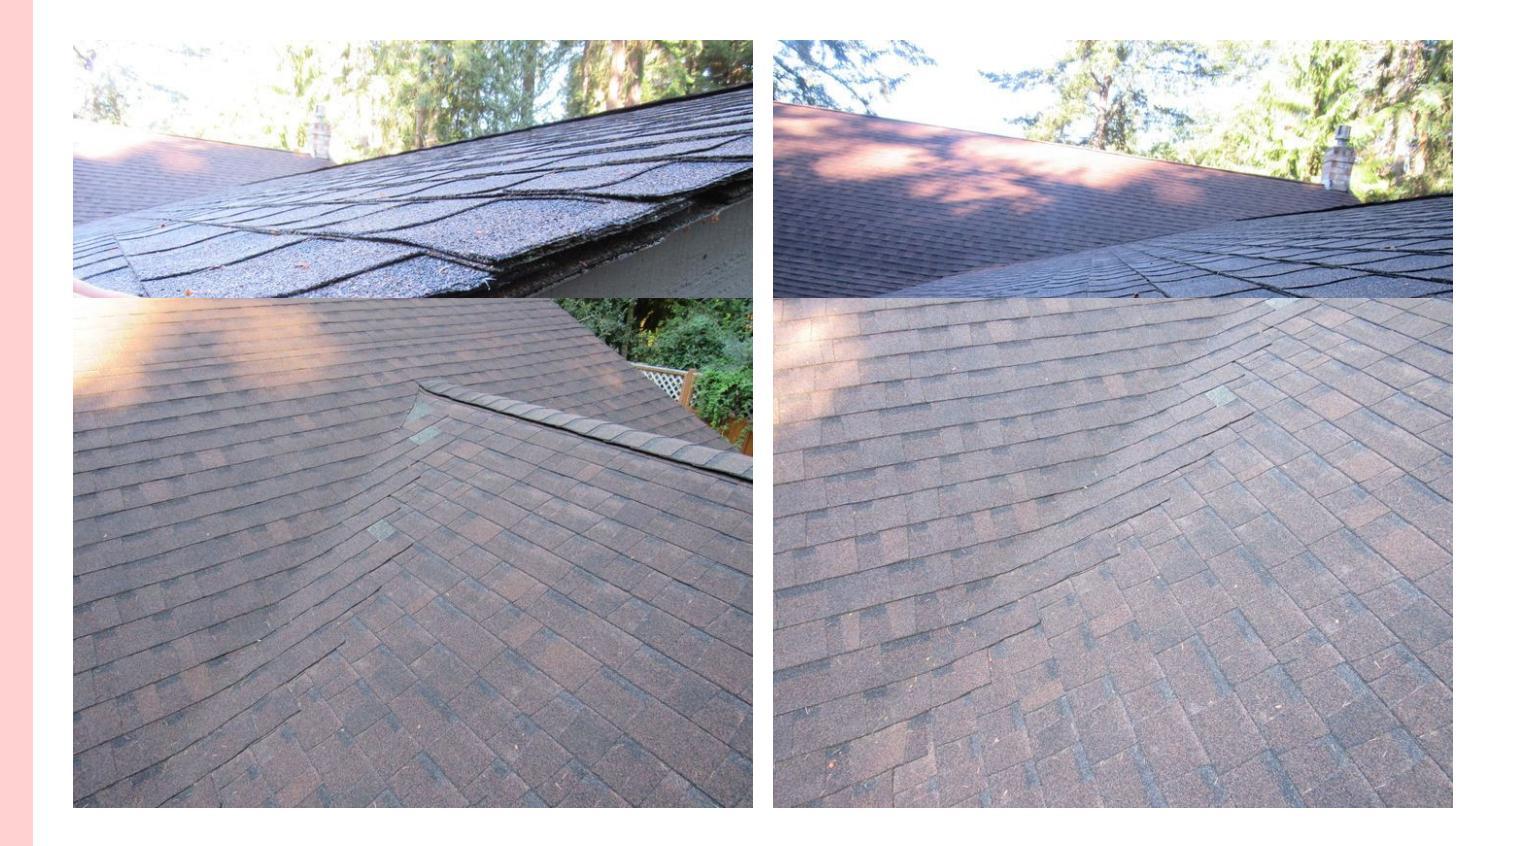
Water can easily run behind this valley.

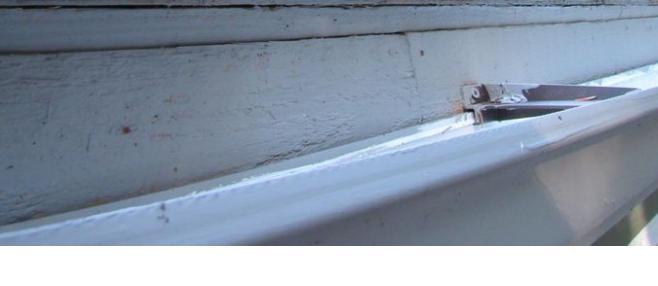
No drip edge flashing installed - these are now required

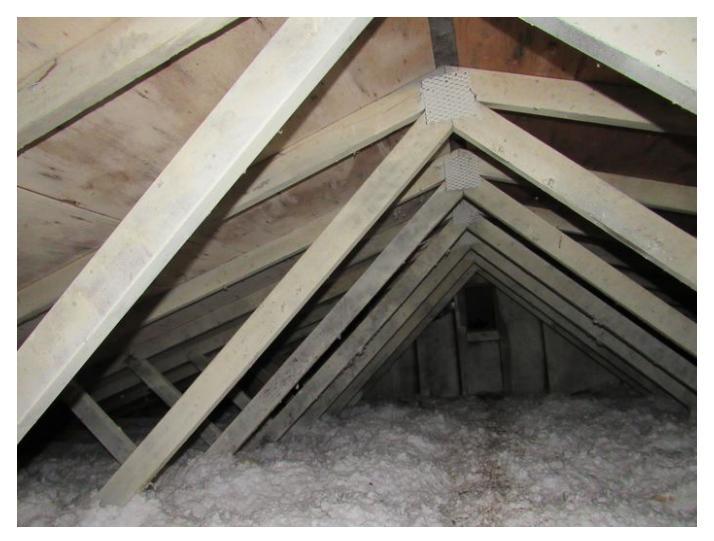
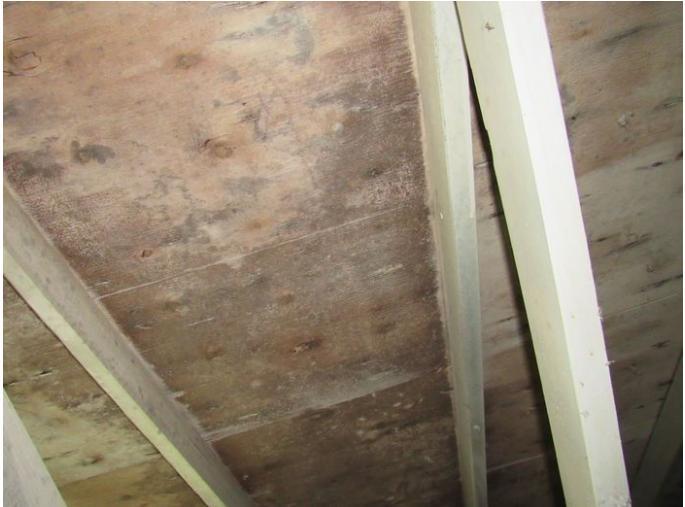
This may be a persistent problem - note the white paint on the attic framing

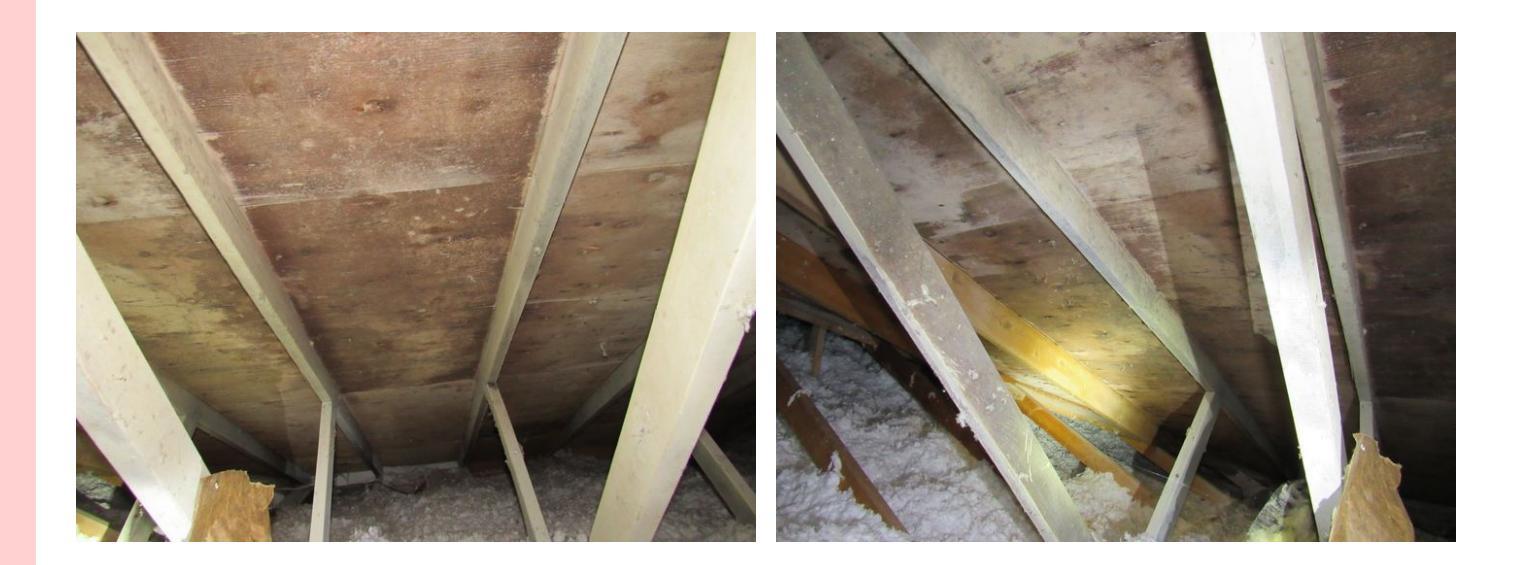
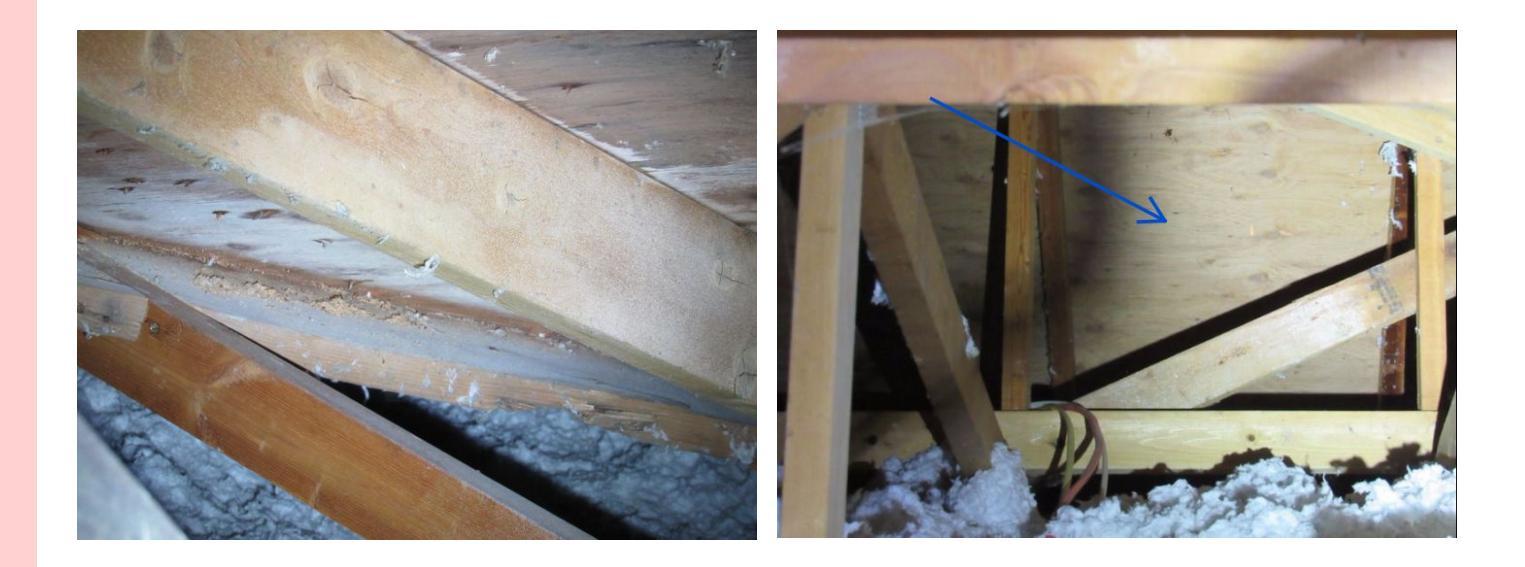
I was unable to access above the main house attic - but it looked more clear in here

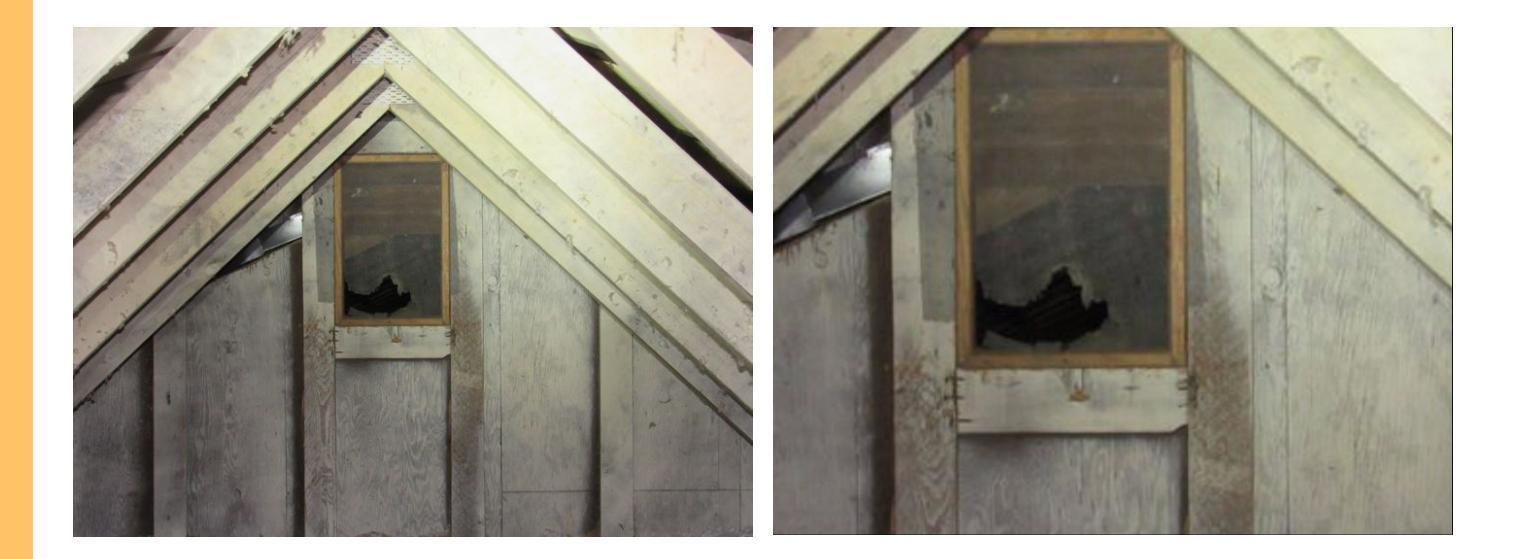
**(RA-8) Repair:** The screens that protect the gable vent openings are damaged and require repair to exclude birds and rodents and ensure proper ventilation. Use 1/4 inch wire mesh to seal-up openings from rodents and birds and make sure screens are not blocked by paint or other debris. Refrain from using tight-mesh window screen as this can obstruct air flow.

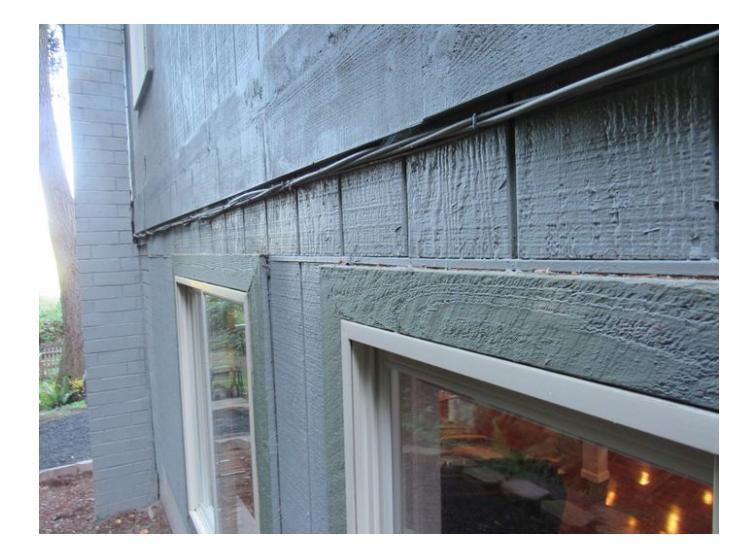
(EG-1) Monitor: The exterior trim system here has been done as a picture framed or cap over trim, where the trim is not lead into the siding but laid over the top of the siding. This is a common practice, but is <u>sub-standard</u>. All points subject to moisture entry shall be appropriately flashed. There is not a commonly accepted flashing detail for the "cap over detail" that I am aware of. The risk here is water can collect behind the trim and could leak into the siding where nails from the trim penetrate the siding. I would be most concerned about the exposed trim details. Have this further evaluated and repaired as recommended by a qualified contractor. I found nothing urgent inside the house today to indicate a repair is needed at this time.

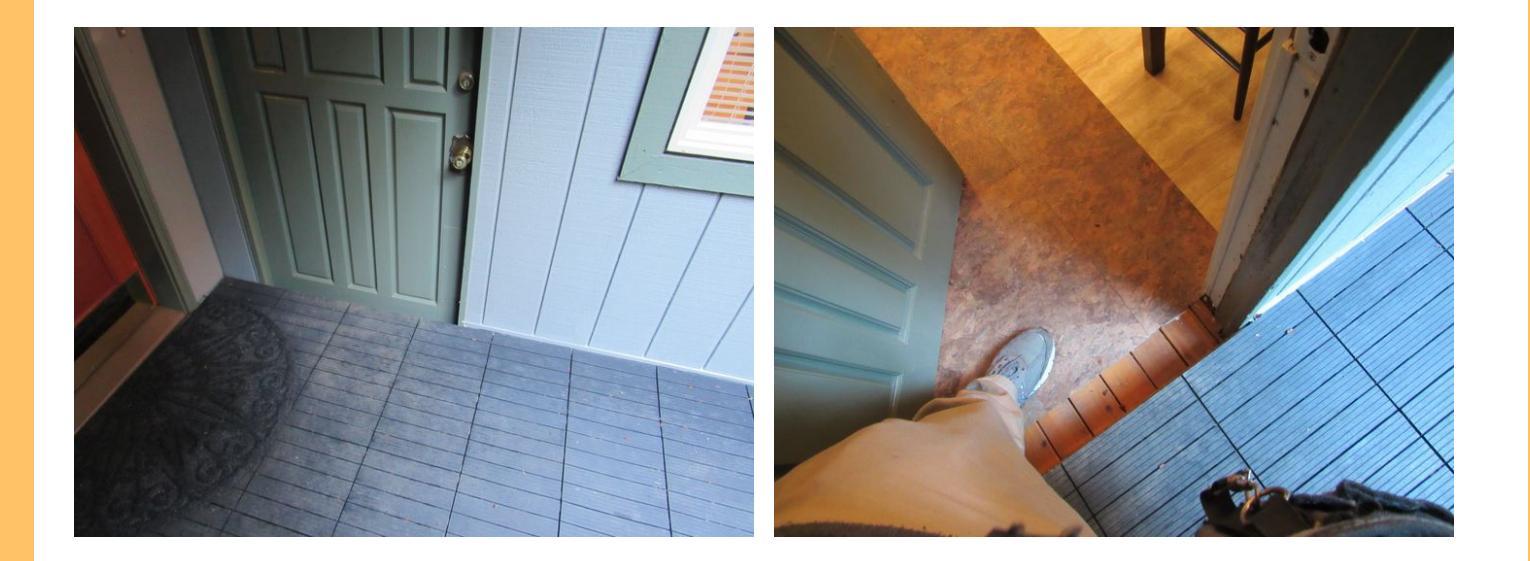
**F** (EG-2) **Repair:** The exterior door is below the deck at the entry. This is a non-standard configuration that could present a safety hazard. Have this evaluated and repaired by a qualified general contractor.

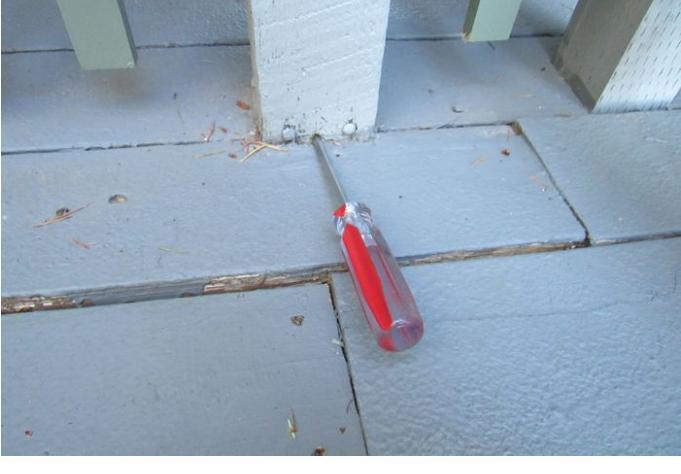
Signs of settlement at the lower deck and deck posts

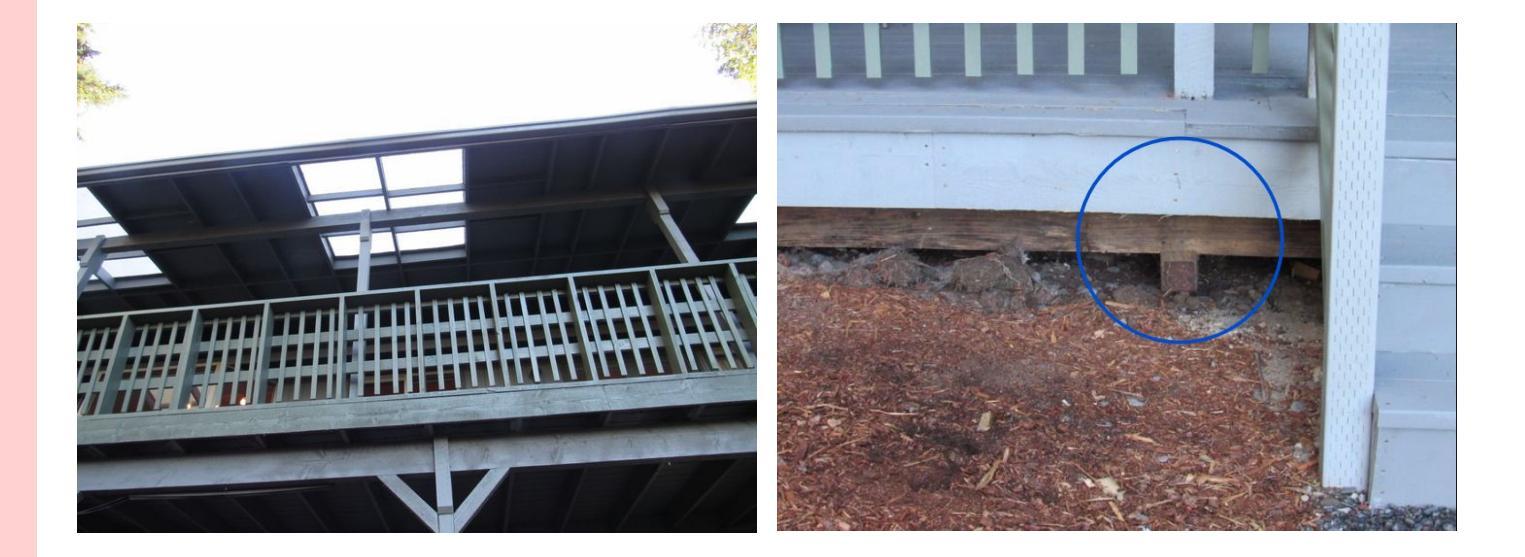
Under-sized footings and saddle for this large deck

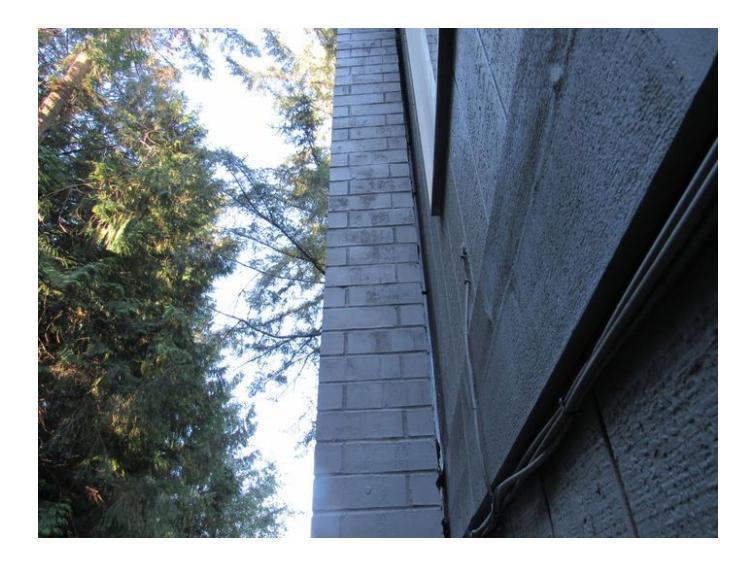
**(EG-7) Note:** It is odd the way there is a gap between the masonry chimneys and the siding. I see no signs of structural settlement with the chimneys - this seems to be just how they were done.

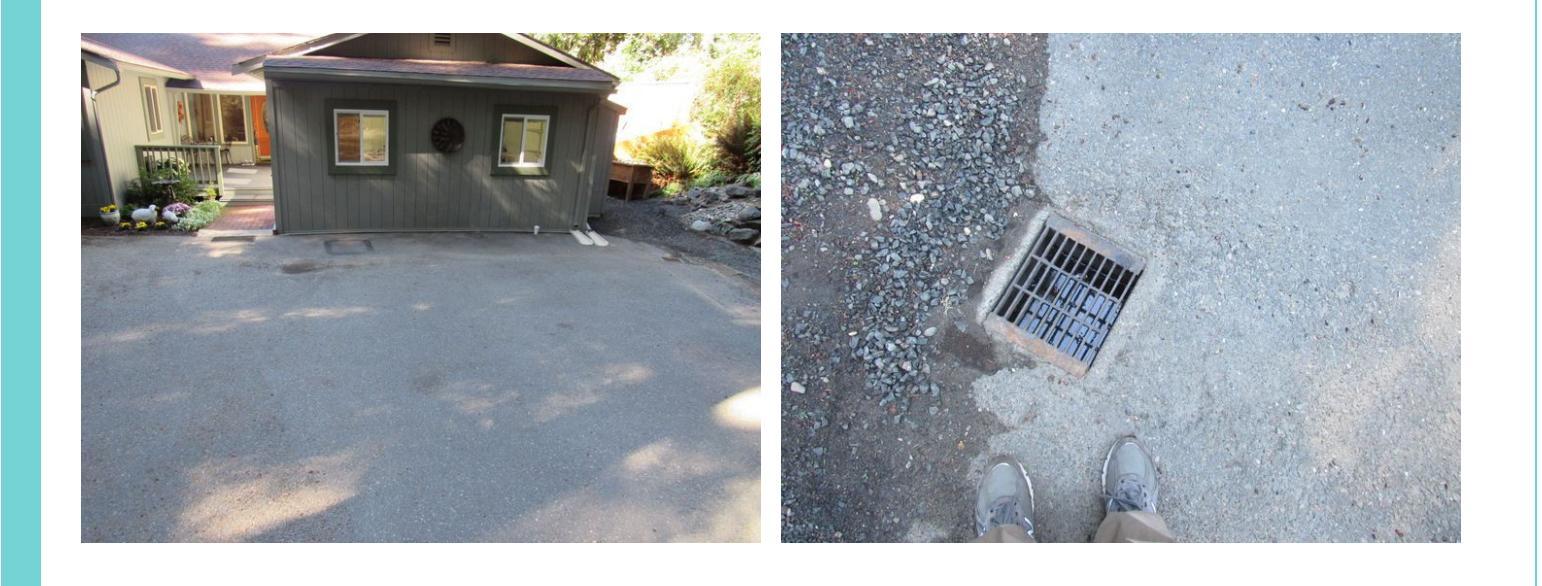
G-1) Monitor: The grade of the driveway is slopping toward the building - see entry side of the house. Standards recommend a quarter inch / foot slope away from the building or better. Be sure to keep this catch basin clear at the entry driveway - this looks important for moving water around the building.

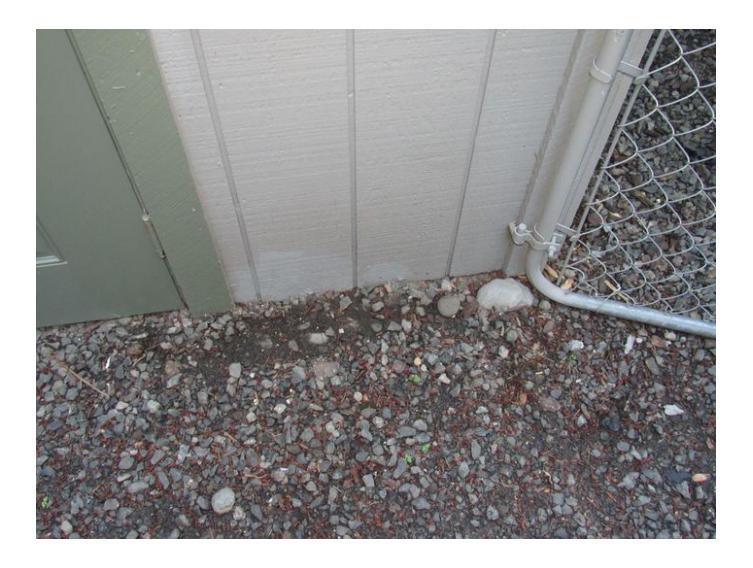
Rodent entry points noted at N storage shed

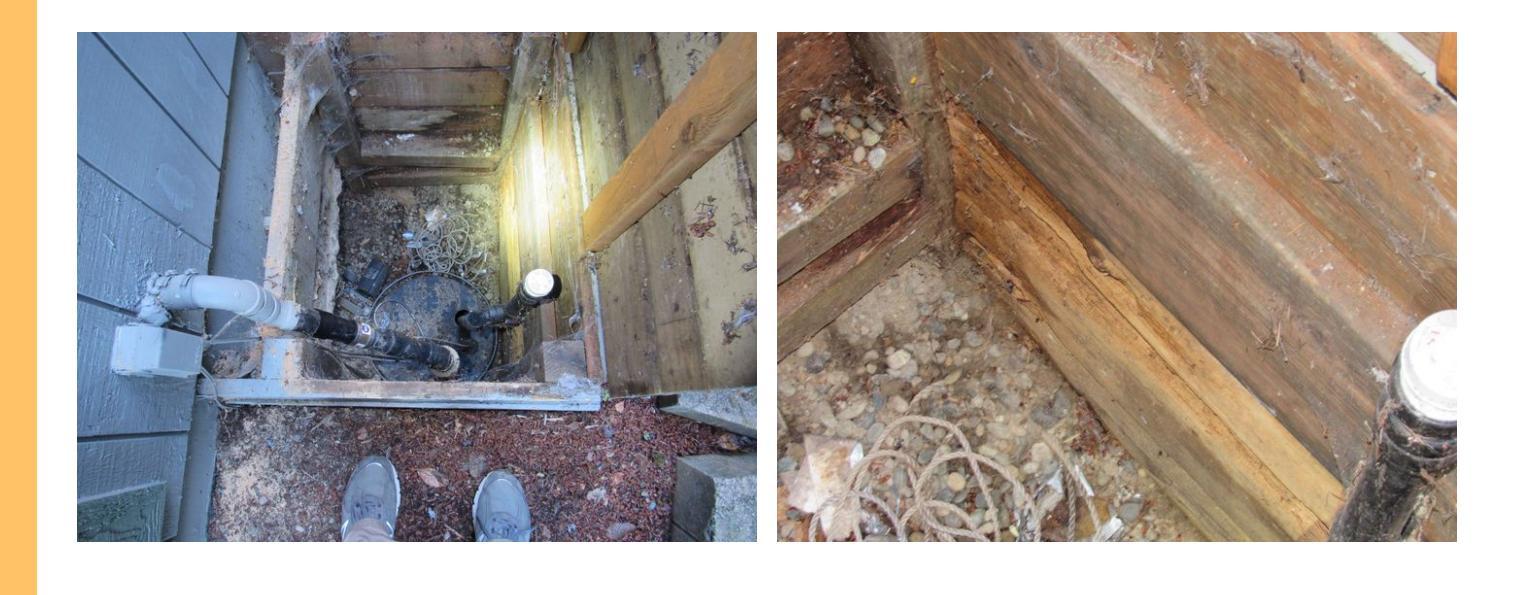
**G-3) Repair:** The wood well for the septic pump on the south side is rotting and will require replacement / repair at some point soon.

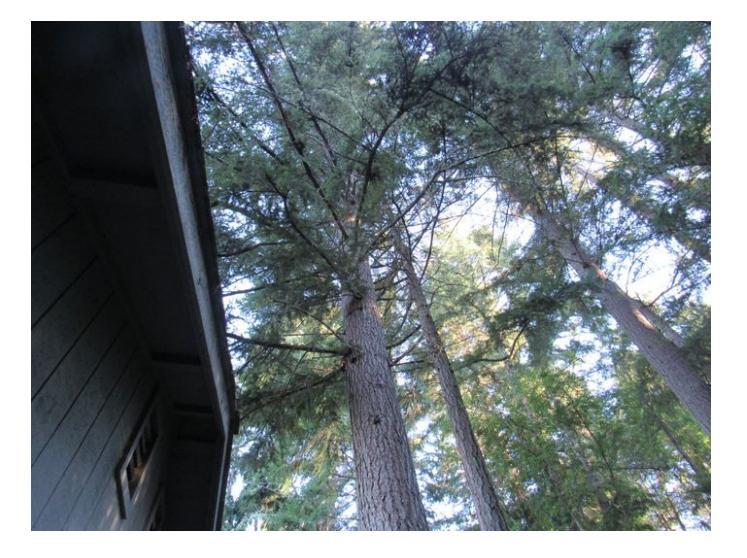
**G-4) Due Diligence:** An arborist should be hired to further evaluate the large trees on the property and prune or remove as recommended. Whenever large trees are located near a house a higher level of maintenance should be expected to keep trees safe and healthy and to eliminate the risks of damage to the home or building materials and to eliminate rodent entry points. With larger trees such as firs pruning is recommended to eliminate the sail effect and reduce strain on these tress during high winds.

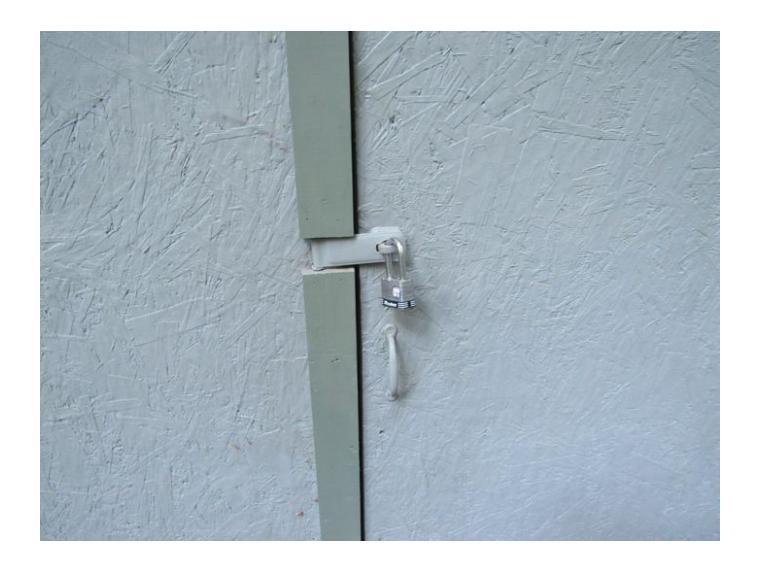
**G-6 Note:** The storage closets in the carport were locked at the time of inspection and inaccessible.
