This report is prepared exclusively for **John Doe**  
Inspected On: **12-17-2021**

## 2022 Tiffin Allegro Red 37PA

**Inspected By:**

Wayne Kosters

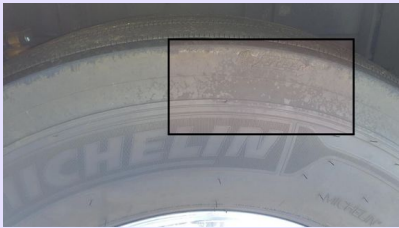
**(TW-2) Minor Issue:**  
Weather checked tires

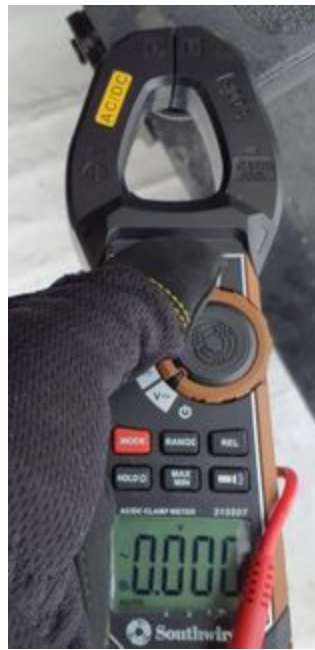
*No Excessive Voltage at Steps*

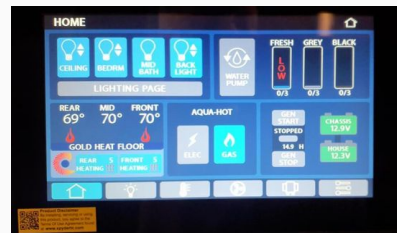
Monitor Panel

🔧 **(WS-3) Minor Issue:** The prospective owner was unable to connect to the Spyder interface / monitor panel via Wi-Fi. It is recommended that this interface be verified and the owner guided through the setup process.

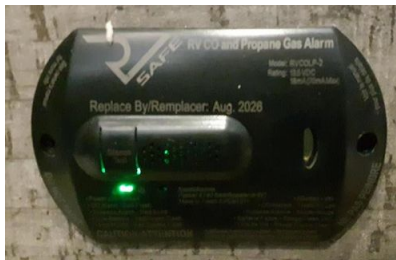
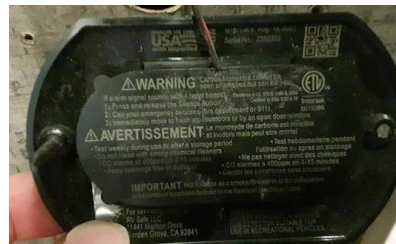
The combination LP / CO detector located near the floor on the curbside near the bedroom passed the LP spray test

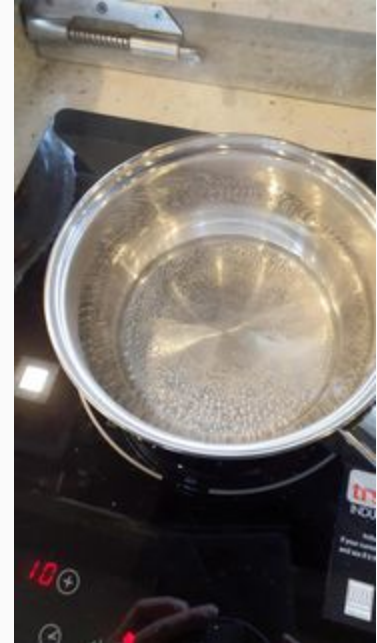
*Induction Cooktop*

☆ **(AK-3) Notice / Comment:** Induction cooktops requires pots and pans that are made of ferrous (meaning magnetic) materials. Check your cookware's retail box for the induction symbol. To tell if your current cookware is compatible with the induction technology, grab a magnet and see if it holds.
